**Behavior of Dams during the 1995
Hyogoken-Nambu Earthquake and
Earthquake Resistance of Dams**

Behavior of Dams during the 1995 Hyogoken-Nambu Earthquake and Earthquake Resistance of Dams

Yoshikazu YAMAGUCHI, Dr. Eng.

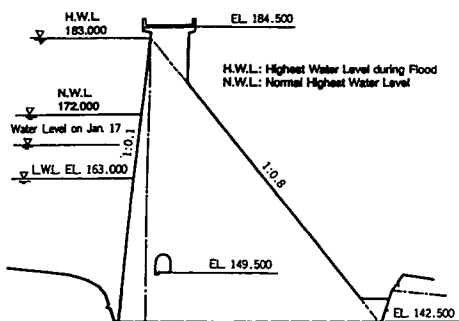
Figure 5. Cross section of Yuzuruha Dam.

The Yuzuruha Dam, a concrete gravity dam with a height of 42 m, is located about 43 km from the epicenter. Figure 5 shows the cross section of the dam. According to the report by the site office, concrete fragments fell down from the upstream face of the dam. However, the on-site inspection revealed that repair mortar spread at the surface of the dam had fallen down and there was no damage in the dam body itself (see Photo 1).

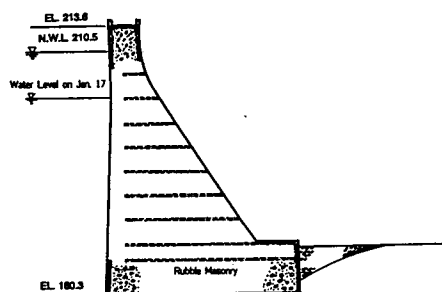
Figure 7. Cross section of Gohonmatsu Dam.

The Gohonmatsu Dam, Japan's first concrete gravity dam (rubble masonry structure) with a height of 33.3 m and completed in 1900, is located about 19 km from the epicenter. **Figure 7** shows the cross section of the dam. Rock fragments fell from the left abutment into the spillway, but the spillway was not damaged. Hairline cracks were observed in the capping concrete on the crest railing, but no cracks were observed in the dam body.

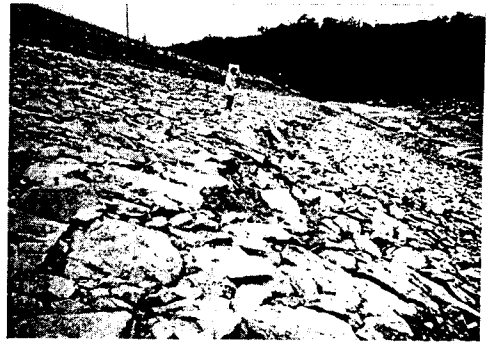
The reservoir is located about 31 km from the epicenter. **Figure 8** shows the cross section of Dam No.1. This 24.5-high dam was constructed using decomposed granite soil as fill material and was embanked on a foundation of weathered granite. A shallow sliding occurred in the upstream surface (see **Photo 3**). Later examination revealed that the sliding was shallow and did not affect the safety of the dam.

Photo 3. Kitayama Dam No. 1 : Shallow sliding at the upstream slope.
