Some Case Studies of Hydrodynamic Bearings in Power Plants in Japan

Some case studies of hydrodynamic bearings in power plants in Japan

Tanaka M.^a

Keywords : Journal bearing, thrust bearing, oil seal, damage, tribology, steam power plant

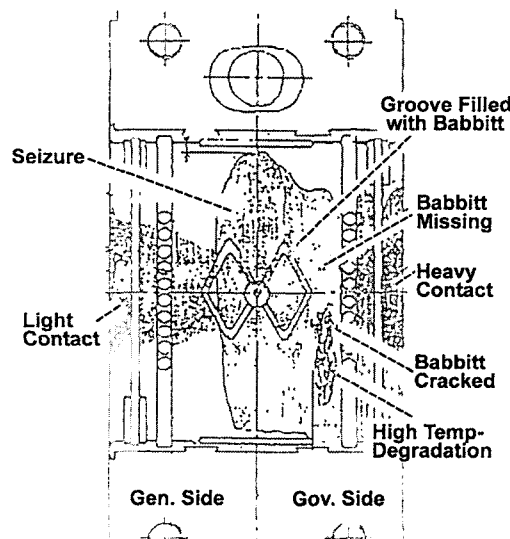
The first case to be discussed is journal bearing seizure which happened in a steam turbine power plant of 500 MW in output. The operation monitoring system announced high temperature warning of the pad surface and discharged oil in a sleeve bearing installed in a low-pressure turbine during startup. When urgently stopped and inspected, and seizure and heavy uneven contact were found on the pad surface.

Figure 3 shows a schematic of the damaged surface of the bearing pad. There are oil discharge ports in the grooves at both bearing ends. Seizure is found to have taken place on most part of the pad surface, and the jack-up oil groove is filled with Babbitt metal that melted, flew and solidified again. Heavy contact is observed on the governor side, while light contact is found on the generator side.

Fig.3 Damaged surface of journal bearing

Fatigue crack of bearing metal was ruled out because macroscopic and microscopic inspection found neither pinholes nor casting defects. Chemical composition and hardness of the bearing metal were found to be normal.

The primary (direct) cause is that the hydrostatic oil film failed to develop because the high oil pressure could not be maintained due to large bearing clearance on the generator side that resulted from excessive bearing tilt angle. However the initiators that triggered the chain reaction were the reduction of bearing width carried out to suppress oil whip that had happened in this turbine before, and also the large jack-up oil groove unchanged in

spite of the width reduction. Hydrostatic oil film can be easily developed with a large oil groove, but in this case the jack-up oil system was not effective because of its large groove size. The reduction of the bearing width resulted in the decrease in the restoring moment of oil film. The expediting promoter was a tight clearance of the spherical key of the bearing (Fig. 4), resulting in the excessive angular misalignment of bearing.

Trouble shooting was carried out as follows. The jack-up oil groove was reduced in size to keep high pressure easily even with a large clearance due to bearing tilt. The spherical seat clearance was increased by 0.1 mm for easy tilt movement of the bearing when applied by restoring moment of oil film in spite of possible clearance reduction due to thermal dilation of the bearing. These countermeasures worked well.

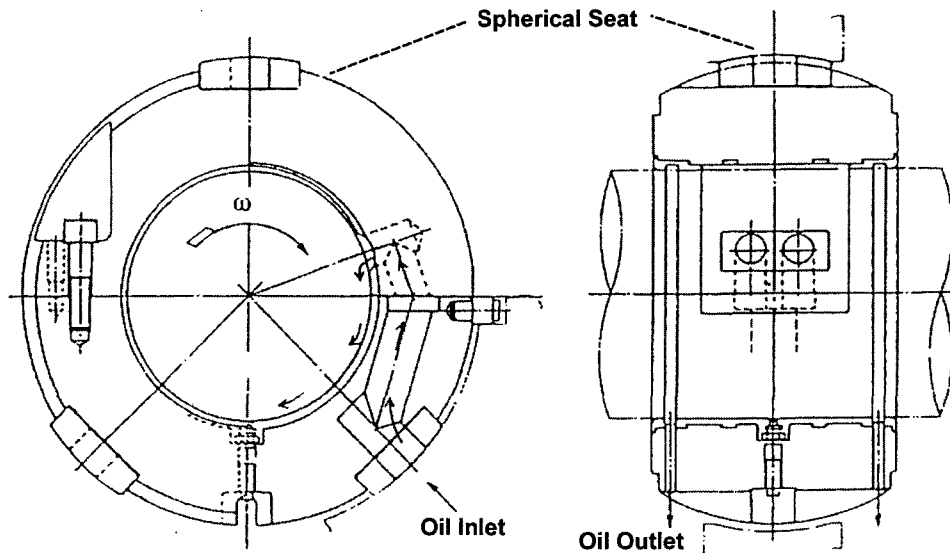
Fig.4 Spherical key of journal bearing

Poorly working spherical seats are reported to have caused many similar troubles of journal bearing. The dimension of the spherical seat clearance is difficult to decide because bearing housings usually dilate and/or deform due to temperature change. Furthermore, friction between keys and seats cannot be predicted accurately, because the friction mode is boundary lubrication or dry friction. Basic studies are needed to unravel these uncertain factors which are often omitted to go over at the design stage.

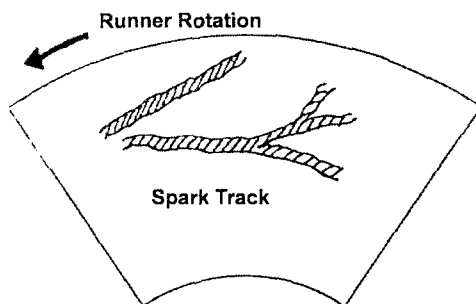
Another unit of identical design was inspected, and spark tracks of 0.5 to 1.5 mm in depth and frosting damage were observed on thrust pad surfaces (Fig. 5). Consequently electric pitting was assumed to trigger the meltdown trouble.

Fig.5 Electrical Pitting on thrust pad

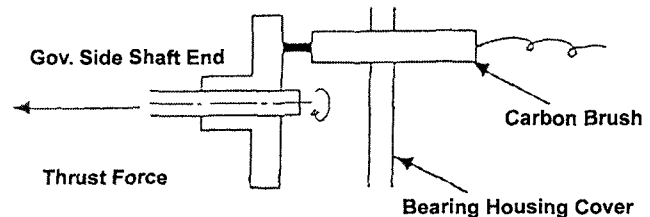
Carbon brushes are usually installed to ground or earth rotors (Fig. 6). However carbon brushes were found not to maintain good contact with the rotating surface because of soft spring pressure. This is the initiator that triggered the chain of events. Furthermore, two promoters were found, that is, oil film formed in the brush tip clearance increased the electric resistance of the contact point, and the turbine thrust force acted so as to separate the contact.

Fig.6 Carbon brush earth

For countermeasure, the design of the carbon brush unit was changed, and an oil-free contact point was newly selected for the brush.

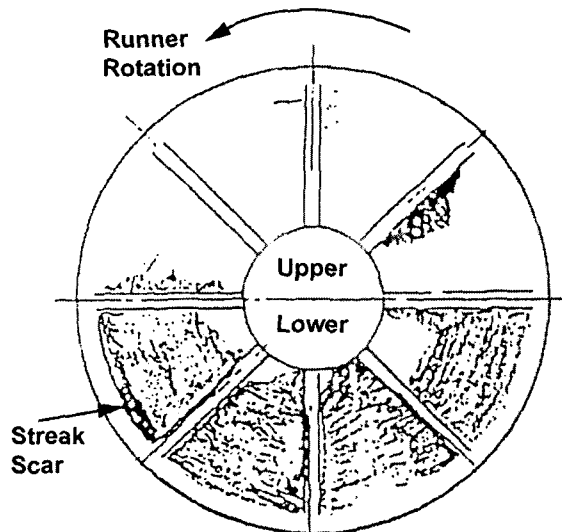
The metal temperature thermometer was found to read 35 degree above the supply temperature during startup and also to read higher with the increase in power output. When inspected, surface damage was found on the land part of lower pads, while the tapered part was discoloured. Furthermore, a circumferential scar was found on the outer peripheral part (Fig. 7), and some metal debris was found in the strainer of the lubricating system.

The initiator is the increase in thrust load, compared to that of the original turbine of 30 MW. When the steam turbine of higher power output of 65 MW was designed, the thrust load was regarded unchanged, resulting in using a thrust bearing of the same design. However the thrust load actually increased, because of higher contribution of the reaction stage.

Each pad was made so that the original clearance should decrease gradually from the inner periphery to the outer periphery in order to increase load carrying capacity of the bearing. However, operating clearance calculated at the outer periphery was found too small, and local deformation of the pad assembly due to high operating temperature rise there may have decreased the oil film thickness, causing metal-to-metal contact. This is regarded as one of the promoters.

Fig.7 Damage on lower thrust pads

For countermeasures, the spherical seat clearance was increased from 20 micrometer to 40 micrometer in order to ensure the bearing alignment more easily. The thrust bearing clearance at the outer periphery was increased to 80 micrometer to avoid local thermal deformation and direct metal-to-metal contact even at high operating temperatures. Furthermore, another pair of thermocouples was newly installed to detect uneven loading from temperature difference measured. One pair of thermocouples is difficult to detect uneven loading quickly.

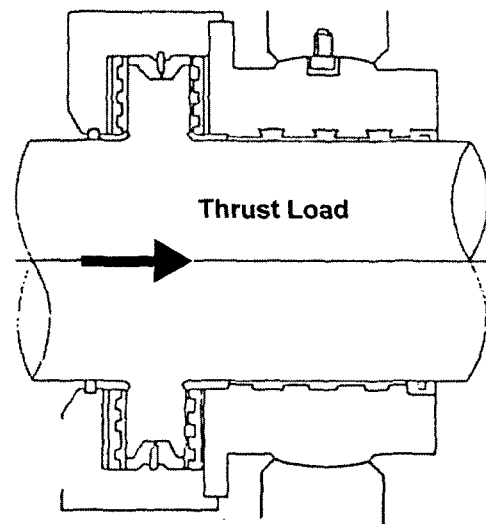
This thrust bearing is also affected by the operating condition of the journal bearing because both bearings are contained in the same housing (Fig.8). When the bearing casing moves vertically due to temperature change and the spherical seat of the journal bearing does not work well, thrust pads are loaded unevenly because of misalignment. Then excessive load would be applied to the lower pads, and this is regarded as the possible primary cause of the surface damage. On the other hand, poorly working spherical seats are regarded as another promoter.

Fig.8 Bearing housing

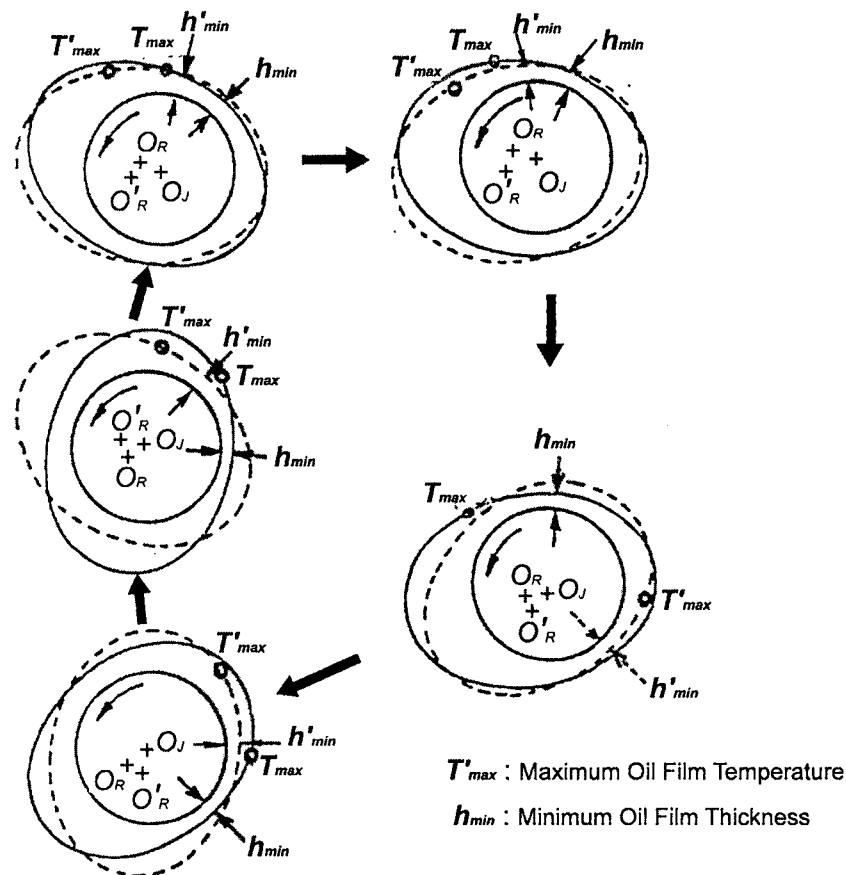
From experiments conducted with a model seal ring of actual size, the seal ring was found to deform elliptically due to non-uniform thermal distribution. Furthermore, the axis of the elliptical shape was found to rotate with time. The period of one revolution was found to be 99 seconds. This periodical deformation yields cyclic loading to the Babbitt metal, and is presumed to be the primary cause.

Thermo-hydrodynamic analyses revealed that this cyclic deformation was a self-excited oscillation that takes place when some conditions are satisfied [1]. Figure 9 shows the schematic of the cyclic deformation. The seal clearance corresponding to the ring shape defined by the solid line at one time prepares the ring shape defined by the broken line at the time of next step. The key factor of this phenomenon is the difference of the circumferential positions of the minimum film thickness and the maximum oil film temperature.

Fig.9 Cyclic thermal deformation of seal ring

On the other hand, the initiator was designing a seal ring with the same section area unchanged and with the diameter increased, based on the design of a seal ring of small size for 2-pole generator. Therefore the bending stiffness of the seal ring was insufficient, resulting in large deformation. The promoter was a large amount of heat generation due to a small seal clearance and also the high viscosity of sealing oil.

For countermeasure, the seal ring section area was increased by about 50 %, resulting in the increase in bending stiffness. Furthermore, the seal clearance was increased and the supply temperature of sealing oil was increased, which reduced heat generation in the oil film and suppressed the self-excited oscillation.

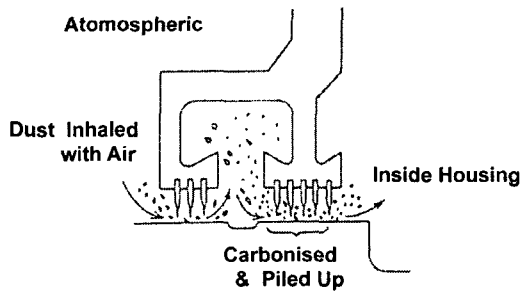
When inspected, mixture of lagging dust and carbonised oil was found in a labyrinth oil seal installed by the journal bearing housing on the high-pressure turbine side (Fig. 10). The temperature measured at the seal was about 160 degree. A reproduction experiment showed that oil started to carbonise when the temperature exceeded 170 degree. Lagging dust lowered the critical temperature that starts carbonisation.

The primary cause of the rubbing vibration is the pileup of dust and carbonised oil in the seal. When the pileup increases in amount, the shaft contacts the hard substance and the rubbing vibration starts. Then, the pileup comes off and the vibration stops, but the pileup restarts again. This explains that the vibration repeats intermittently with the period of about two hours. There are three elements of oil, dust and high temperature that make the pileup at the seal.

Fig.10 Conventional oil seal

The initiator is the sub-ambient pressure in the bearing housing that induces air flow from outside, and dust of lagging material comes with the air. The dust is trapped by the labyrinth blades and absorbs some oil droplets coming from the other side. Oil component carbonises due to the high environmental temperature at the seal position, and a hard substance is left. The sub-ambient pressure in the bearing housing must be kept to prevent oil from coming out of the bearing housing. If the pressure is very low, no oil would come into the seal section to carbonise there, but much dust would come into lubricating oil. Consequently, the set pressure was not low enough, and some amount of oil leaked into the seal section. It is a trade-off problem.

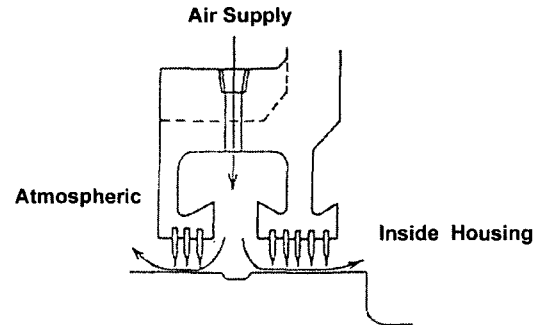
Fig.11 New oil seal

Figure 11 shows a newly designed oil seal. Pressurised air is supplied to decrease the seal temperature and also to purge both of oil droplets coming from inside and lagging dust coming from outside.
