A Review of Crud Mitigation and Management Strategy

Joon-Hyung Choi, Jin-Seok Lee, Jung-Min Suh, Jae-Won Kim, Young-Koo Kim
Korea Nuclear Fuel Co. Ltd., 493 Deokjin-Dong Yusung-gu, Daejeon, Korea, 305-353

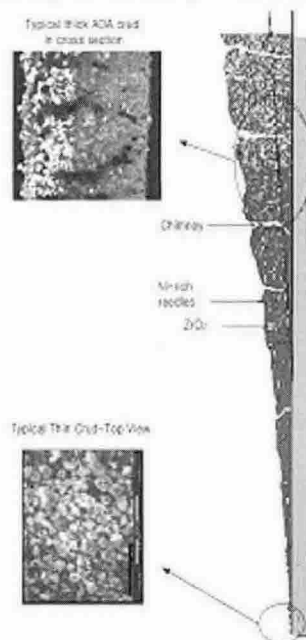
Based on the observed crud deposition patterns, it is sure that tenacious crud deposits are typically more extensive on the periphery of an assembly when two high power assemblies are coupled to create an assembly-to-assembly interface where sub-cooled boiling occurs at that interface.

The nine failed rods were located on peripheral faces of the assemblies and those faces were adjacent to other fresh assemblies in Cycle 9 and the examinations identified through-wall penetrations for eight of the ten failed rods. Those penetrations had similar characteristics and are believed to be the primary failure locations. Based on

information generated by the diagnostic inspections, it is believed that a relatively thick layer of tenacious crud deposits on high power rods directly contributed to the observed fuel failures.
