Failure of Ammonia Synthesis Converter Due to Hydrogen Attack and Its On-Stream Assessment Using ToFD Method

Farabirazy Albiruni[†] · Joon-Hyun Lee^{*}

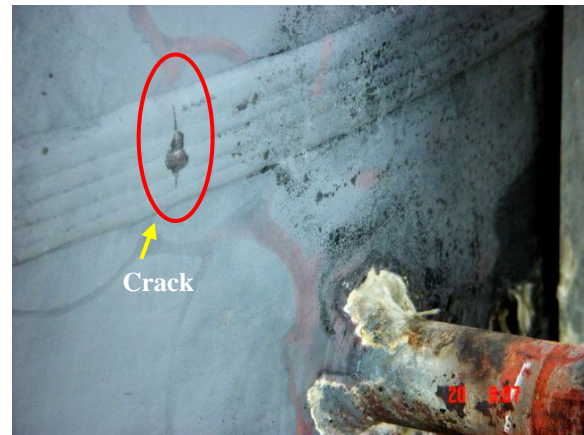
Visual observation found a leaky transverse crack with 40 mm in length on CW 2 as shown in Fig. 1 below. The crack position was 100 mm in distance after south side thermo well nozzle (180° orientation). This result agreed with the result from infrared camera observation and explosive gas level measurement that showed the area around the south side thermo well nozzle suffered leakage. By looking the crack characteristic, it is obvious that hoop stress was the major contribution for crack propagation. For TWPV which is applied internal pressure, the maximum hoop stress occurs on ID surface. Then it can be deduced that crack start from ID surface of CW joint. Maximum hoop stress, high temperature and direct contact with hydrogen gas are the major factors for crack initiation and propagation.

Fig. 1 A leaky transverse crack position on CW 2

Hardness test from OD surface shown that CW2 around the leakage zone have hardness value above the maximum value after PWHT i.e. more than 250 VHN according to NACE standard MR0175 and API 942 (4, 5). This is most caused by improper local PWHT during fabrication, such as:

The synthesis gas contained in this TWPV is rich with hydrogen gas with operating temperature around 300 °C. With improper local PWHT applied, not all bainite structure transformed into tempered bainite and residual stress reduce significantly as shown by hardness results. This makes the vessel still has high sensitivity to high temperature HA and failure occurred in two years operating time of this vessel.

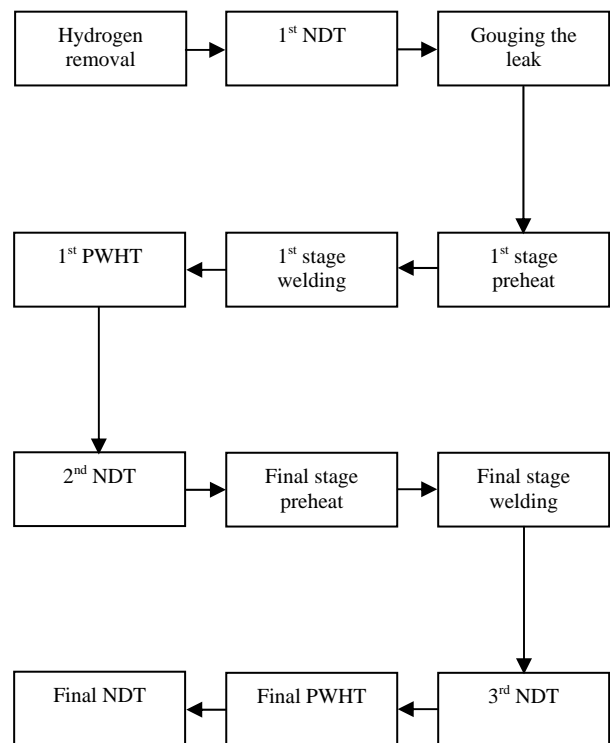
Fig. 2 Flow chart of repair procedure

Hydrogen removal is intended to remove absorbed hydrogen atoms in CW 2. This is done by using heating elements which were attached from OD surface of the vessel. The CW 2 temperature then increased into 400 ° C and held in this temperature for 5 hours and finally

The 1st preheat was performed by increasing the temperature of CW 2 into 225 °C ± 10 °C. The 1st stage welding was conducted using SMAW and fill the leak's gouging result up to 50 mm height of weld deposit (half the shell thickness). After that PWHT was applied to this repair zone by increasing temperature into 450 °C ± 10 °C and held for 4 hours, then into 720 °C ± 10 °C and held for 3 hours, finally the temperature decreased into 200 °C. In order to attain the uniform temperature distribution on repair zone, 4 thermocouples were installed on it.

The final preheat was performed by increasing the temperature of CW 2 into 250 °C ± 10 °C. The final stage welding was performed up to full thickness of the shell. Then, the final PWHT was applied to this repair zone by increasing temperature into 740 °C ± 10 °C (for WM) and 650 °C ± 10 °C (for BM) for 4 hours, and finally the temperature decreased into 200 °C.

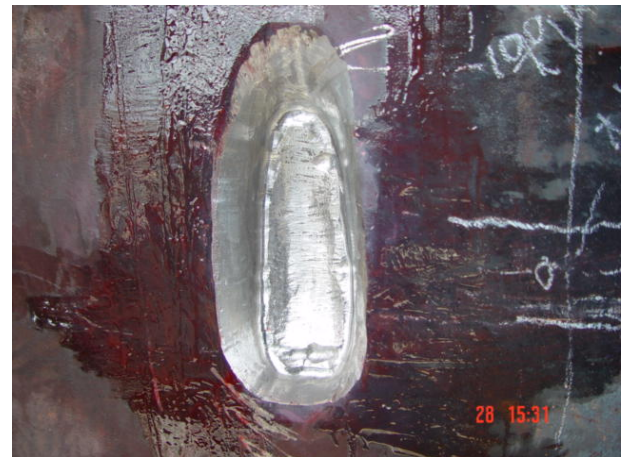
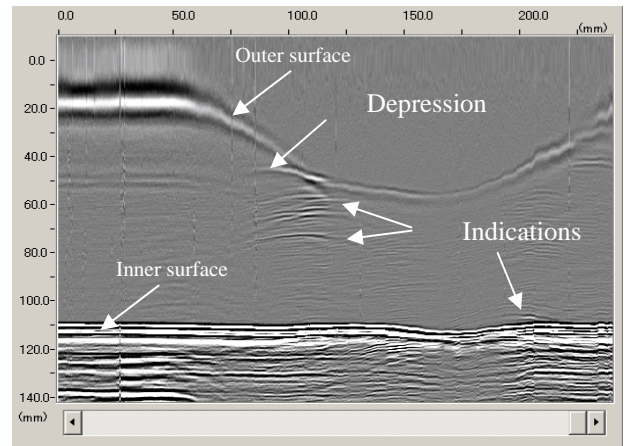
Final hardness test result is presented in Table 5 while the non destructive test results in Table 6. Fig. 3 shows the shell repair after weld up to 50 mm and its ToFD result respectively.

Fig. 3 (a). Shell repair (b) ToFD result after 1st PWHT stage

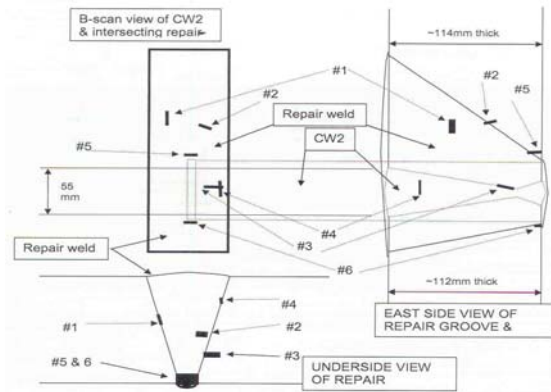
HTCUT performed after one year since the repair time. This testing conducted on-stream to vessel with outer surface temperature reach 240 °C. The gain setting for this testing was 80-85 dB. In this gain range, this testing is not suitable for detection of defects that may occur within the outer 0-25 mm range due to high level noise during testing. The accuracy of the defect's depth measurement is likely within ± 10% accurate meanwhile the height of defect is greater than actual height.

HTCUT and high temperature ToFD results are shown that all indications found were acceptable and showed

that CW2 in good condition. The results are shown in Fig. 4 and 5 respectively. The indication found from HTCUT is summarized in Table 7.

Fig. 4 Indications found by high temperature conventional ultrasonic

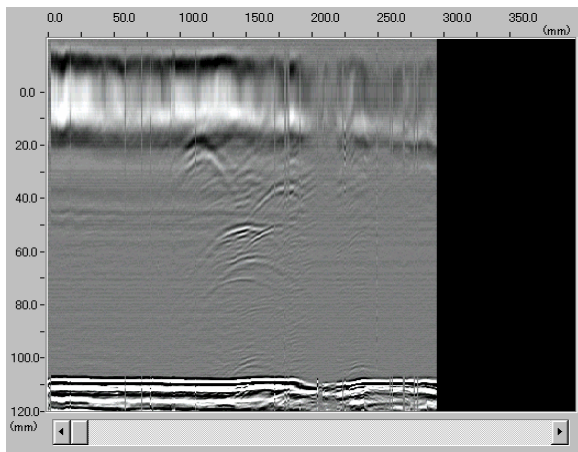
High temperature ultrasonic ToFD was also performed in order to solve the weaknesses of HTCUT for estimating the defect's height. Same as conventional one, high temperature ToFD is also not suitable for detection of subsurface defect and give high level noise up to 20 mm due to gain adjustment as shown in Fig. 5 below.

Fig. 5 Indications found by high temperature ToFD
