SAMPOONG COLLAPSE

A Tragic Man-made Disaster

1. Outline of the Accident

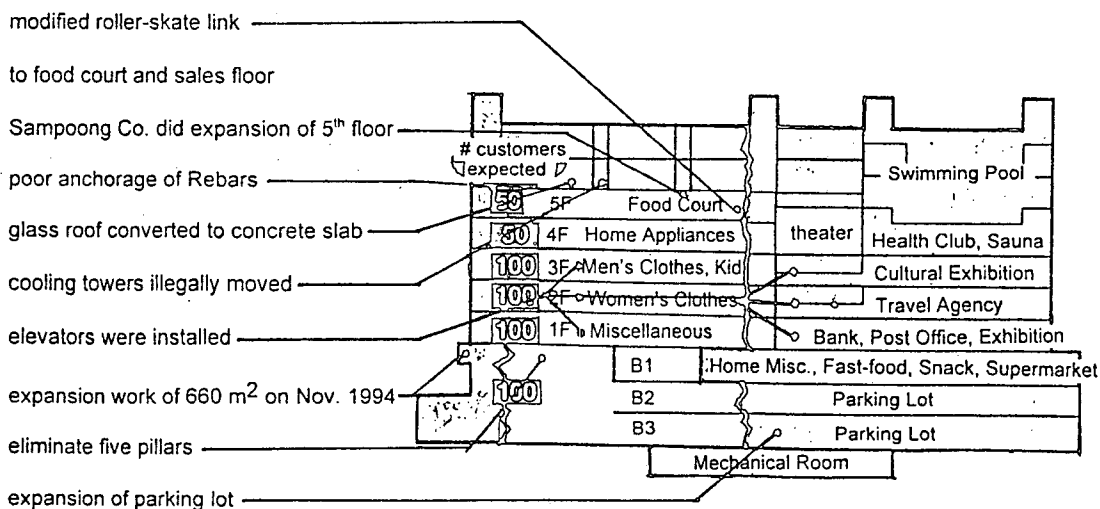
- ~mostly store employees and evening shoppers.
- (5) Bldg. Structure : Reinforced concrete structure, flat slab system w/ drop panels.
- (6) Stories : Five stories above ground and four basement floors.
- (7) Floor Area : Total 73,877m²
- (8) Construction Period : Sept. 1987~Dec. 1989.
~elapse of year : five and a half years.
- (9) Section of Building
