Detection of the Ultrasonic Signals due to Partial Discharges in a 154kV Transformer

Dong-Jin Kweon*, Sang-Bum Chin* and Hee-Ro Kwak**

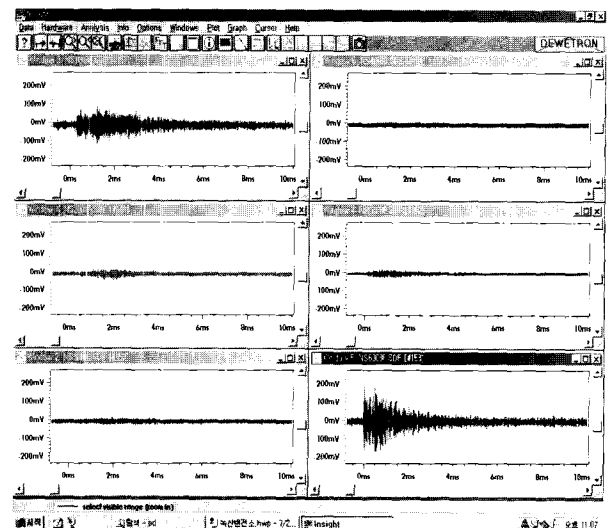
Fig. 6 Ultrasonic signals in the first test

In the first test, the 18 ultrasonic signals occurred for 14 hours of measuring time. 11 of them had the maximum value in magnitude at sensor ⑥, 3 of them had at sensor ①, 2 of them had at sensor ③, and the rest were at sensors ② and ④. The delayed time from the ultrasonic source to the sensor was the shortest where the magnitude of the ultrasonic signal was the maximum.

Fig. 6 shows an example of ultrasonic signals in the first test. The magnitude of ultrasonic signals was in the order of sensors ⑥, ①, ② and ⑤. The result of Fig. 6 illustrates that the partial discharge was the closest to the sensor ⑥

and nearly the same distance from sensors ② and ③. The reliability of detecting sensitivity which was doubted due to the signal prolonged by the transformer structure from the core and winding was confirmed by the result of Fig. 6. This is because the ultrasonic signals could now be detected by both sensors ⑥ and ③ mounted diagonally.

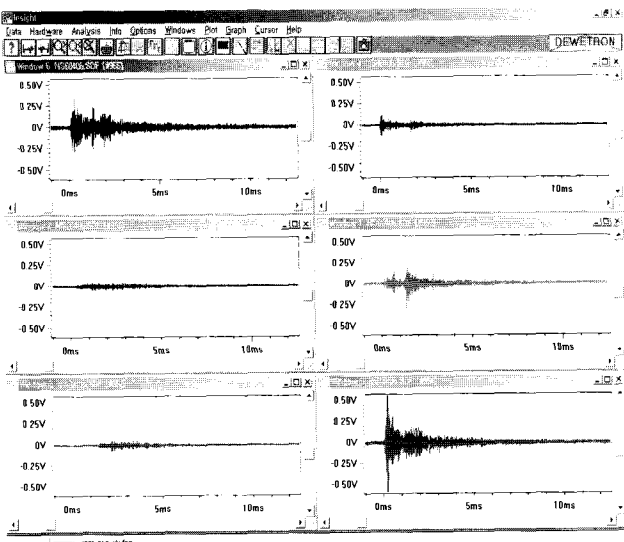
Fig. 8 Ultrasonic signals in the second test

Fig. 8 shows some examples of ultrasonic signals in the second test. The 19 ultrasonic signals occurred for 9 hours

of measuring time. 17 of them had the maximum value in the magnitude at sensor ⑥, one had at sensor ⑤, and another had at sensor ①. As shown in Fig. 8, the magnitude of the ultrasonic signals was in the order of sensors ⑥, ①, ⑤ and ④. In addition, the ultrasonic signals were clearly measured at sensors ④ and ⑤. Therefore, the existence of the partial discharge in the transformer was confirmed by the analysis of the magnitude and the time difference of the ultrasonic signals.

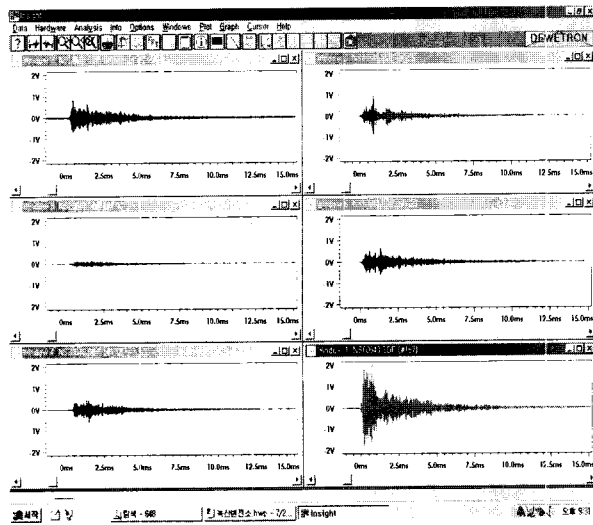
Fig. 10 Ultrasonic signals in the third test

Fig. 10 shows some examples of ultrasonic signals in the third test. The 18 ultrasonic signals occurred for 24 hours of measuring time. 17 of them had the maximum value in magnitude at sensor ⑥, and the other was at sensor ①. As shown in Fig. 10, the ultrasonic signals at its maximum were measured at sensor ⑥, and the minimum at sensor ②. From this, it was inferred that the partial discharge source was estimated around the sensor ⑥, that is, the upper position of the transformer.

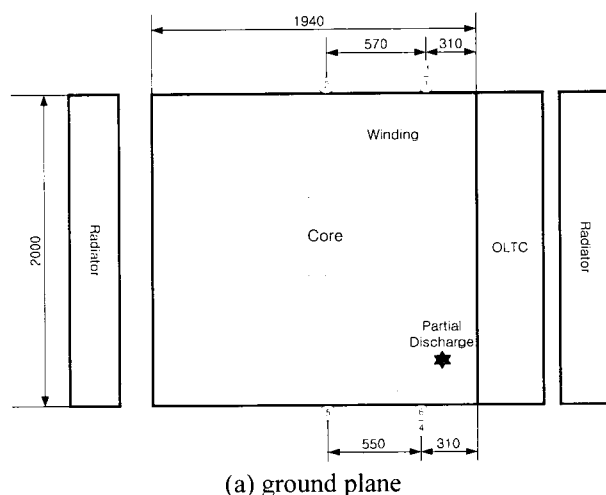
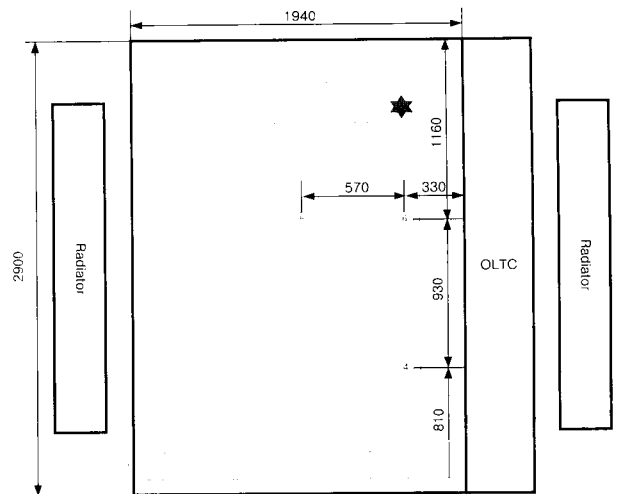
Fig. 11 Location of the partial discharge

Based on the results of the gas analyses in oil and the ultrasonic detecting tests that find the partial discharge, an internal inspection was carried out to the transformer. After draining the oil, the inside of the transformer was visually inspected. After 5 minutes of inspection, the partial discharge was found to be based on the estimated position result of ultrasonic detecting tests as shown in Fig. 11.

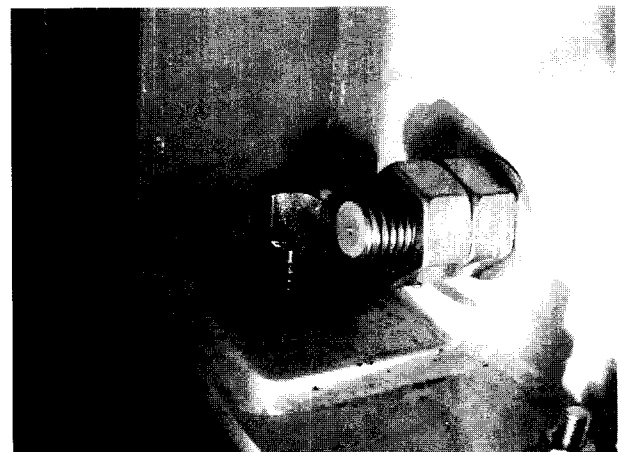
As shown in Fig. 12, the carbonized marks due to partial discharge on the pressboard supporting the bolt which fastens the windings and the frame were at the upper position of the transformer. It was considered that the partial discharge occurred due to the phenomena of the loose bolt. Even though another partial discharge was inspected as well, it could not be found anymore. After the transformer was repaired by erasing the carbonized marks and fastening the bolt, the transformer is in service without any abnormal symptoms. The reliability of the developed on-line ultrasonic detector used in this study could be confirmed by measuring the ultrasonic signals due to partial discharge in the power transformer.

Fig. 12 Carbonized marks due to the partial discharge
