Application of hydrogeological and geophysical methods to delineate leakage pathways in an earth fill dam

Sung-Ho Song¹ Yoonho Song² Byung-Doo Kwon³

ABSTRACT

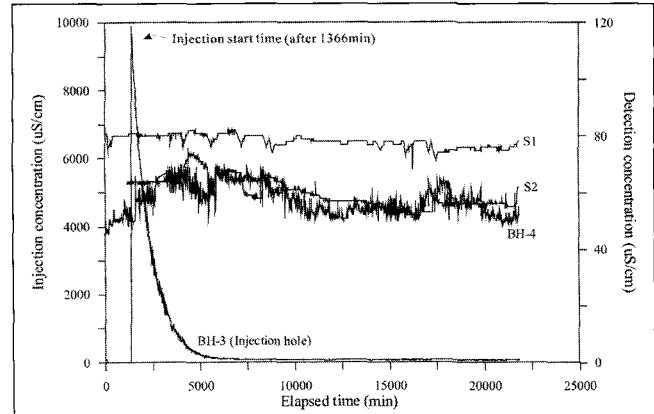
Test 1 was performed by continuous injection of tracer at the rate of 0.56 L/sec for 20 minutes into BH-3. This borehole is located in rock at the right-hand end of the dam wall, and the test was to analyse the effect of aquifers in the abutment and surrounding rocks. The total amount injected was 700 L, and conductivity measurements were made every five minutes for 25 days. The electrical conductivity in BH-3 returned to background values after two days, but neither the conductivity in BH-4, located in the dam wall near the right abutment, nor the conductivities at S1 and S2, changed during the test period (Figure 3).

Fig. 3. NaCl concentrations in tracer Test 1. Left-hand axis: concentration in injection borehole BH-3. Right-hand axis: concentration in observation boreholes.

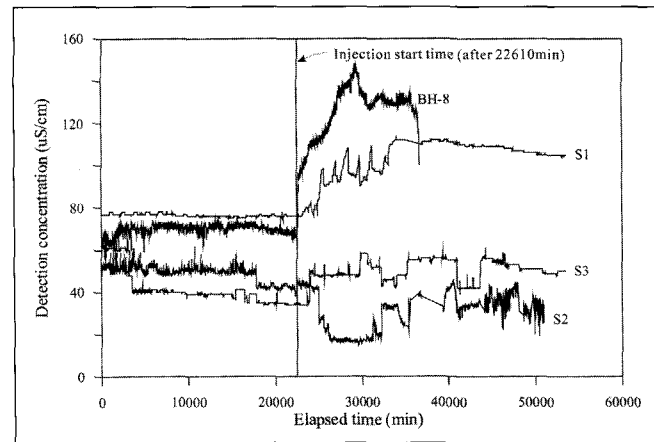
Test 2 was performed by the instantaneous injection method, with 1000 L of tracer injected at BH-7, located near the centre of the crest, to find leakage through the right abutment. The maximum increases of electrical conductivity at both BH-8 and S1 were observed about 6800 and 11500 minutes after injection, respectively, but conductivities at S2 and S3 did not change during the test period (Figure 4). This indicates that the tracer was being diluted in the subsurface as it moved to the leakage point. From the results, it is obvious that leakage is through the right abutment; the leakage rate from BH-8 to S1 is calculated to be 12.1 m/day.

Fig. 4. NaCl concentrations in tracer Test 2.

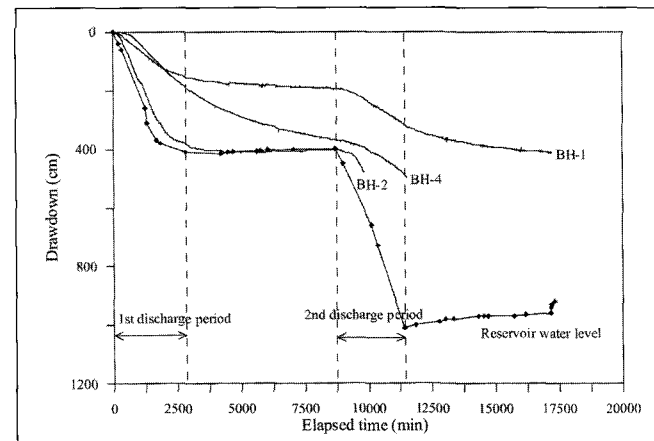
Fig. 5. Drawdown curves for the three piezometers in the dam wall. The drawdown rate in hole BH-2 is the same that of the reservoir water level.

The drawdown curves at BH-1, BH-2, and BH-4 show that the piezometric level at BH-2 varied in a similar way to the reservoir levels, but the level at BH-4 continued to descend even when discharge was halted. The drawdown at BH-1 also followed reservoir water levels, although the changes were smaller than at BH-4 (Figure 5). These results indicate that the major leakage may occur at the bedrock boundary near BH-2 and BH-4.

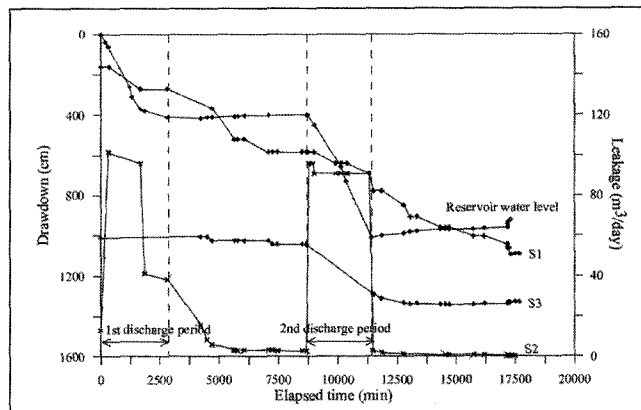
Leakage rates at leakage points S1, S2, and S3 were also recorded to observe the effect of changing reservoir levels. As shown in Figure 6, the trend of leakage changes at S1 was similar to the trend of the reservoir level, whereas the leakage at S2 occurred only during discharge periods. At S3, leakage was approximately constant until the second discharge period. This indicates that the leakage pattern at S1 was mainly affected by leakage through the right abutment, and also that the leakage pathway in this dam may be through the right abutment close to the bedrock boundary near BH-2 and BH-4.

Fig. 6. Leakage curves (m^3/day) at the three leakage points during discharge of water from the reservoir. The leakage pattern at point S1 was similar to the variation in discharge of reservoir water.

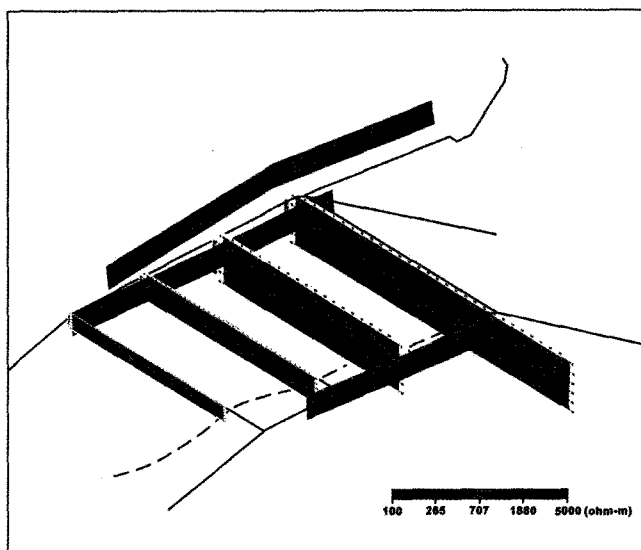
The electrical resistivity sections show a major low-resistivity anomaly of less than 300 $\Omega\cdot\text{m}$ from the right side of the dam to the outside of the crest, and this anomaly splits up at the lower step along the right abutment (Figure 7).

Fig. 7. Results of the dipole-dipole electrical resistivity survey. Inset at upper left indicates location of the lines on the reservoir dam. The dotted line indicates the boundary of the right abutment. A low resistivity region along right abutment elongates at the lower step.

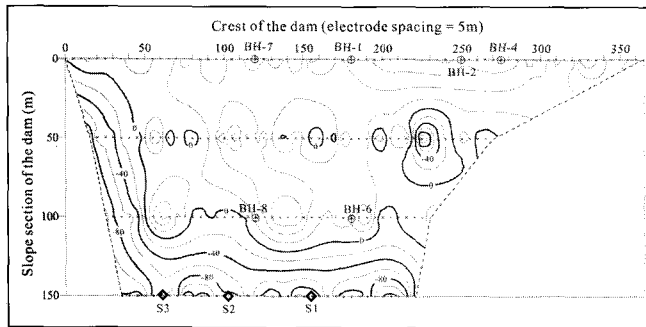
Fig. 9. Interpolated contour map of SP obtained from an array of non-polarizable electrodes on the crest and slope of the reservoir dam. A strong negative SP anomaly can be seen near the right abutment at the first step of the dam wall, spreading towards the downstream toe. The electrode locations are marked by a x symbol along the crest and each step.

As we can see in Figure 9, a strong negative anomaly of up to -120 mV is observed at the first step, near the right abutment, and the anomaly splits at the third step. This compares with the low-resistivity regions at the lower step in the dipole-dipole survey result, from which we can delineate the leakage pathway through the right abutment.

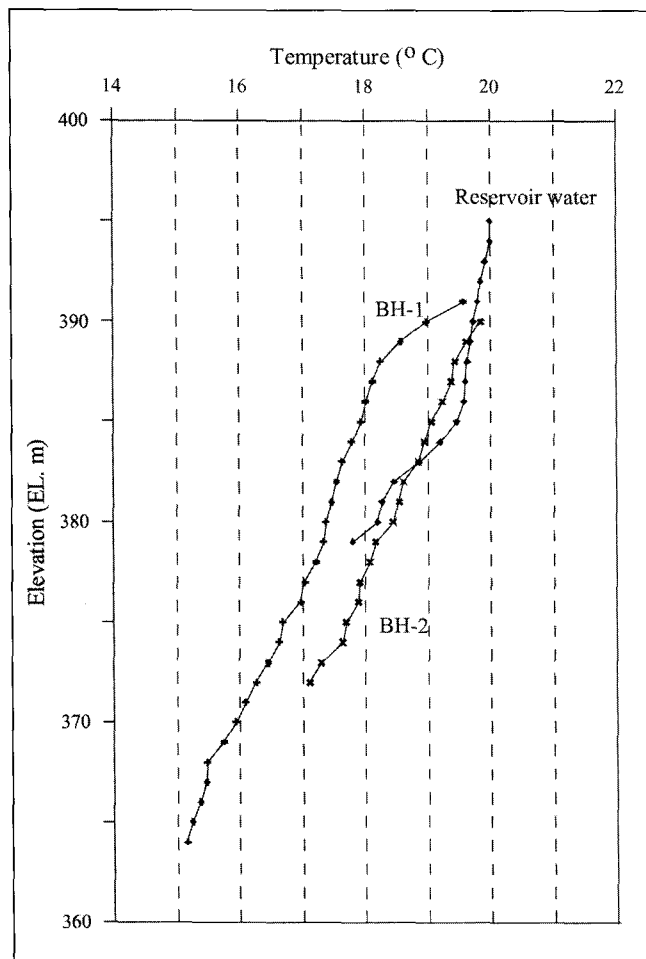
Fig. 10. Comparison of temperature logs at two pilot holes in the dam wall with reservoir water temperatures. Temperature variation of water in BH-2 is similar to that of reservoir water.

We ran temperature logs in the reservoir water and in boreholes BH-1 and BH-2 in the dam, to identify the leakage pathway through the right abutment (Figure 10). We could verify that there is a leakage pathway through the right side of the abutment, because the variation of temperature with depth in BH-2, located close to the right abutment, is almost the same as that in reservoir water.
