## Compaction Grouting for remedial works of Settlement of CWIS(Cooling Water Intake Structure) of a Power Plant

Su-Jung Gwak<sup>1)</sup>, Man-Soo Lee<sup>2)</sup>

The unexpected settlement of the CW Intake Structure (CWIS) of Combined Cycle Power Plant 450MW CCPP in Bangladesh has been continuously observed after this structure was completed.

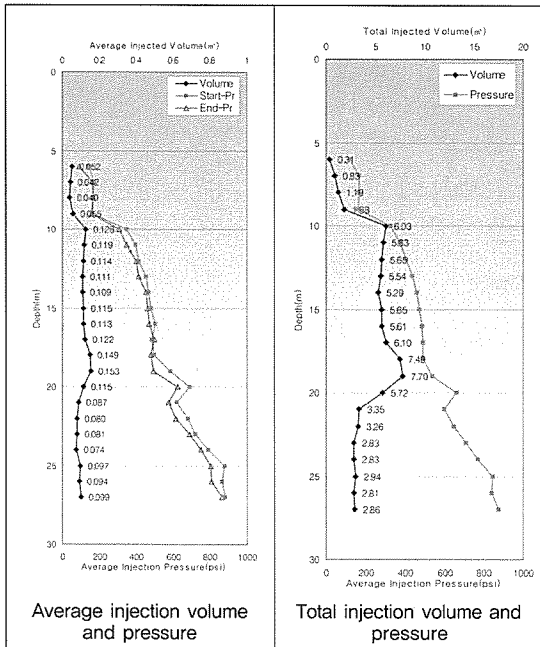
Fig. 3 Injection Profile per depth for Hole at right side of the CWIS

Based on the analysis of Injection profile per depth for hole at right side of the CWIS as shown in the below graph, the density of soil layer under G.L-21.0m was high therefore injection pressure must also high. That's why injection volume was less. But from G.L-21.0m to G.L-10.0m, the injection pressure had been rather lower and the density also loose. Especially from G.L-19.0m to G.L-18.0m, the injection volume was the largest in quantities same as the CPT test result done before injection.

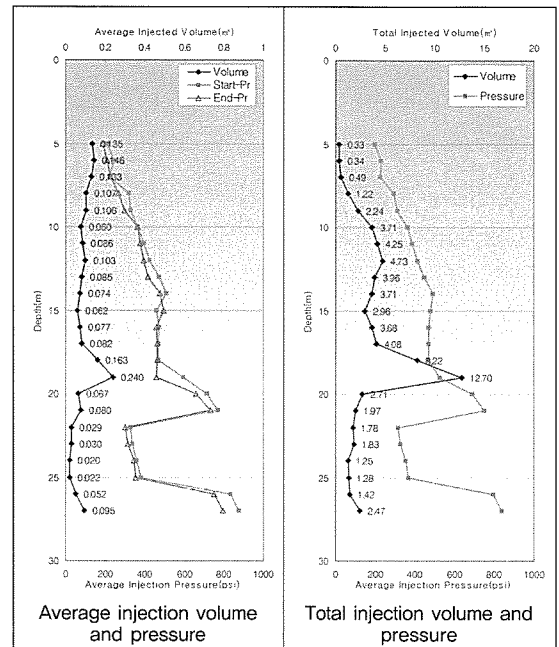
Fig. 4 Injection Profile per depth for Hole at left side of the CWIS

Based on the analysis of Injection profile per depth for hole at right side of the CWIS as shown in the below

graph, the density of soil layer under G.L-20.0m was high therefore injection pressure must also high. That's why injection volume was less. But from G.L-20.0m to G.L-10.0m, the injection pressure had been rather lower and the density also loose. Especially from G.L-19.0m to G.L-18.0m, the injection volume was the largest in quantities same as the CPT test result done before injection.

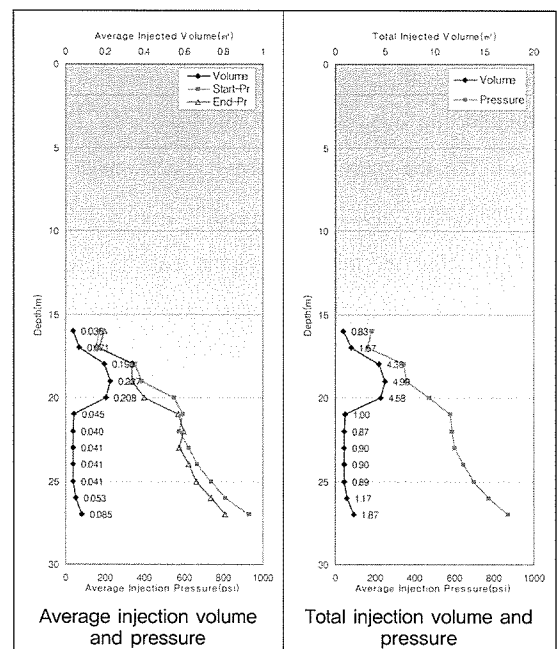
Fig. 5 Injection Profile per depth for Hole at water side of the CWIS

Based on the analysis of Injection profile per depth for hole at right side of the CWIS as shown in the below graph, the density of soil layer under G.L-21.0m was high therefore injection pressure must also high. That's

why injection volume was less. But from G.L-21.0m to G.L-17.0m, the injection pressure had been rather lower and the density also loose. Especially from G.L-20.0m to G.L-18.0m, the injection volume was the largest in quantities same as the CPT test result done before injection.

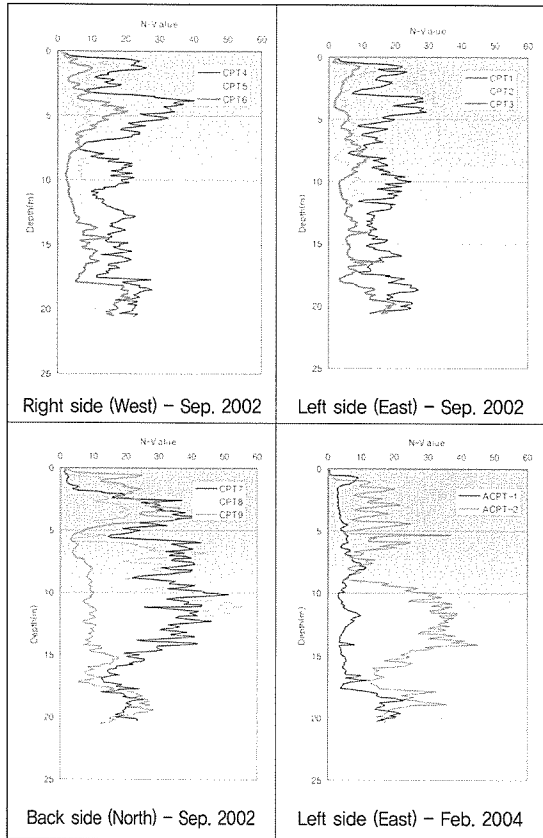
Fig. 7 Subsurface Conditions by CPT result before grouting execution

loose to loose zone of sands and silty sands below 3m(G.L-18.5m) the base of CWIS(on southern side area), where it abuts the sheet piles(test location CPT 2, CPT 3, CPT 5 and CPT 6). But the subsurface profile at test locations CPT 1, CPT 4, CPT 7, CPT 8 and CPT 9 indicated the presence of a medium to very density zone of sand and sand silty.

The additional CPT's indicated the presence of a very

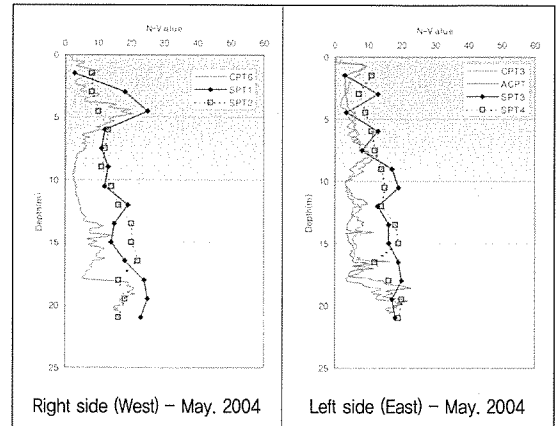
Fig. 8 Analysis of SPT Test result after Grouting Execution

Comparing the SPT result before and after remedial work as the below ;

- 3) Based on the analysis of comparing the SPT results before and after remedial work, N-value has been increased average 52~66% per depth. Soil condition has been much improved after CGS work.

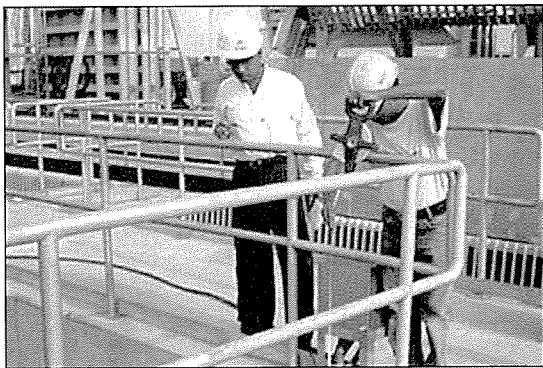
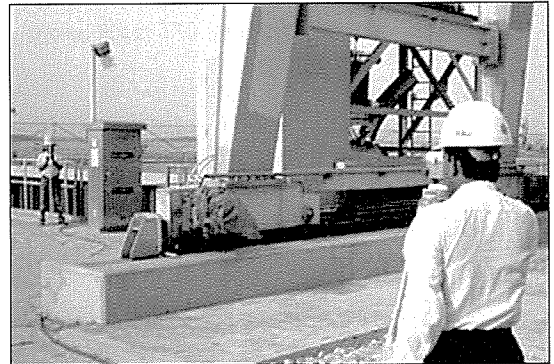
Fig. 10 Settlement Analysis

Based on the comparison of the settlement value for six points and water level data, it is concluded that settlement of the CWIS had been occurred in case water

level had gone up and down as shown in the below graph. Compaction Grouting System(CGS) works had been executed since March 20, 2004, starting from the point on the right side of the CWIS. At the beginning

stage, the settlement at the point 5 had occurred about 1mm due to water inflow during drilling works. However, after the completion of grouting execution on April 10, 2004, settlement has been no more in progress.

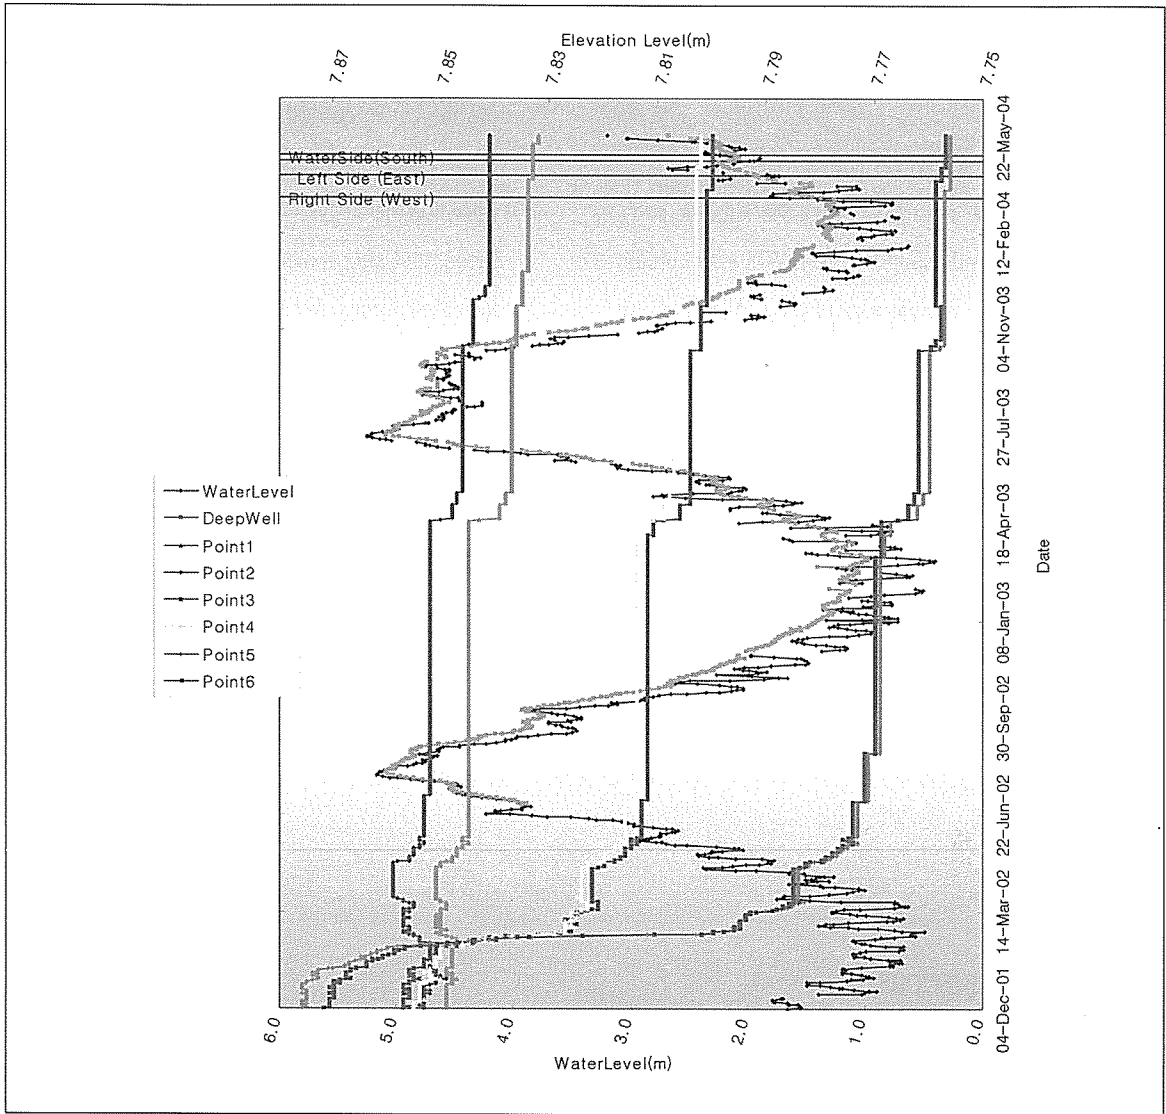
Fig. 11 Level Check Result

From April 11, 2004 to April 26, 2004, CGS works had been executed on the left side of the CWIS, settlement of the CWIS had been occurred about 1mm due to same reason as point 5. But after the completion of grouting execution, settlement of the CWIS has no more occurred at present.

- 4) Based on the comparison of the settlement value for six points and water level data, after the completion of CGS work, settlement of the CWIS has no more occurred at present.
