Analysis of Annual System Operating Characteristics at Hangwon Wind Farm on Jeju Island

제주 행원 풍력발전단지의 연도별 시스템 운전특성 분석

Abstract

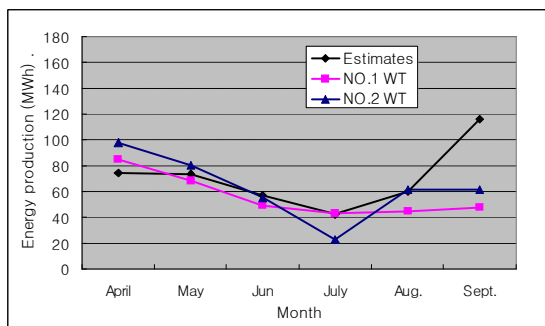
Fig. 3 The comparison of the estimated production and the actual production in 2005

Based on the wind data obtained from the meteorological mast and the power curve of the 600 kW wind turbine tested, the wind turbine production was estimated and was compared with actual production. Figure 3 represents the comparison of the estimated production and the actual production in 2005.

The number 1 wind turbine has the largest difference between the estimated production and the actual production in September. Also when compared with the estimated production, it can be seen that the number 2 wind turbine has sufficiently lower actual production during July.

The primary reason for this is that those months have the lowest availabilities, as shown in Tables 3 and 4. Therefore, it can be concluded that the stop of the wind turbine, due to various problems, directly affects the wind turbine production.

In the case of the number 2 wind turbine during September, in spite of the comparatively high availability of 90.1 percent, there is a great difference between the estimated production and the actual production. That resulted from the half-operation of the wind turbine generator system. The system specially operated only half of the rated power of the wind turbine for safety during that time because of the malfunction of a bypass contactor.

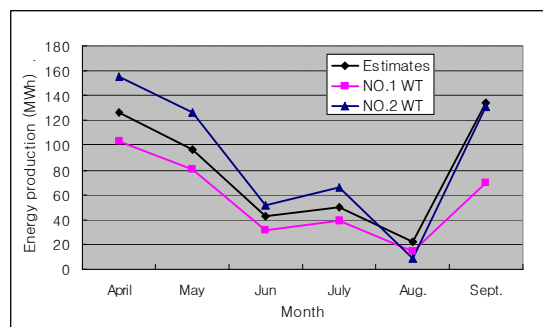
Fig. 4 The comparison of the estimated production and the actual production in 2006

The comparison of the estimated production based on the wind data from the meteorological mast and the actual production in 2006 is shown in Fig. 4. It can be seen that the difference between the two wind turbines production is sufficiently observable through all the months. The reason for this is that the number 1 wind turbine had a low availability as shown in Table 3. Furthermore it had switched to half-operation due to a malfunction of the

VRCC (Vestas Rotor Current Control) from May to September. The number 2 wind turbine production was much lower during August than the estimated production, even lower than the number 1 wind turbine production. That was mainly caused by the lowest availability in August, as shown in Table 4. With regard to the number 2 wind turbine, the actual production in April to July is higher than the estimated production during those months, while two kinds of production have similar values in September. The causes are considered to be coming from both a very high availability and the wake effect behind the wind turbines.

On the other hand, in the case of September 2006, since the prevailing wind direction was from the east-northeast and the northeast, where the sea lies, wind flow distortion did not occur much for both the meteorological mast and the number 2 wind turbine. Accordingly, the actual production was considered to be almost the same as the estimated production, as shown in Fig. 4.

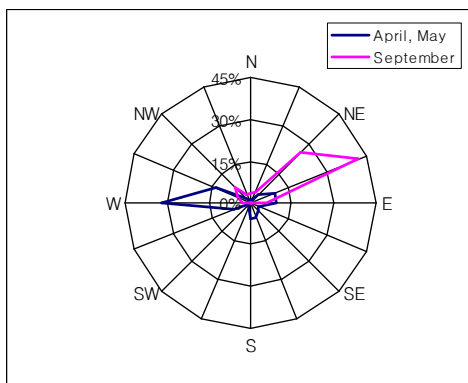
Fig. 5 Wind roses for both April and May, and September based on the wind direction data with a wind speed of more than 4m/s

In order to clarify the wake effect, the wind roses in April, May and September were derived from the wind direction data with a wind speed of more than 4m/s, which makes the wind turbine operate. The result is shown in Fig. 5. The prevailing wind directions in April and May were from the west and the west-northwest. As shown in Fig. 1, the number 1, 2 and 3 wind turbines are located in the west of the meteorological mast from which the wind data were obtained. According to the IEC standard 61400-12, whenever the

west and the west-northwest winds blow, the meteorological mast is in the wake of the number 1, 2 and 3 wind turbines that are operating. The turbulence intensity in the wake is increased over the ambient level, and the increased turbulence was observed to reduce the energy capture of the wind turbine.⁵⁾ Therefore, the estimated production in April and May, 2006 could be an example affected by the wake behind the wind turbines.

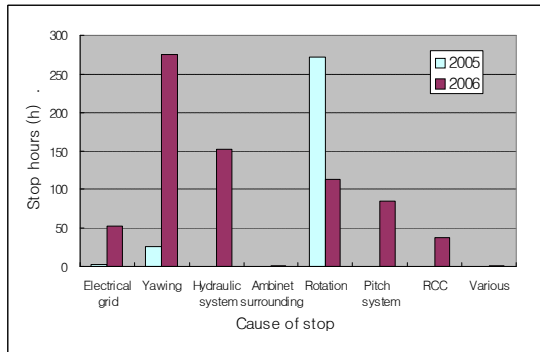
Fig. 6 The stop hours according to the cause of stop of the number 1 wind turbine

into 12 categories.⁷⁾ Figure 6 indicates the stop hours according to the causes of stops for the number 1 wind turbine. Of the 12 categories, the errors in generators, power factor correction, thyristors and the internal errors in the control unit rarely occurred. That is, the errors occurred in less than an hour. The errors that occurred for more than one hour are shown in Fig. 6.

In 2005, the most wind turbine stop hours were recorded due to a rotational problem. In this case, an oil leak in the gearbox resulted in low gear oil pressure or high gear temperature, and thus the controller in the wind turbine made the rotation of the rotor blade stop according to an operating and safety strategy. In 2006, it can be seen that the stop hours due to rotational problems fell by more than 50 percent in comparison with those of 2005.

The stop hours in 2006 caused by yawing were much longer than those in 2005. In the case of the number 1 wind turbine, it can be seen that the overload of yaw motor occurred more frequently in 2006, so it led to longer stop hours. The errors in hydraulic systems, pitch systems and RCC (Rotor Current Controller) occurred only in 2006. The stop hours due to the electrical grid increased in 2006.

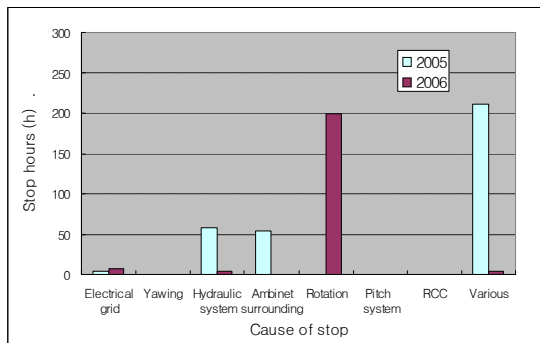
Fig. 7 The stop hours according to the cause of stop of the number 2 wind turbine

Figure 7 shows the number of stop hours which occurred in the number 2 wind turbine. In 2005, the longest stop hours were recorded as a result of various errors. In this case, the feedback error was caused by a hydraulic motor failure which led to the stop of the wind turbine. However, these errors rarely occurred in 2006. The stop hours, due to

rotation, were longest in 2006, while they did not occur in 2005. The problems with the hydraulic system made the wind turbine stop for about 58 hours in 2005, but it was considerably reduced in 2006.

The stop due to the ambient surrounding, which was recorded when the external conditions were poor, occurred only in 2005. From the error text, it became evident that the turbine stop was caused by the gust. The errors in electrical grid rarely occurred in both years. The errors in yawing, pitch system and RCC did not occur in the number 2 wind turbine, while those occurred in the number 1

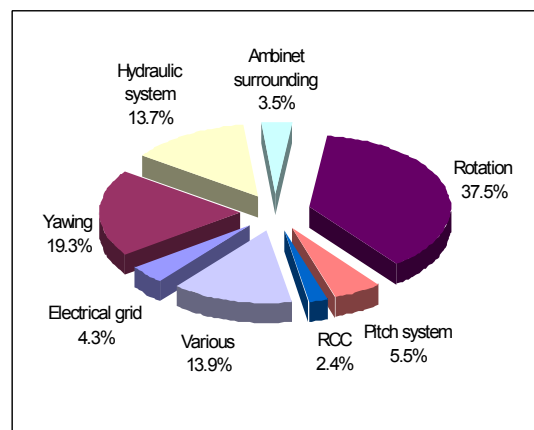
Fig. 8 The distribution for the cause of the stop for the two wind turbines for both years

Figure 8 represents the distribution for the cause of the stop for the two wind turbines for both years, which is the ratio of the stop hours for each cause to the total stop hours. The highest percentage is found in the rotation, which accounts for 37.5 percent. The second longest stop hours were caused by the yawing, which comprised 19.3 percent of the total stop hours. On the other hand, the lowest percentage is found in the RCC, which is 2.4 percent.
