A Study on the Variation of Ground Safety Factor by Earthworks

Jinhwan Kim*, O-II Kwon, Yong Baek, and Chang-Yong Kim

Geotechnical Engineering Research Division, Korea Institute of Civil Engineering
and Building Technology

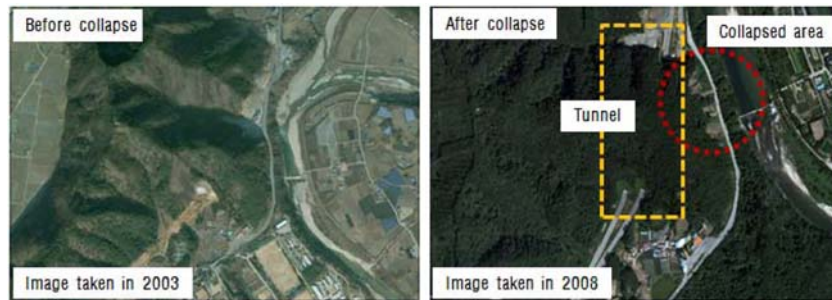
Area A is located on National Highway No. 44 (Hongcheon-Inje). Several slope failures occurred at this site in 2004 (Fig. 1). Material from the mass movement was transported into a small river that flows in front of the collapsed slope. At this site, the road was being straightened and tunnel construction was in progress at the time of the collapse. Therefore, we consider that the ground was weakened by the blasting vibrations that occurred during the process of tunnel construction, following which heavy rainfall triggered the slope failures.

Fig. 1. Slope failure in area A.

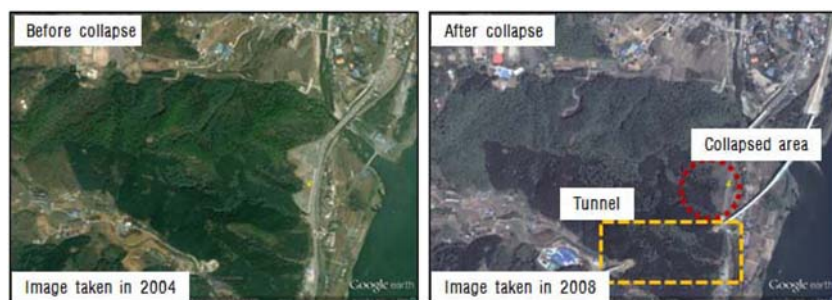
Area B is located on National Highway No. 46 (Seoul-Chuncheon) and is the site of a debris flow that occurred

Fig. 2. Slope failure in area B.

along the valley portion of the slope in 2009 (Fig. 2). Tunnel construction was in progress near the southwestern part of the debris flow. Again, we consider that both a weakening of the ground strength due to tunnel blasting and the occurrence of heavy rainfall led to the occurrence of the debris flow.

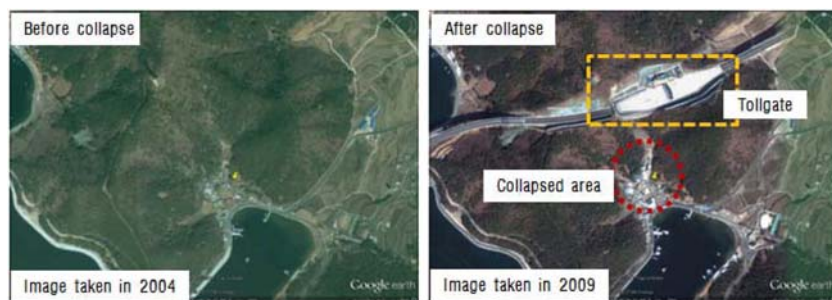
Fig. 3. Slope failure in area C.

Area C is the site of a house that was located in the lower reaches of a valley and which was damaged by a slope failure that occurred in the valley (Fig. 3). A national expressway and tollgate were being constructed in the upper reaches of the valley above the village. We infer that the slope failure was triggered by heavy rainfall in the

context of poor drainage in the catchment basin and the construction of the expressway above the village.

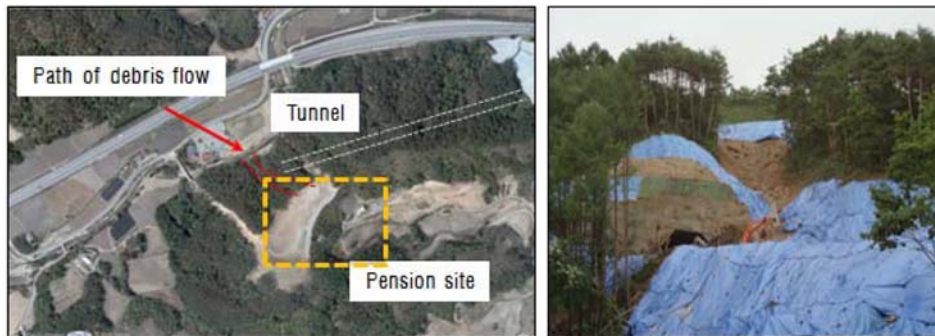
In area D, slope failure in the form of a debris flow occurred in the valley in the right side of the tunnel portal construction site. A site for building a pension in the upper part of the tunnel portal, and the collapse occurred at the boundary of the site, leading to sediments being transported into the entrance of the tunnel portal under construction (Fig. 4). We consider that the collapse occurred because of a lack of proper drainage facilities at the pension building site, which had a large catchment area.

Fig. 4. Slope failure in area D.

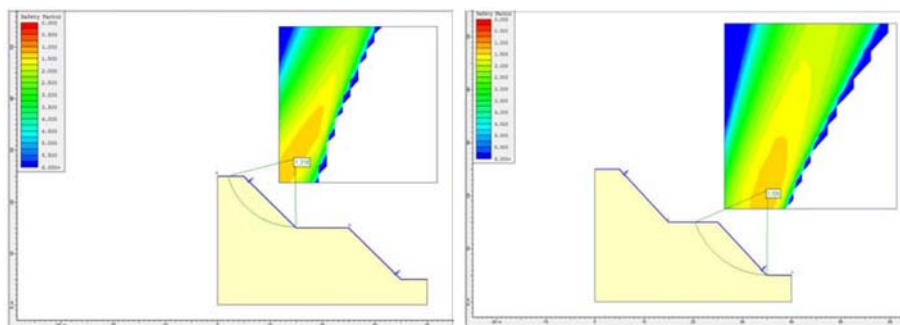
Fig. 5. Results of stability analysis for case 1 for a road width of 10 m (left: above the road; right: below the road).

ground safety factor is higher for shallower slopes (Table 4). Although the variation in the ground safety factor of the slope above the road is small in any one case, the safety factor of the slope below the road increases with increasing road width from 0 to 5 m, and for road widths in excess of 5 m, it is essentially constant.

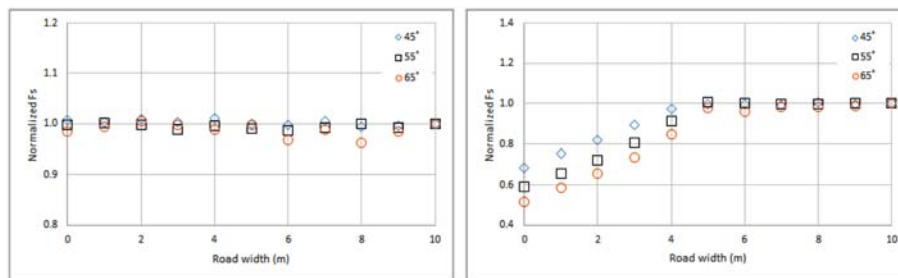
**Fig. 6.** Variation in the normalized safety factor for cases 1-3 (left: above the road; right: below the road).

To examine the variation in the normalized values of the safety factor, we plotted the values with respect to road width for the slope both above and below the road (Fig. 6). For the slope above the road, there is essentially no variation in the normalized safety factor (left-hand diagram

of Fig. 6). In contrast, for the slope below the road (right-hand diagram of Fig. 6), the normalized safety factor increases as road width increases from 0 to 5 m (representing narrow roads or the early stage of construction), and is essentially constant for road widths of between 5 and 10 m (wide roads or the later stage of construction). For road widths of <5 m, the normalized safety factor varies with above-road slope angle, being lower for slopes of higher inclination. For an assumed final road width of 10 m, the normalized safety factor is essentially constant for road widths greater than 4-5 m, which suggests the need for management of the slope below the road during the initial stages of road construction.

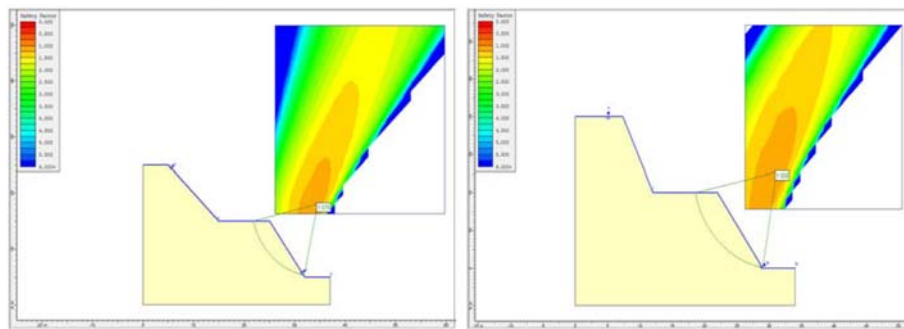
Fig. 7. Results of stability analysis for the below-road slope for cases 4 (left) and 5 (right) for a road width of 10 m.

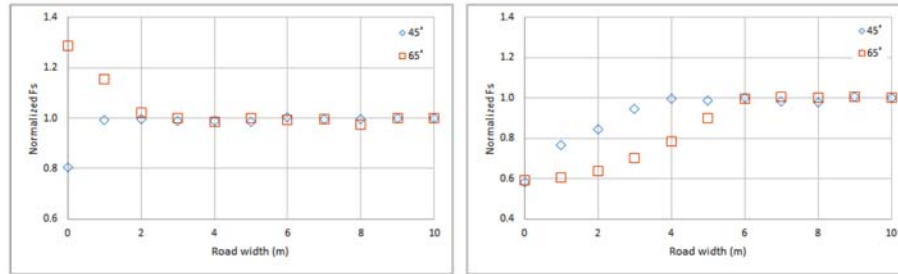
Fig. 8. Variation in the normalized safety factor for cases 4 and 5 (left: above the road; right: below the road).

The pattern of variation in the normalized safety factor with respect to increased road width for the slope above the road differs according to slope angle (left-hand diagram of Fig. 8). Whereas there was essentially no variation in the normalized safety factor for the above-road slope in cases 1-3, variation in the normalized safety factor is simulated to occur during the early stage of road construction (i.e., road widths of up to 2 m). In the case where the inclination of the initial slope surface is cut at a higher angle of 55° , the safety factor tends to be lower, and where cut at a lower angle it tends to be higher. For road widths in excess of 2 m, the normalized safety factor is essentially constant.

The slope below the road for cases 4 and 5 shows a similar pattern of variation in normalized slope factor with respect to road width to that of cases 1-3. However, a constant normalized safety factor for the below-road slope is reached later in the construction process (i.e., at a wider road width) where earthworks are performed with an above-road slope angle that is higher than that of the below-road slope angle (case 5), compared with one that is lower (case 4) (Table 7 and right-hand diagram of Fig. 8). The normalized safety factor is essentially constant once a road width of about 6 m is achieved for case 5, compared with about 4 m for case 4.
