# Cause Analysis of Flow Accelerated Corrosion and Erosion-Corrosion Cases in Korea Nuclear Power Plants

Y. S. Lee<sup>1†</sup>, S. H. Lee<sup>1</sup>, and K. M. Hwang<sup>2</sup>

<sup>1</sup>Korea Hydro & Nuclear Power Co., LTD, Central Research Institute

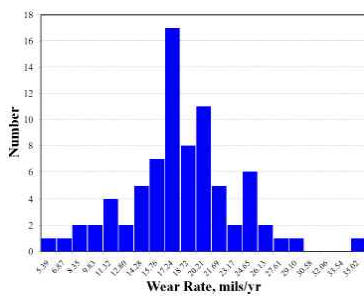
Fig. 2. EPRI TPM evaluation result.

As shown in Fig. 2, it was identified that pipe wall thinning goes along resulting from EPRI TPM (Total Points Method) evaluation using 3 cycles UT data. In order to analysis wall thinning cause, numerical simulation was performed using CFD (Computational Fluid Dynamics) code, FLUENT. Fig. 3 shows the water flow distribution, radial water velocity distribution, and turbulence intensity

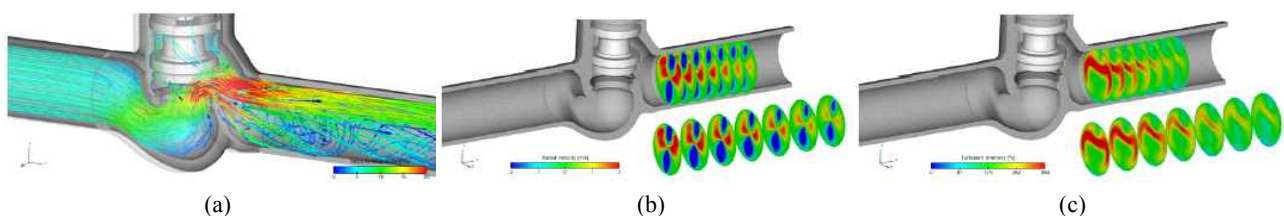
Fig. 3. Numerical simulation results of the check valve and downstream pipe ; (a) Water flow distribution, (b) Radial water velocity distribution, (c) Turbulence intensity distribution.

distribution as the numerical simulation results of the check valve and downstream pipe. Water flow is faster at upper side of the check valve and downstream pipe than the other side. Radial velocity is also faster and turbulence intensity is higher at upper side of the check valve and downstream pipe than the other side. Wall thinning was generated by internal water flow shape of swing type check valve upstream of the pipe. Internal water flow shape of some check valve can evoke wall thinning of downstream pipe. It is concluded that the main cause of the wall thinning for the downstream pipe of the check valve is FAC caused by the water vortex flow due to internal flow shape of the check valve.

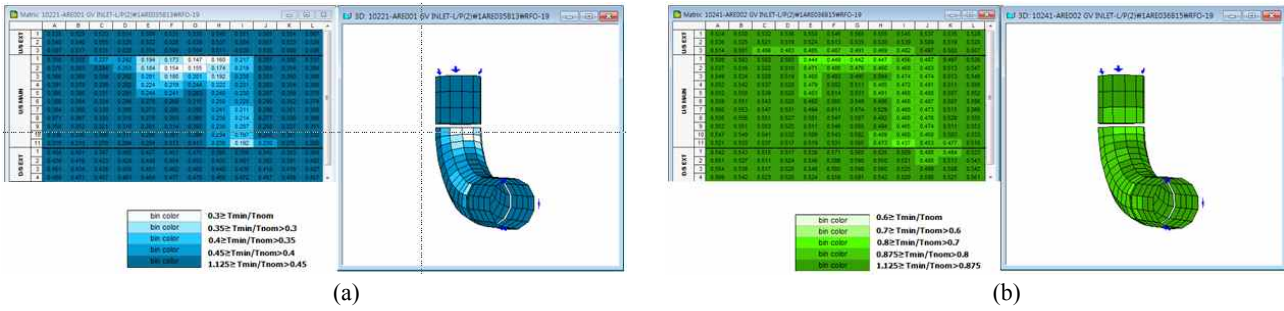
Fig. 4. UT data distribution of the elbow and pipes at (a) SG1 and (b) SG2.

Analyses of UT data were performed to find the wall thinning difference between two elbows installed in SG1 and SG2 lines. Fig. 4 shows UT data distribution of the elbows and pipes at SG1 and SG2. The elbow of SG1 was being thinned at the intrados and was thinner than the upstream pipe. The elbow of SG2 was little thinned and had the similar thickness with the upstream pipe.

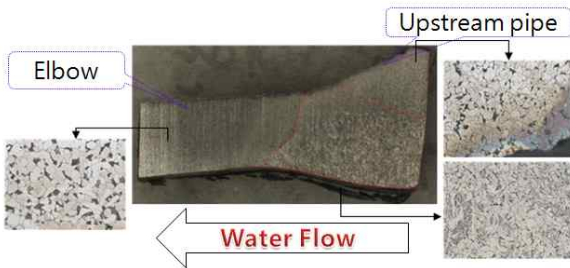
Fig. 5. OM image at SG1 elbow and upstream pipe.

OM (Optical Microscope) image observation was performed to investigate thickness difference between SG1 elbow and upstream pipe. Fig. 5 shows the microstructure image of the upstream pipe, the weld area, and the elbow for the direction of water flow. As the protruding part exists at the upstream pipe by thickness difference, it is possible for pipe wall to be thinned by the protruding part of the upstream pipe. Or, if welding bid had existed at the weld area, it is possible for pipe wall to be thinned by welding bid. Fig. 6 shows Isometric drawing of SG1 elbow line. As the control valve (242VL) is located in the upstream of the elbow, it is also possible for pipe wall to be thinned by the control valve. To investigate wall thinning cause of the elbow by the control valve, the welding bid, and the protruding part of the upstream pipe, CFD numerical simulations were performed.

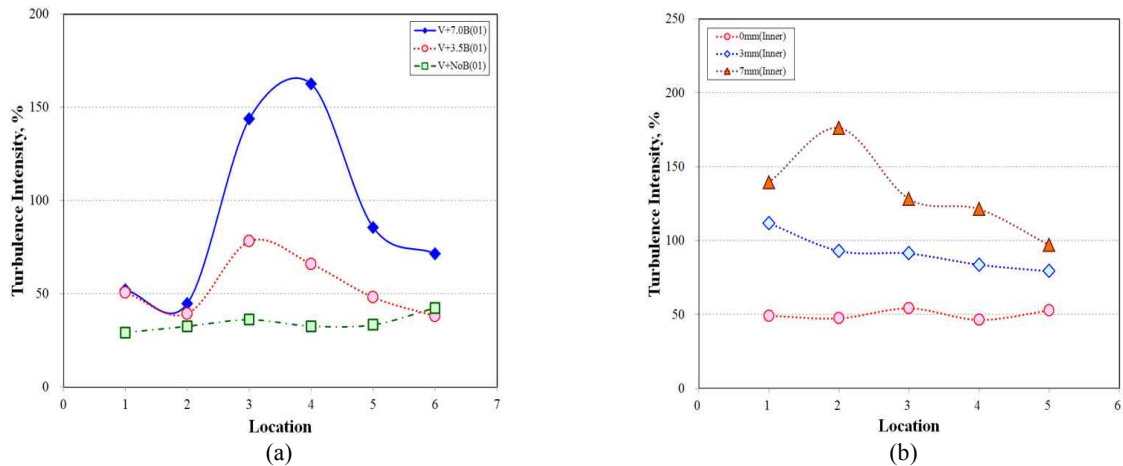
Fig. 7 (a) shows numerical analyses results for wall thinning affected by the welding bid, where V+7.0B means existing of 7.0mm bid at the downstream elbow of valve. Fig. 7 (b) shows numerical analyses results for wall thinning affected by the protruding part of upstream pipe. The welding bid affects elbow wall thinning. The thickness difference by the protruding part of upstream pipe also affects elbow wall thinning. The main cause of the wall thinning for the downstream elbow of the control valve is FAC due to the water vortex flow by the welding bid or the thickness difference.

Fig. 7. Numerical simulation results of the elbow wall thinning ; (a) Turbulence intensity by the welding bid and (b) Turbulence intensity by the thickness difference.

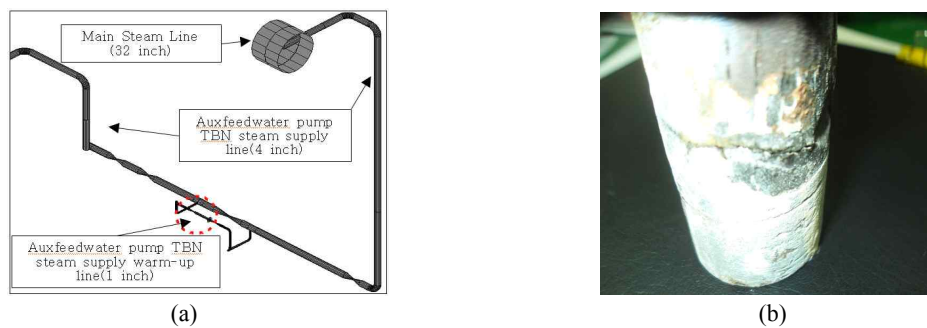
Fig. 8. Diagram and picture of small bore pipe line ; (a) 3D of small bore pipe line and (b) Failure picture of small bore pipe.

Steam leak was founded in a small bore pipe (SA106 Gr. B, Class3) located in the downstream of the orifice at SG A in main steam system. The function of the pipe is warming-up the auxiliary feedwater pump turbine with main steam and flowing steam goes to the condenser as shown in Fig. 8. The pipe was replaced and the same pipe at SG B and the other plants were inspected. All

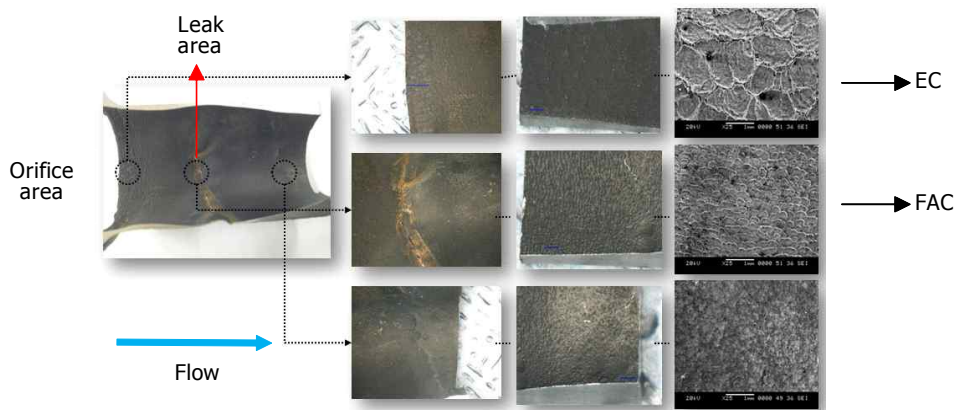
Fig. 9. Surface of small bore pipe.

generator moisture separator re-heater and power up-rate. Fig. 9 shows surface analyses results by stereoscopy and SEM for three areas from the orifice. At the near surface of the orifice, damaged shapes by erosion were observed. At the near leak area, the FAC degradation like orange peel shape was observed. And, at the farther area of the orifice, surface damages were not nearly observed.

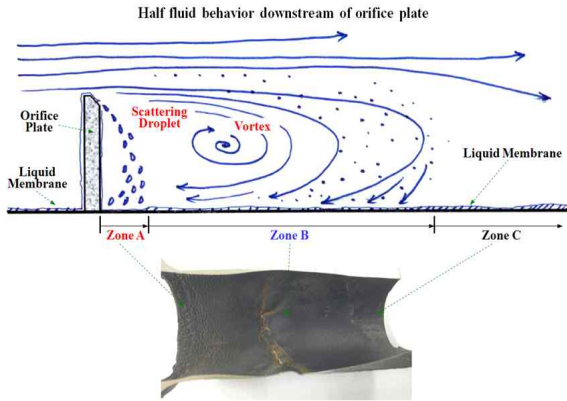
Fig. 10. Fluid behaviour for the downstream pipe of the orifice.

The main cause for the leak on the downstream pipe of the orifice is EC due to the liquid droplet and FAC due to the water vortex flow presented by wet steam as

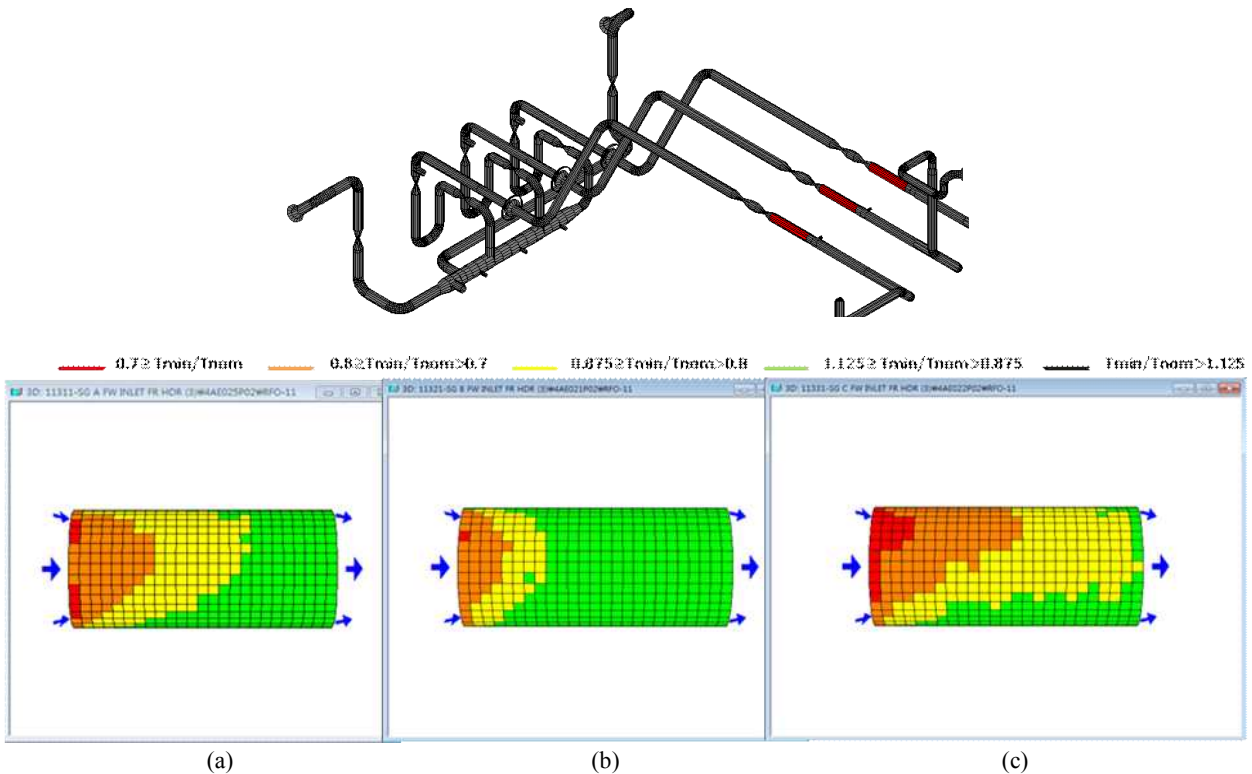
Wall thinning was founded at the downstream pipes of the feedwater check valve. The similar pipes were also thinned and replaced. Adjacent pipe areas of check valve were thinned as shown in Fig. 11. This case is very similar to the case 1.

Fig. 11. Thickness changing rate distributions for the downstream pipe of the check valve ; (a) A straight pipe at SG A, (b) A straight pipe at SG B, (c) A straight pipe at SG C.

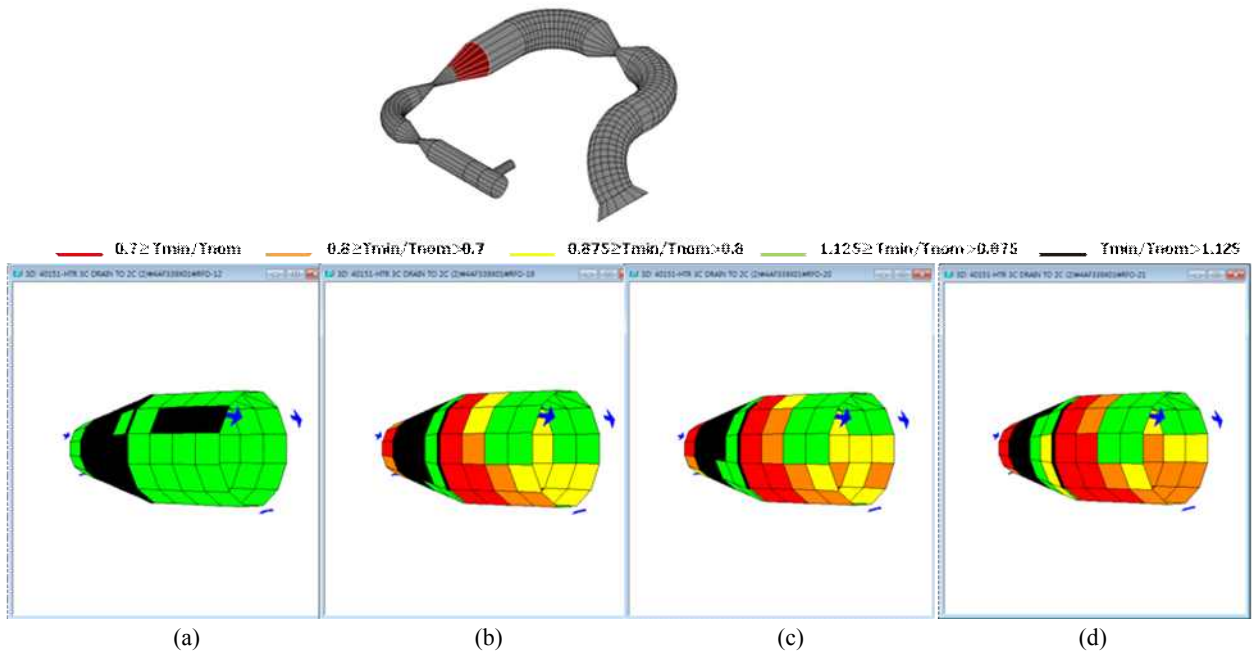
Wall thinning was founded at the pipe and expander located in the downstream of the control valve. As time goes on, value of the measured wall thickness is below 70 % compared to that of the nominal thickness as shown in Fig. 12.

**Fig. 12.** Thickness changing rate distributions for the downstream pipe of the control valve with inspection times (RFO) ; (a) RFO12, (b) RFO19, (c) RFO20, (d) RFO21.

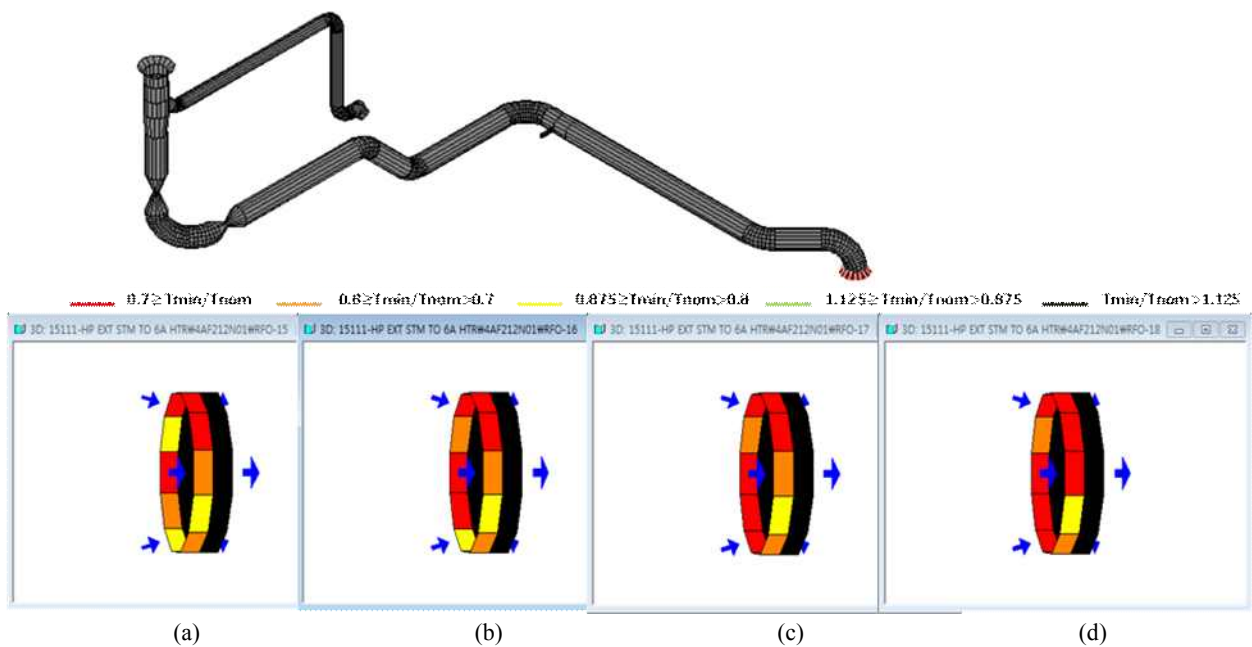
Wall thinning was founded at the carbon steel nozzle located in the downstream of low alloy steel elbow. As time goes on, value of the measured wall thickness is below 70 % compared to that of the nominal wall thickness as shown in Fig. 13. This is FAC due to entrance effect.

**Fig. 13.** Thickness changing rate distributions for the carbon steel nozzle with inspection times (RFO) ; (a) RFO15, (b) RFO16, (c) RFO17, (d) RFO18.
