Stress Corrosion Cracking of Heat Exchanger Tubes in District Heating System

The purpose of this paper is to present failure analysis, of the heat exchanger tube in a district heating system. SS304 stainless steel is used, as material for the heat exchanger tube. The heat exchanger operates in a soft water environment containing a small amount of chloride ions, and regularly repeats operation and standstill period. This causes concentration of chloride ions on the outer surface of the tube, as well as repeat of thermal expansion, and shrinkage of the tube. As a result of microscopic examination, cracks showed transgranular as well as branched propagation, and many pits were present, at the initiation point of each crack. Energy dispersive spectroscopy analysis showed Fe and O peak, as well as Cl peak, meaning that cracks were affected by Cl ion. Failure of the tube was caused by chloride-induced stress corrosion cracking by thermal stress, high temperature, and localized enrichment of chloride ions.

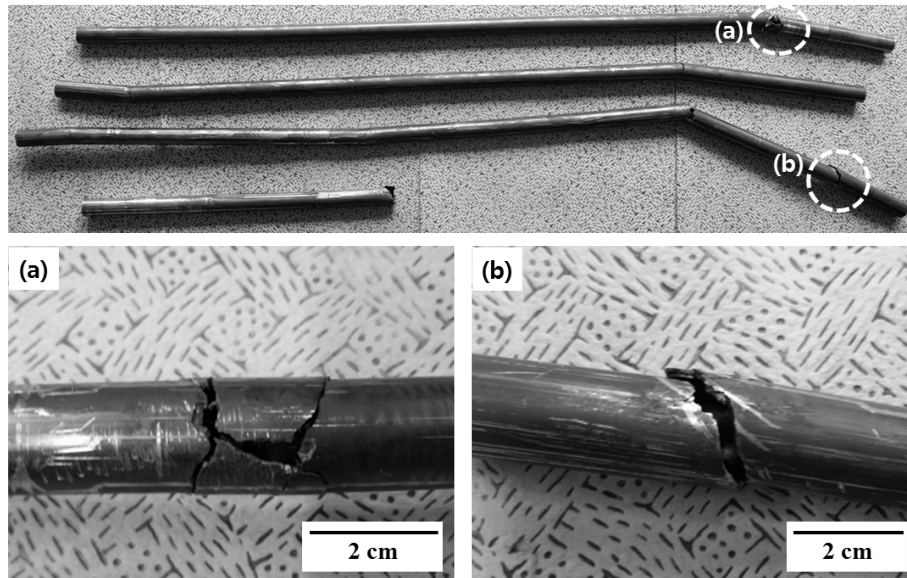
**Fig. 1** Photographs of the failed tubes; (a) circumferential and longitudinal direction crack, and (b) circumferential direction crack.

The failure tubes are shown in Fig. 1 and Fig. 2. Failure of the tube occurred in the whole area of the tubes, and the cracks were formed both the circumferential and longitudinal directions. Cracks appeared not only at the end of the tube connected to the shell but also throughout the tube. The size of the cracks varied from micron scale to complete rupture. Cracks were mostly formed in the circumferential direction, and a few cracks did occur in the longitudinal direction (Figs. 1a and 1b). The fractured surfaces were almost matched with each other, and plastic deformation could not observe. Brown oxide and orange

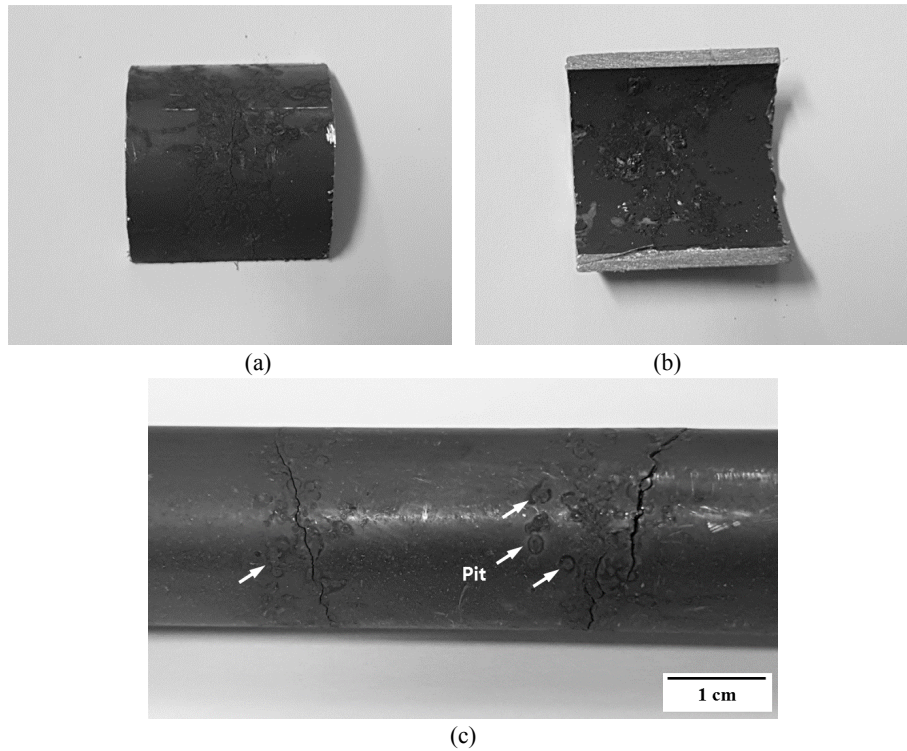
Fig. 2 Corrosion products formed on the tube surface; (a) outside of the tube, (b) inside of the tube, and (c) pits adjacent the crack.

oxide were observed on the outside and inside of the tube, respectively (Figs. 2a and 2b). Many pits were found adjacent to the cracks formed on the tube surface (Fig. 2c). These pits could act as a crack initiation point due to the stress concentration, pitting corrosion could cause tube failure.

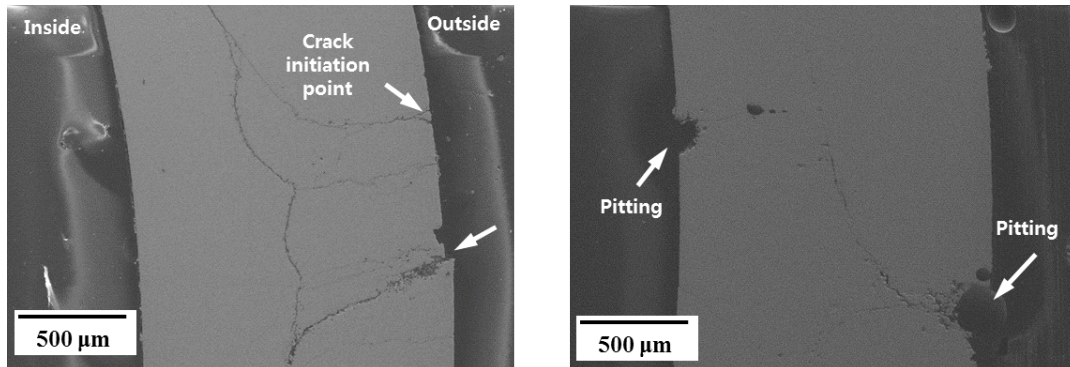
Fig. 3 Cross-sectional views of the failed tubes.

The cross sections of the failed tubes are shown in Fig. 3. Pits were found on both sides of the tubes. Pits at the outer side of the tube were deeper than those at the inner side. Most of the cracks started from the outside of the tube. At the crack initiation site, the pits were observed,

which verifies that pits acted as initiating points of the cracks. In Fig. 4, the numerous cracks had transgranular branched shape and sharp tip which are typical forms of SCC [7].

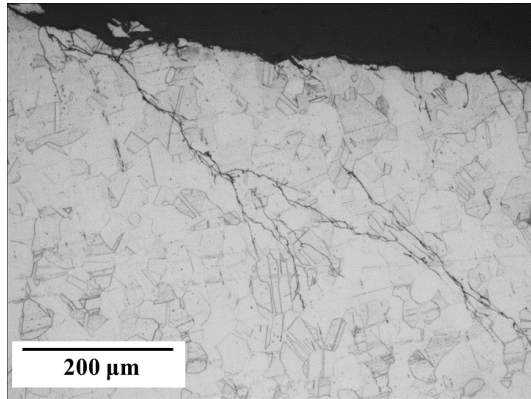
Fig. 4 Microstructure of the outer side of the failed tube wall.

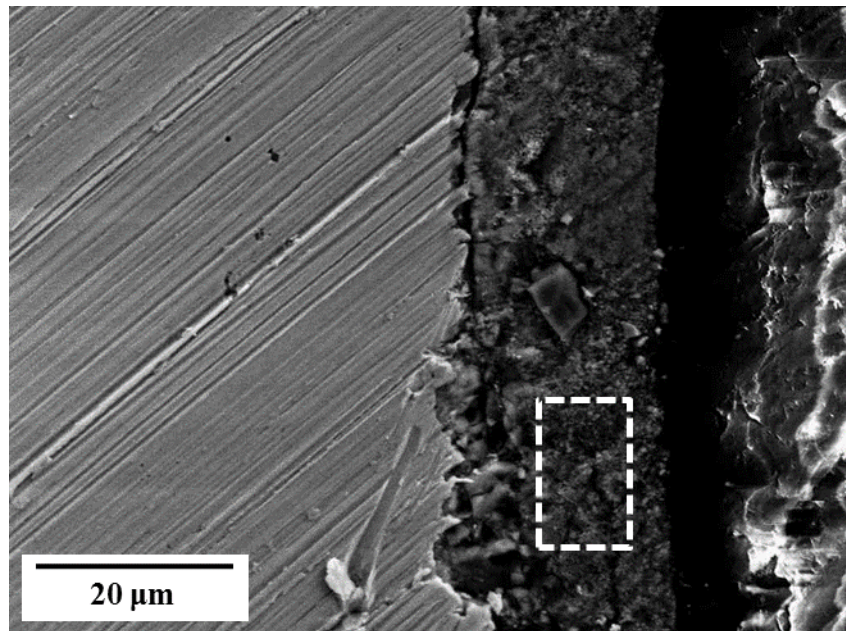
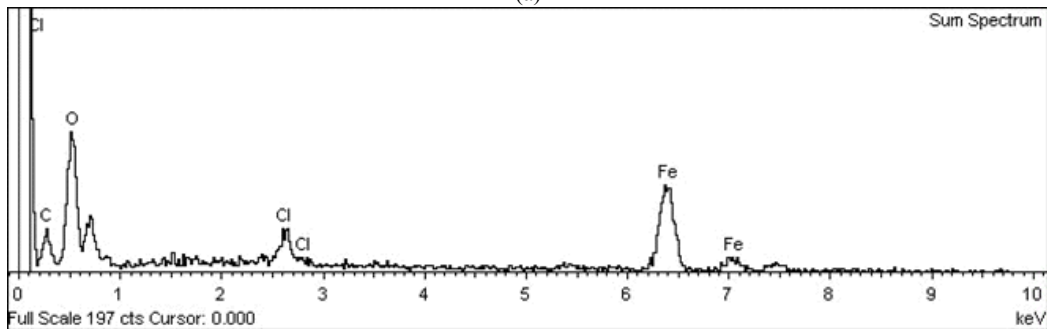
Fig. 5 shows the SEM image and EDS data of the corrosion product adjacent to the crack on the outer surface of tube. The corrosion products were formed with a maximum thickness of about 20 μm. The EDS analysis shows not only Fe and O peak but also Cl peak. The enrichment of Cl ion means that cracks were affected by chloride ion. Although the steam and district heating water only

contain a small amount of chloride ion, chloride can locally concentrate on the surface of the tube due to the repetition of the operation and standstill period of the heat

exchanger [9-13]. This may lead to chloride-induced pitting corrosion and cracking.

Fig. 5 (a) Corrosion products formed on the cracks and (b) EDS spectra of the corrosion product.

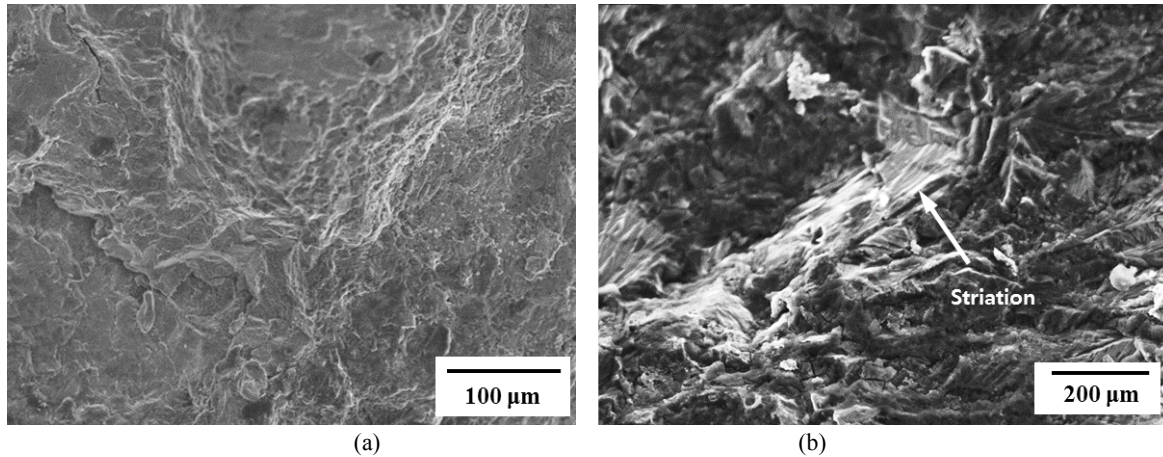
Fig. 6 shows SEM fractographs of the failed tube. The interior of the crack was divided into two areas with and without corrosion products (Figs. 6a and 6b), and the fracture mode possesses both cleavage and quasi-cleavage appearance. Striations are observed on the fracture surface with corrosion products, which is an evidence of corrosion fatigue cracking (CFC) [7,14]. The fracture was caused by corrosion cracking accelerated by fatigue of the tube. Generally, the boundary between SCC and CFC phenomenon is not clear, but CFC often regarded as a subset of SCC in the same environment [15,16], so they can occur at the same time. When SCC and CFC occur together, SCC propagation rate is faster than that of CFC and thereby SCC has the most significant influence on the life time

Fig. 6 SEM fractographs of the fracture surface; (a) a region without corrosion products, and (b) a region with corrosion products.

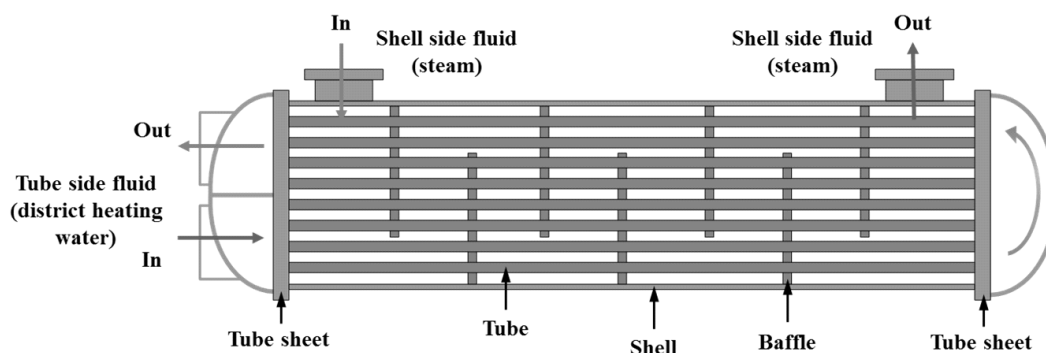
Fig. 7 shows the shell-tube heat exchanger. The tube and shell are welded to the tube sheet and the designed tube and shell length is 4,500 mm (at 25 °C). As shown in Table 1, the tube and shell are made of SS304 and A516 gr 60 materials. Since the tube and shell having different materials are fixed to the tube sheet, thermal stress is generated in the tube and shell according to the temperature change. In accordance with the onset of deformation, the stress applied to the tube is calculated by the following equations, and the information related to thermal stress calculation is listed in Table 3.

L_0 is the length of the shell or the tube at a given temperature, σ is the thermal stress and E is the Young's modulus. If the length of the shell is longer than the tube, tensile stress is generated to the tube. As a result, a tensile stress of 46.9 MPa and a compression stress of 127.9 MPa are generated in the tube during the operation period and the standstill period of the heat exchanger, respectively. Although the stress generated in the tube is a small value to be failed, but it is sufficient to induce SCC. SCC can occur with relatively low stress (~98 MPa) for the SS304 [17].

Fig. 7 Schematic diagram of the shell-tube heat exchanger.
