A Study of the Affected Layer and Stress Corrosion Crack of Ultra-high-strength Steel (300M) for Aircraft Parts

In this paper, the cause of the link assembly fracture of aircraft landing gear during operation was analyzed with emphasis on inspections of the affected layer on the machined surface of ultra-high strength steel(300M) and analysis of crack growth on the fracture surface.

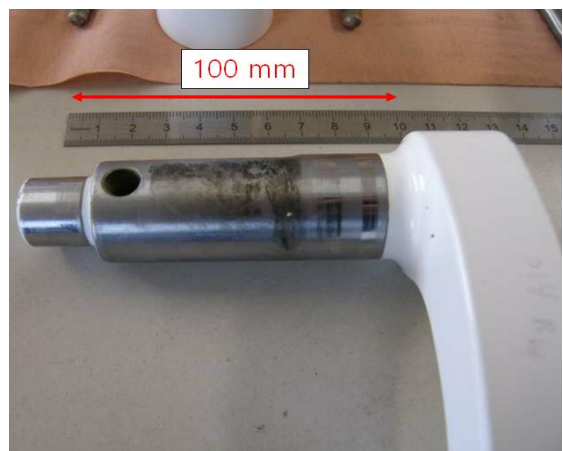
Fig. 1 Shapes of non-fractured part

The fractured is a part of the link assembly of the aircraft landing gear. The shape of original part is shown in Fig. 1. Fig. 2 show fracture surfaces. It can be seen that the fracture proceeded diagonally.

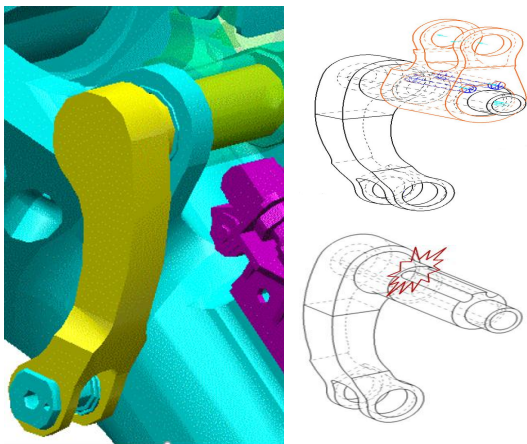
Fig. 3 Working mechanism and fracture point of the part

Fig. 3 show the operating mechanism of the part and the point where the fracture occurred.

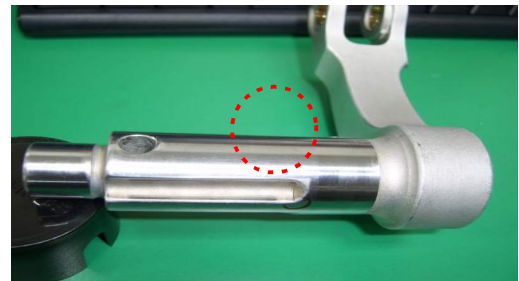
(a) Shape of the similar defected part

First, a visual inspection of the same type of aircraft was conducted to find the cause of the defect. As a result, the traces presumed to be similar defects are shown in Fig. 4. It is identified at the end of Groove. In particular, Ridge(Tool Mark) was identified on the curved surface of Groove as shown in Fig. 4(b) and (c). Fine cracks were observed around the ridge grooves.

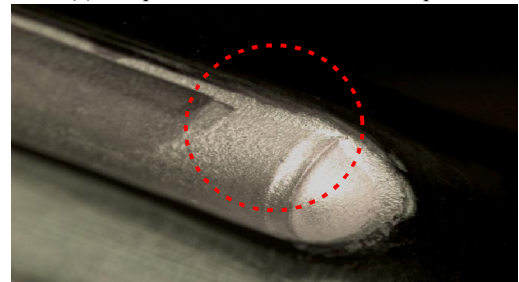
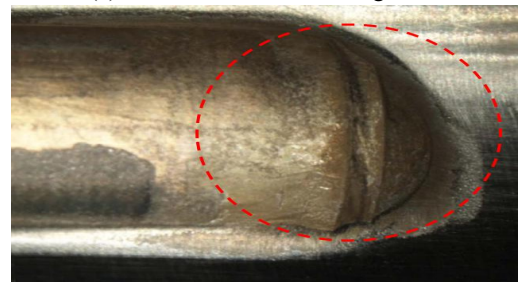
Fig. 4 Similar defect of other parts

(b) View of the defect on groove

(c) View of the defect on groove

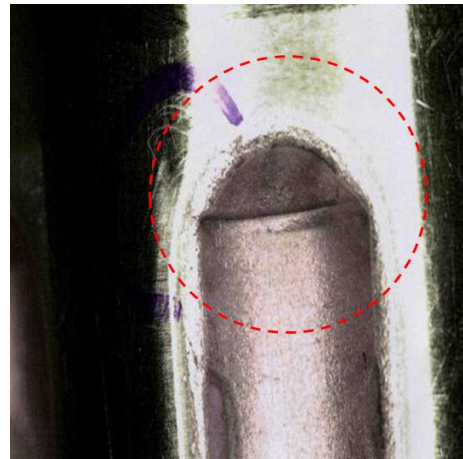
Fig. 5 NDI point of the defected part

Non-destructive inspection(NDI) was performed on the total quantity of defected products where the ridge edge was identified to check the defects that may exist inside the parts(Fig. 5).

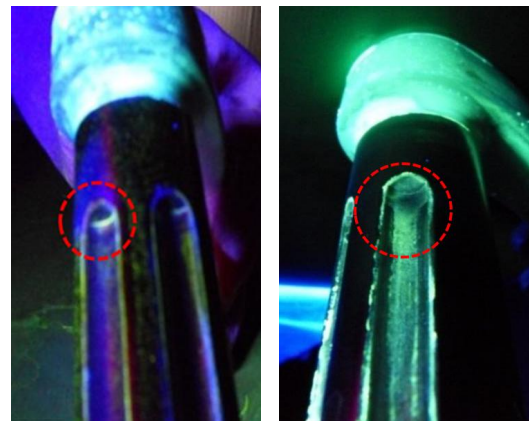
Fig. 6 NDI for the defected part

First, magnetic particle inspection(MPI) was performed on the total quantity of defected products for the purpose of surface defect detection. In general, it is possible to check Indication when there is crack or tool mark through MPI. As indicated by Fig. 6(a), in-depth analysis was required by fluorescence penetrate inspection(FPI). FPI was also performed for the total number of defected. Indication did not appear as shown in Fig. 6(b).

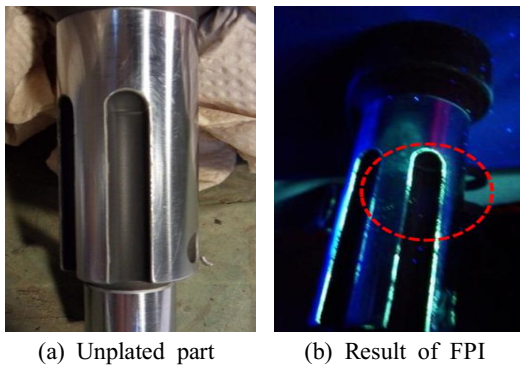
Fig. 7 NDI for the unplated part

Fig. 7(a) shows the part after plating peeling. As a result of performing FPI this part, there was no

indication as shown in Fig. 7(b). Through this, it was confirmed that the indication identified in the MPI was not a crack but a tool mark by machining.

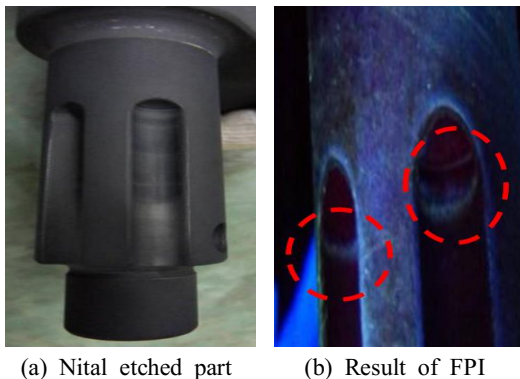
Fig. 8 Nital etched surface of defected part

As the tool mark due to the machining was confirmed, in order to check the surface affected layer due to frictional heat during machining, the defected part was subjected to grit blast and nital etching. Through this, the tool mark estimated by friction heat or burn is shown in Fig. 8(a).

As a result of FPI for this part, an abnormal indication that was generated by burn during machining was confirmed in the tool mark on the notch in Fig. 8(b).

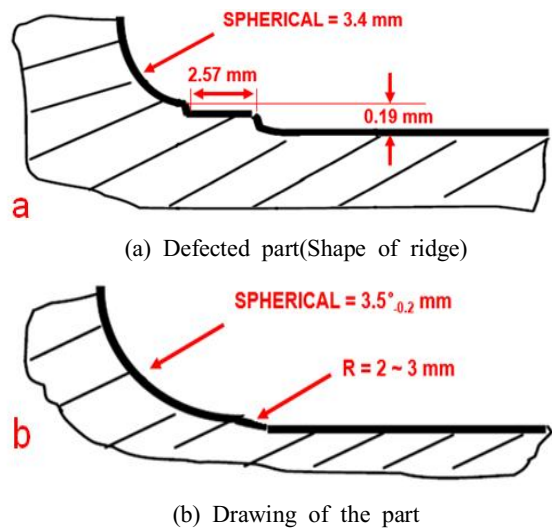
Fig. 9 Compare parts and drawing dimensions

curves. As a result of the measurement, a stepped ridge confirmed at the tool mark located at the end of the groove. Fig. 9(a) shows defect(ridge), Fig. 9(b) shows the drawing of Groove.

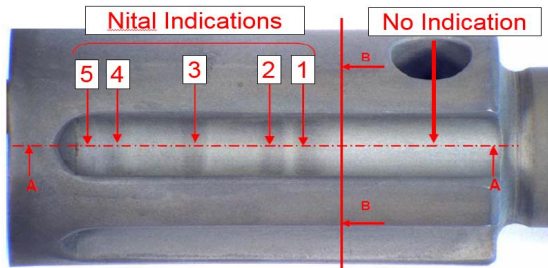
Fig. 10 Microhardness checking area after Nital etching

On the other hand, Vickers microhardness test was performed in accordance with the ISO 6507-1 standard to confirm the micro hardness of the tool mark and the affected layer confirmed through the non-destructive test. As shown in Fig. 10, the microhardness was measured by applying 0.2 kgf load to a total of 6 sites(tool mark 5 sites and 1 no indication sites).

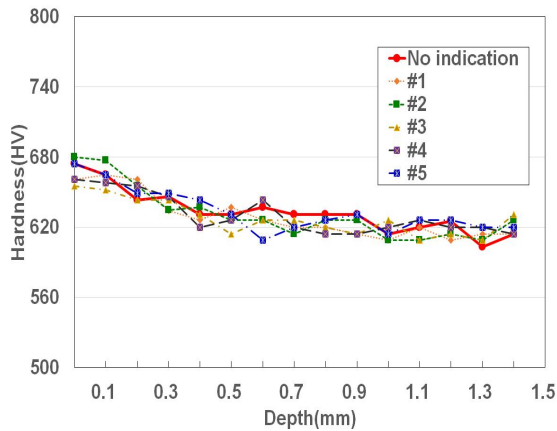
Fig. 11 Microhardness distribution of Indication #1~#5 and No Indication

In Fig. 11, which is the result of measuring the micro hardness, it was confirmed that there was no significant difference between the hardness value of the tool mark and the no indication.

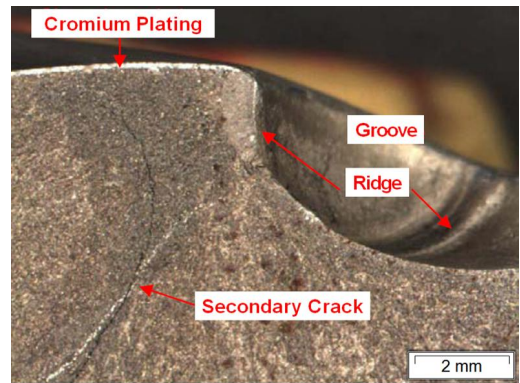
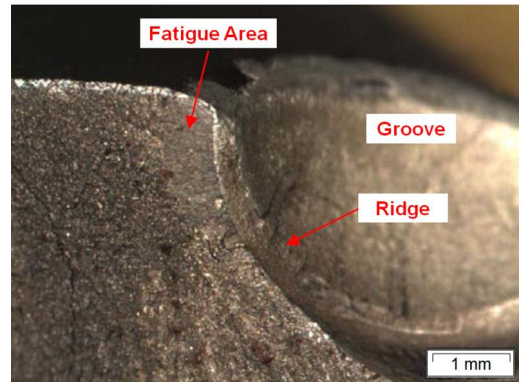
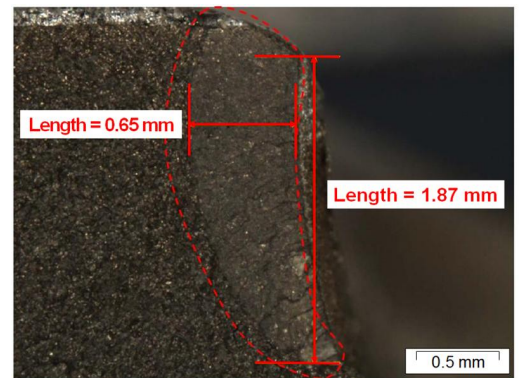
Fig. 12 View of the fracture surface

In Fig. 12(a), which enlarges the fracture surface, it can be confirmed that it is similar to the crack caused by fatigue, and the secondary crack is identified. In Fig. 12(b) and (c), It shows the fatigue fracture in more detail. On the fracture surface, it was confirmed that fatigue progressed to 1.87mm width and 0.65mm depth from the ridge edge of the groove(tool mark) and then to failure.

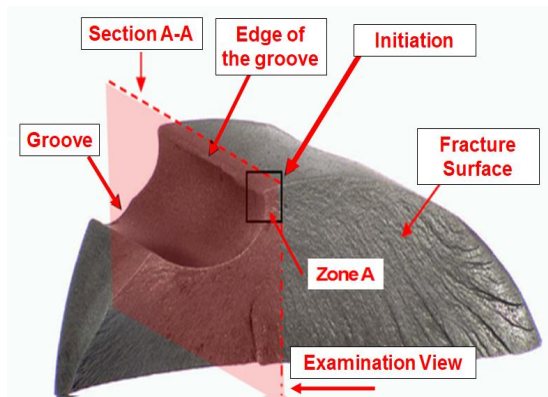
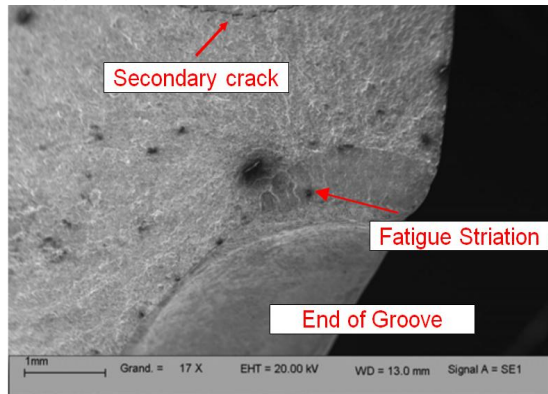
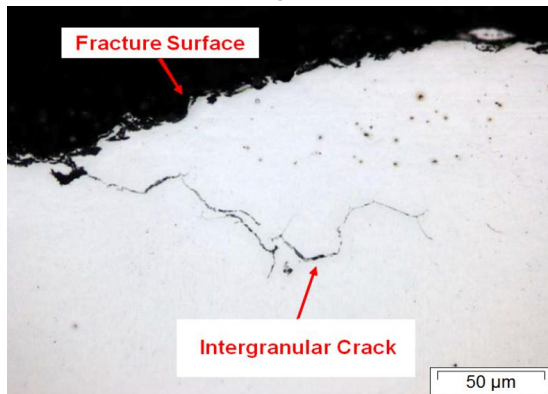
Fig. 13 Analysis of fracture surface

As a result of analyzing the fracture surface as shown in Fig. 13(a) using the scanning electron microscope(SEM), fatigue striation were found in Fig. 13(b). In Fig. 13(c), microsections showed branching with intergranular progressed from the end of the fracture surface. Such observed branching is

consistent with stress corrosion cracking initiated from the end of the fatigue propagation.

Based on these results, it is estimated that fatigue and initial cracking occurred due to stress concentration

in the notch generated in the ridge of the tool mark. Thereafter, stress corrosion cracking proceeded to the cracked part, which promotes final failure.
