Case Study of Slope Investigation on the Cretaceous Sedimentary Rocks Using the Geological Cross-Sections

Myeong-Hyeok Ihm¹ · Woo-Seok Kim^{2*} · Oil Kwon³

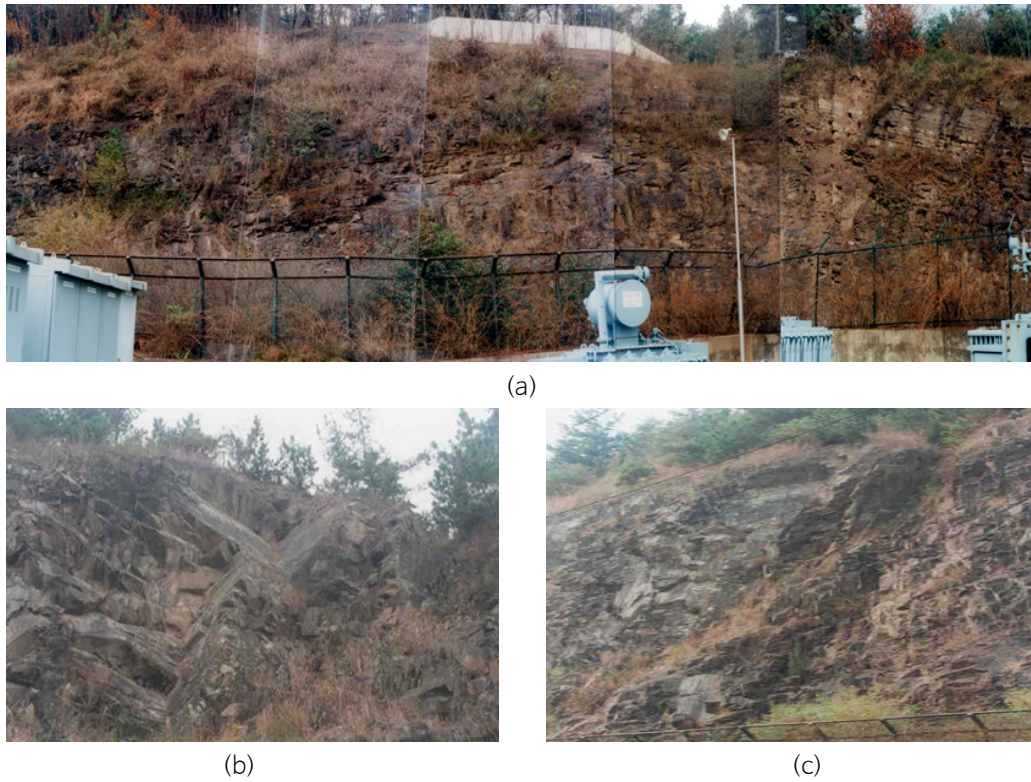
The bedding plane is well developed in the rock layer of the slope, which is the feature of sediment rock, and partially penetrated by two dacite dykes. Several wedge failures (Fig. 2b) occurred according to the shear joint surface in the rock body whose volume was around $2\sim 3\text{ m}^3$ (Fig. 3) at STA. No. 6~8 and plane failures occurred along the contact surface of the dacite veins penetrated at STA. No. 6~7 in the slope (Fig. 2c). Furthermore, the rock body whose volume was around $0.002\sim 0.003\text{ m}^3$ showed toppling failures and a small scale of rockfall in the upper and middle ends of the whole slope section (Fig. 3). The weathered condition of the rock was good but the clay mineral embedded in the stratified and intrusive contact surfaces of shale showed a very fast weathering rate.

Fig. 2. The outcrop photos. (a) The foreground photo for the slope of the study area, (b) The outcrop photo for wedge-failure on shear joints of the slope, (c) The outcrop photo for plane-failure on contact plane at dacite dyke of the slope.

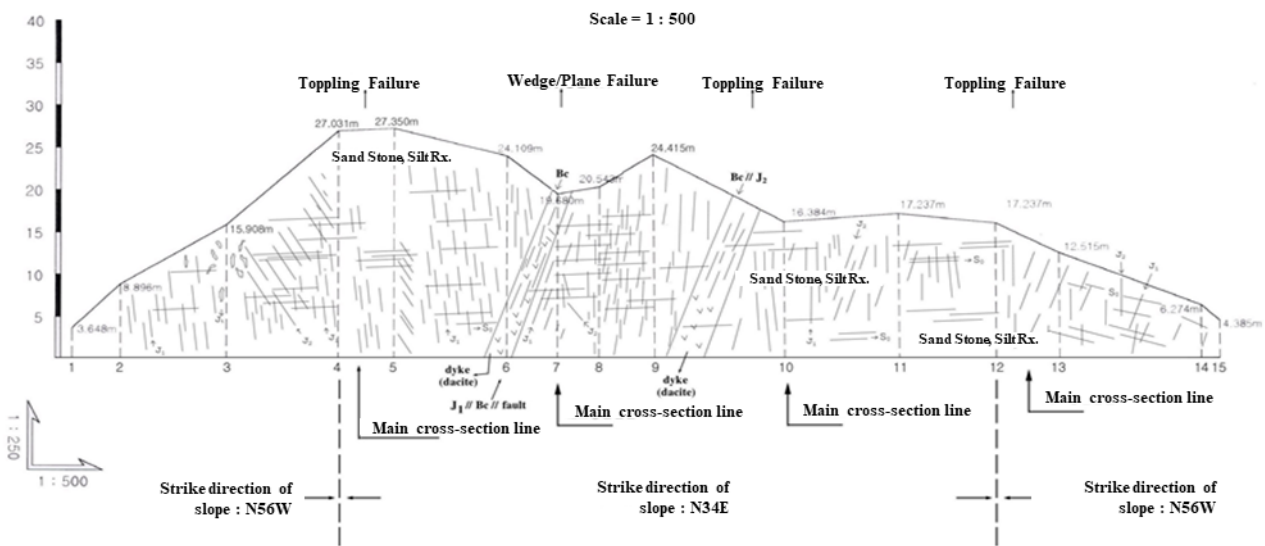
shear joint in STA. No. 11~14. The rock properties in each section inside the slope are presented in Table 1. Fig. 2a shows the photo of the slope and Fig. 3 shows the geologic front-view map that displays the rock composition in the slope, discontinuity type, orientation, spacing, and persistence.

Fig. 3. The unfolded drawing map for geological face-mapping data of the slope.

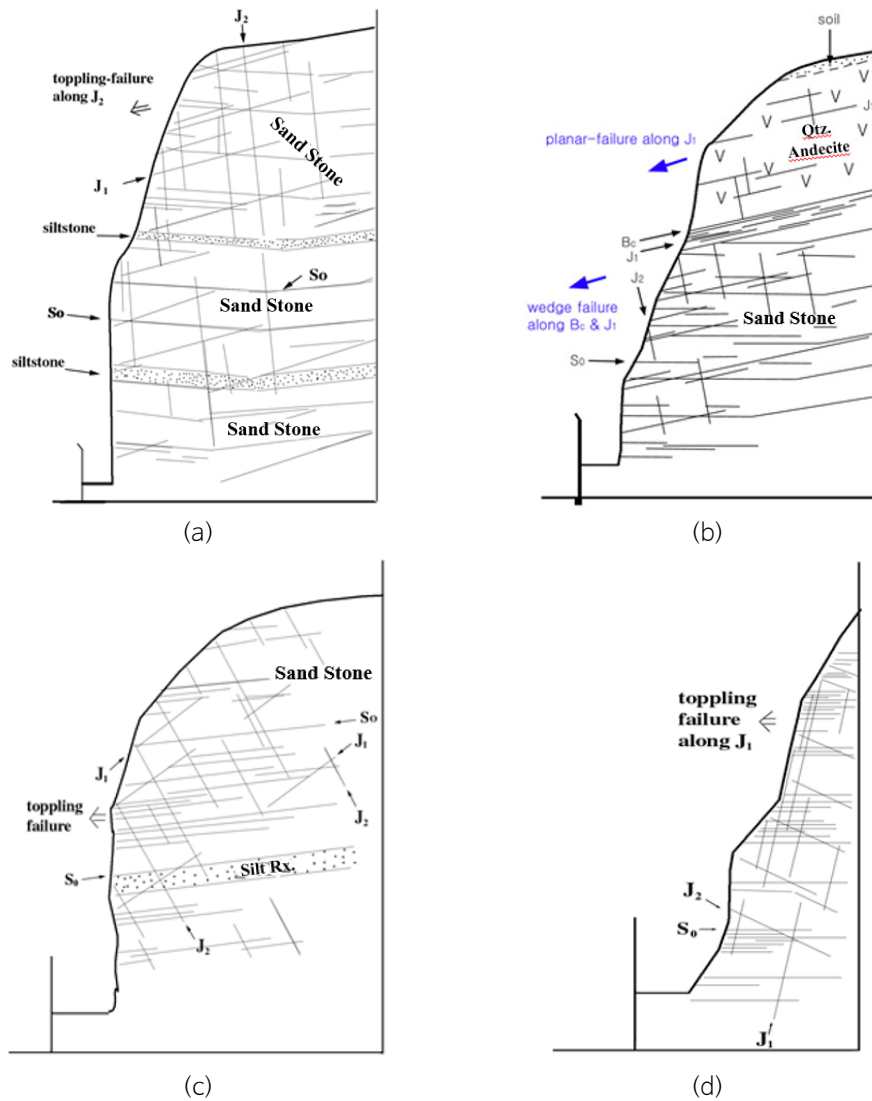
The analysis result of the geologic cross-section in Sta. No. 4 showed that the toppling failure occurred along the high-angle joint (Fig. 5a) and the toppling failure also partially occurred in the slope. As shown in Fig. 5b, the analysis result of the geological cross-sectional view in Sta. No. 7 showed that a plane failure occurred along the low-angle joint as well as a wedge failure occurred in the rock block where the intrusive contact of dacite dykes and low-angle joint were met.

Fig. 5. Geological cross-section of (a) Sta. No. 4, (b) Sta. No. 7, (c) Sta. No. 10 and (d) Sta. No. 12 on the cut-slope.

The analysis result of the geologic cross-section in Sta. No. 10 showed that the toppling failure occurred along the high-angle joint, which was the opposite slope direction, (Fig. 5c) and the toppling failure also frequently occurred in the slope. In addition, as shown in Fig. 5d, the analysis result of the geological cross-sectional view in Sta. No. 12 exhibited that a toppling failure was likely to occur along the high-angle joint.

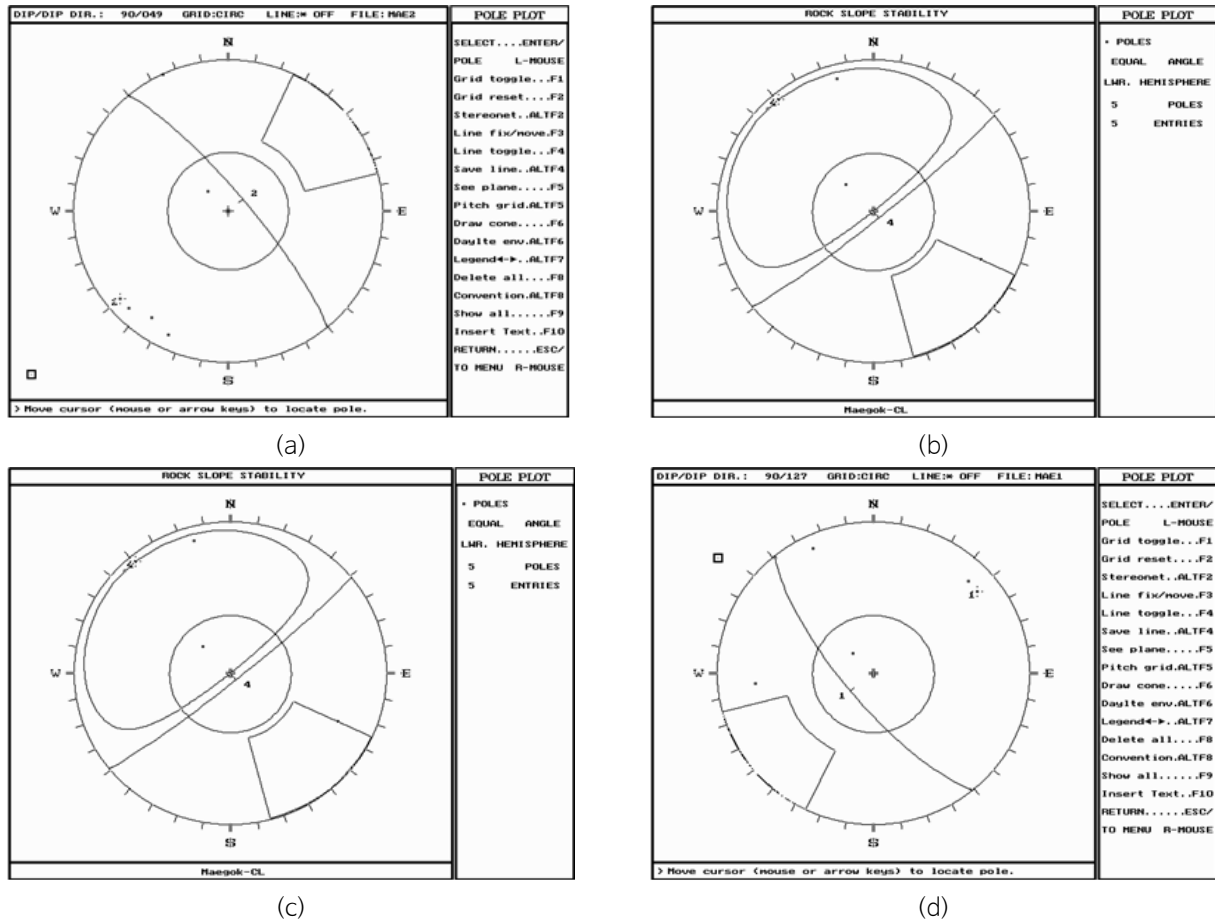
The failure size of the rock body was 0.2~0.3 m³ on average but the failure size of STA. No. 6~8 cross-section (in case that the intrusive contact zone was distributed) was 2~3 m³, which was relatively larger. The load of the failure rock body was around 6 ton · m on average. The sliding direction of the failure rock body showed that in the case of STA. No. 4, STA. No. 10, and STA. No. 12 cross-sections, the toppling failure along the shear joint surface was expected to occur in the gravity direction, and in the case of STA. No. 7 cross-section, the wedge failure along with the intrusive contact and shear joint surface in the 60° southeast direction, and the toppling failure along with the shear joint surface in the gravity direction of the southeast direction.

Fig. 7. The stereonet projection map of discontinuities at (a) Sta. No. 1~4, (b) Sta. No. 4~9, (c) Sta. No. 9~12 and (d) Sta. No. 12~15 on the slope.

As presented in Table 6, Sections STA. No. 3~5 and STA. No. 10~11 showed an unstable state and Sections STA. No. 6~8 exhibited a highly unstable state and Sections STA. No. 12~13 revealed a somewhat unstable state. Thus, a countermeasure method is required overall to improve the stability of the slope.

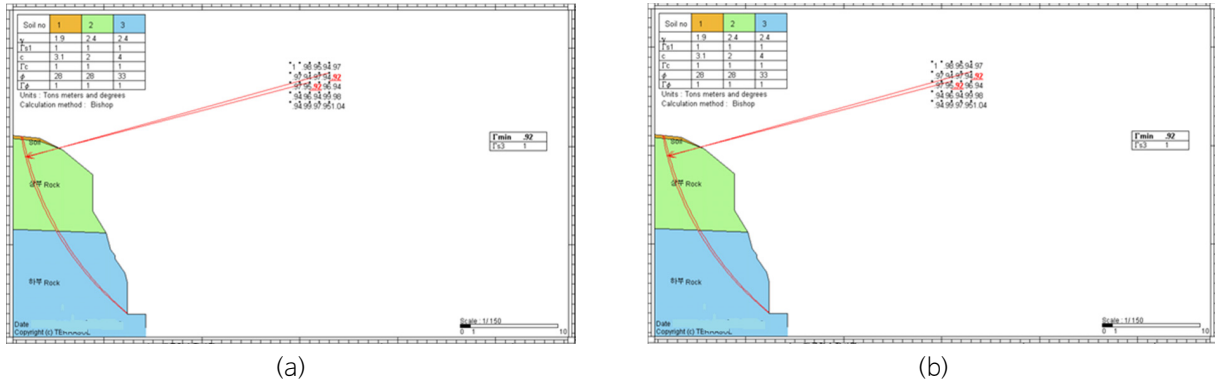
To conduct a stability analysis of the slope, the strength, which was derived in Section 3.4 for the STA. No. 4, STA. No. 7, STA. No. 10, and STA. No. 12 cross-sections, was used as an input value to calculate a safety factor of the representative slope during the dry and wet periods as mentioned earlier. TALREN 5.0 program was used in the limit equilibrium analysis. The period was divided into dry and wet periods and a safety factor analysis was conducted in the in-situ ground for each representative cross-section and only the results in STA. No. 7 are shown in Fig. 8 due to the limited space in this paper. Table 7 summarizes the safety factor at the dry and wet periods for each representative cross-section of the in-situ ground in the slope. The analysis results of the in-situ ground slope revealed that the safety factors in both dry and wet periods did not satisfy the allowable safety factors, which required a countermeasure method.

Fig. 8. The result of safety factor (Fs) at (a) STA. No. 7 on the slope in the dry season and (b) STA. No. 7 on the slope in the rainy season.

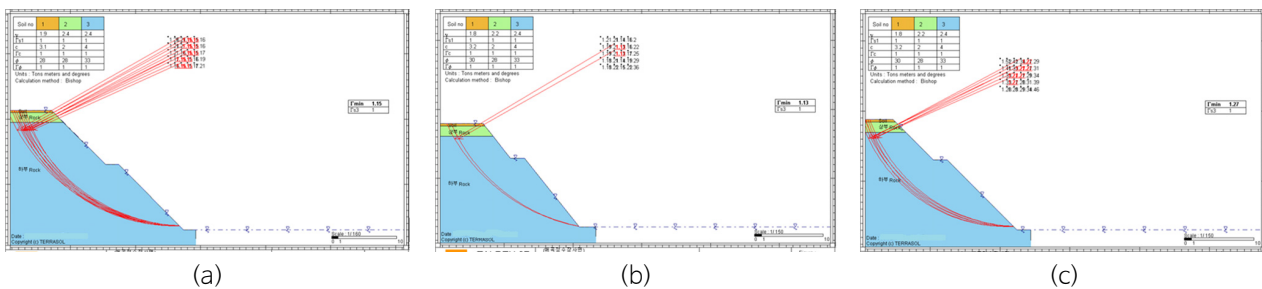
Fig. 9. The result of safety factor (Fs) at (a) STA. No. 7 after relief of the gradient on the slope in the rainy season, (b) STA. No. 10 after relief of the gradient on the slope in the rainy season and (c) STA. No. 12 after relief of the gradient on the slope in the rainy season.

The failure type for each representative cross-section found through the geological cross-sectional view analysis and analysis results of stereonet projection analysis exhibited that a small scale (1~2 m³) of rockfall in the upper side or a toppling failure along the shear joint surface was expected in the gravity direction and a wedge failure along the joint surface was also expected in the southeast direction for some. These results indicated that applying the slope gradient relief method, which was proven and economical considering the field circumstance overall, would be most reasonable. It was reasonable that the STA. No. 3~5 sections were needed to be cut to have the slope gradient gentler than 1:0.6, and the STA. No. 6~8 sections were needed to be cut to have the gradient gentler than 1:1 (Fig. 9a), and the STA. No. 10~13

sections were needed to be cut to have the gradient gentler than 1:0.6 (Fig. 9b & c). In addition, a 10 m-high and 1 m-wide step was needed to be installed according to the design code. Moreover, a rockfall prevention fence was needed to be installed on the slope and green soil surface treatment ($t = 10$ cm) was needed to be installed. Table 8 presents the stability review results after a slope relief method was applied using the set strength integer.
