Letter to the Editor

Comments on a Case Study on Engineering Failure Analysis of Link Chain

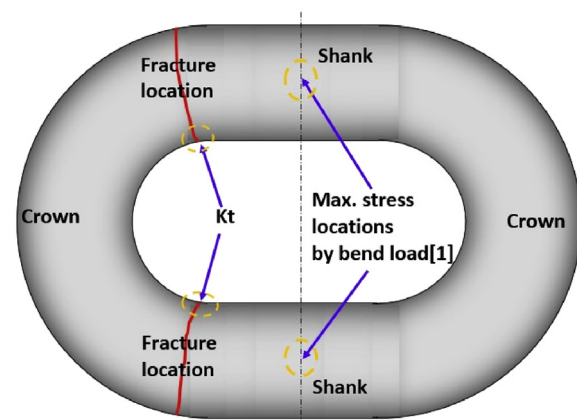
Fig. 1. Schematic of link chain stresses and fracture locations.

The chain fractured at the locations where the crown and shank intersected, as shown in Fig. 1, based on Fig.2 of the article [1]. Radical patterns arrowing to the chain inner surface (intrados) was observed on L/H fracture surface (Fig.3 of the article) [1], suggesting that crack likely initiated around the chain inner surface, where presence of high tensile stress under tension load [5,6] but very low stresses under bending load (Fig.11 of the article) while a so called “crushed damage” area was found there, indicating “crushed damage” could not be formed by the compressive load which the article claimed. The article did not conduct necessary detail examination on “crushed damage” area to determine its nature, it looked like an impact damage after the chain fracture.

Kt and crown top are max. stress locations by tension load [5][6]

As observed in fractographic analysis, there was significant plastic deformation (chain narrowing), suggesting that the chain was fractured by overload. Chain narrowing was in-plane deformation, mainly caused by in-plane loads such as tension while the bending load was out-of-plane load but no out-of-plane deformation was observed on the chain. The chain fractured at the locations where the crown and shank intersected. Coincidentally, the maximum stress of the chain under tension located there (Kt-intrados where crown and shank intersected) [5,6], while the stresses at fracture locations under bending load were very low but the maximum stresses under bending were located on upper surfaces in the middle of shanks (Fig.11 of the article [1] and Fig. 1).

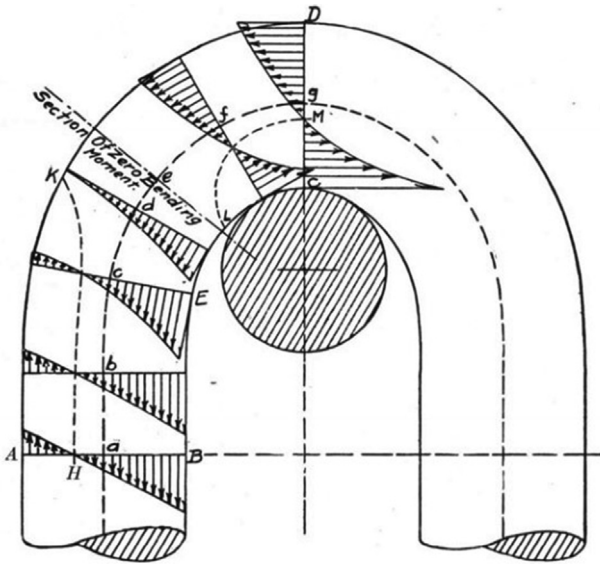
Fig. 2. Stress distribution of link chain under tension load [5].

topographies” (only ~30 microns per step) as microscopic features under high magnifications cannot be taken as characteristic for bending moment fracture. Furthermore, bending moment and tension in chain were not contrary, both sides of the chain were subject to bending moment and tensile force when it was loaded by tension, as shown in Fig. 2 [5], i.e. no real uniaxial tension in link chain loading.
