[Original paper]
*Journal of the Korean Society
for Nondestructive Testing*
Vol. 32, No. 3 (2012. 6)

Acoustic Emission Monitoring of Lightning-Damaged CFRP Laminates during Compression-after-Impact Test

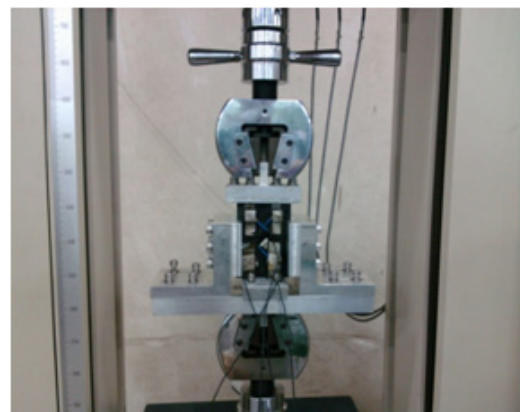
Fig. 1 CFRP coupons in place for CAI test

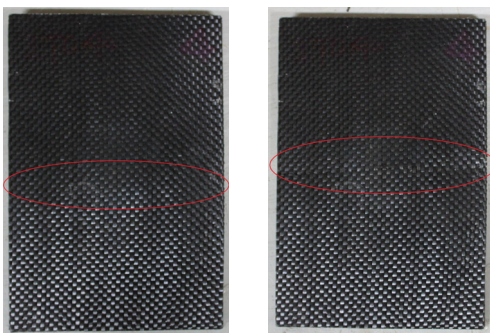
Fig. 2 Photographs of CFRP coupons after CAI tests

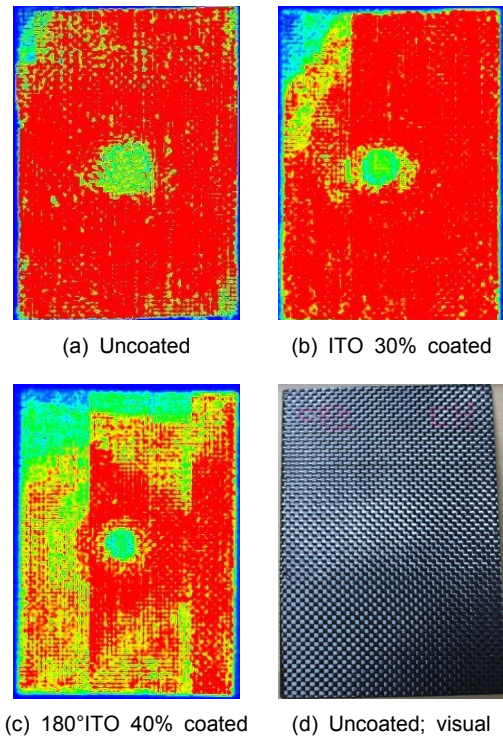
Fig. 3 Impact-damaged area examined by ultrasonic C-scan images for three types of CFRP coupons after the impulse current of 40 kA was applied.; (d) is a visual image of damaged area for the uncoated shown as a reference.

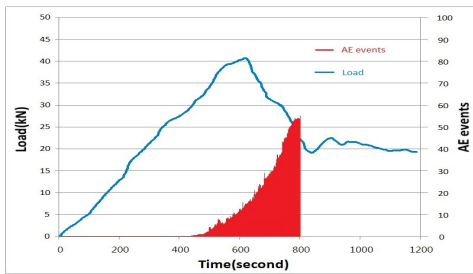
(a) Uncoated and 10 kA

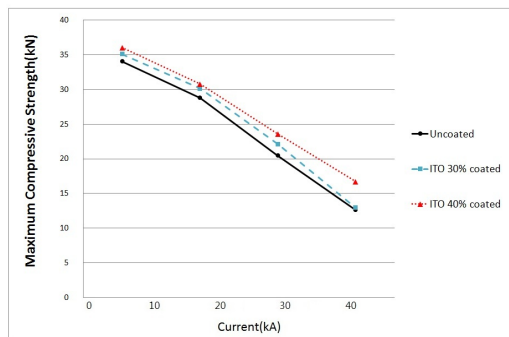
Fig. 6 Relationship between compressive strengths and the levels of impulse current

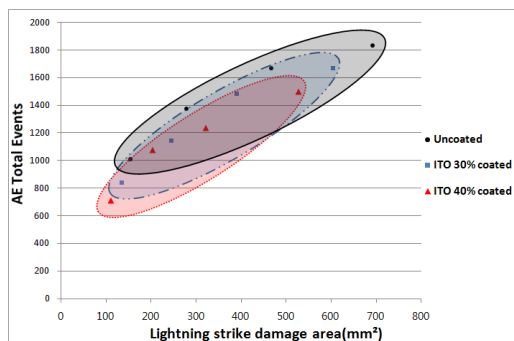
Fig. 7 Relationship between AE total events and the impact-damaged area

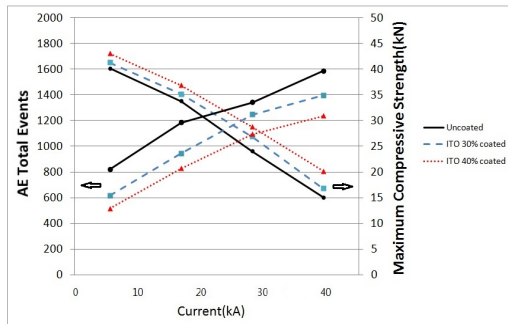
Fig. 8 Relationship between compressive strength and total AE counts

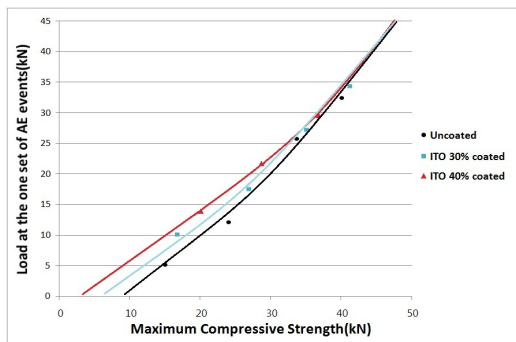
Fig. 9 Relationship between compressive strengths and the stress level of AE counts initiation
