## Brachial plexus impingement secondary to implantable cardioverter defibrillator: A case report

Case Report

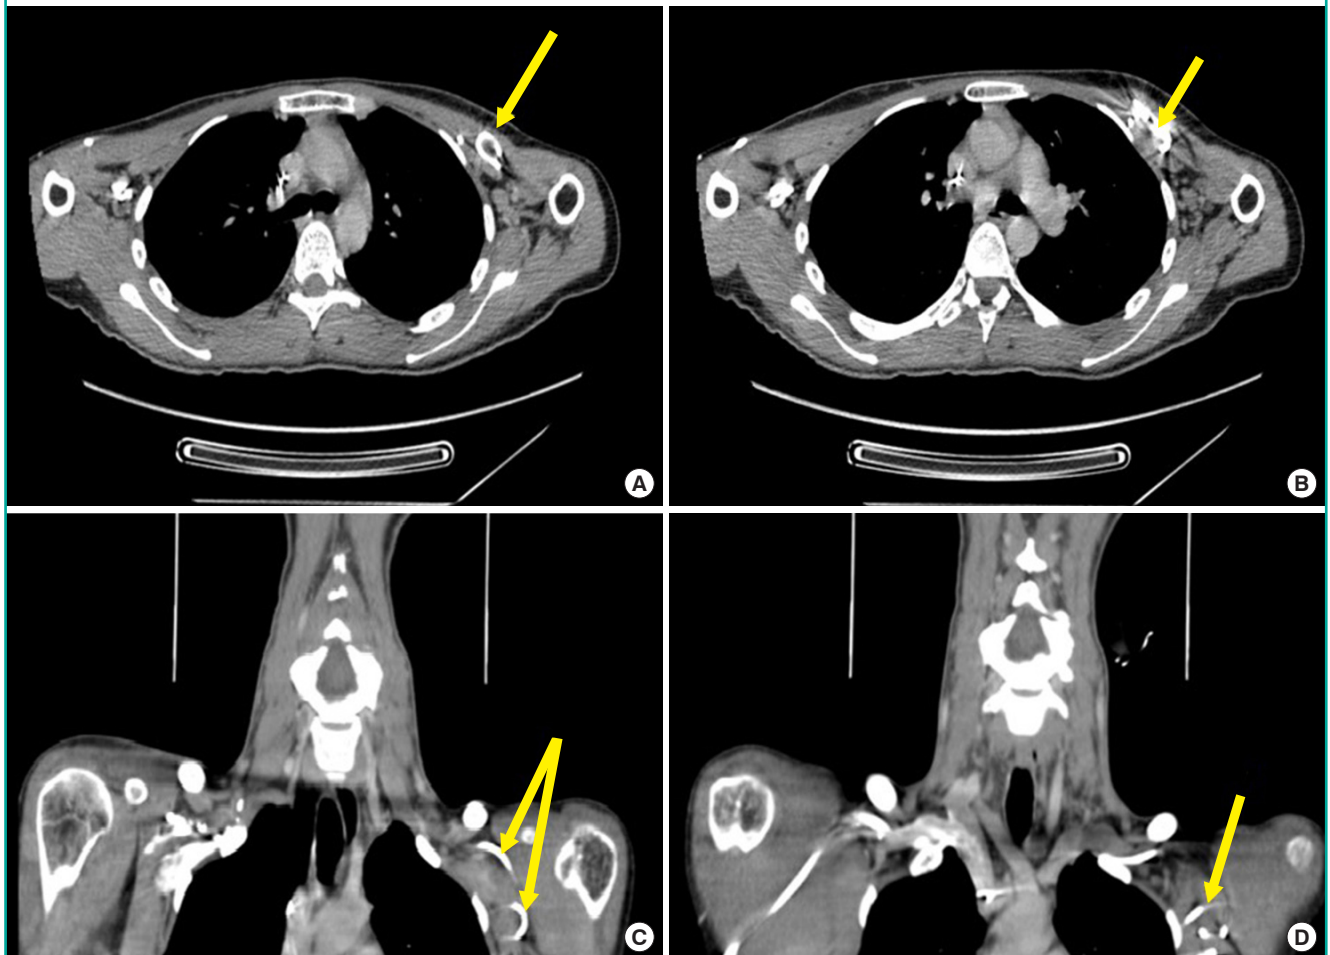
**Fig. 1. Contrast neck CT images**

bus and a computed tomography (CT) angiogram of the neck ruled out a mass lesion as the underlying cause for the brachial plexopathy. Though the CT demonstrated the ICD generator and loop of the ICD lead, it was overall regarded as limited in the evaluation of the brachial plexus involvement (Fig. 1).

Axial plane computed tomography (CT) image. (A) Loop of implantable cardioverter defibrillator (ICD) lead identified in left infraclavicular space (yellow arrow). (B) ICD box identified in left infraclavicular space (yellow arrow). (C, D) Coronal plane CT image. Yellow arrows indicate laterally directed loop lead of ICD in left infraclavicular space.

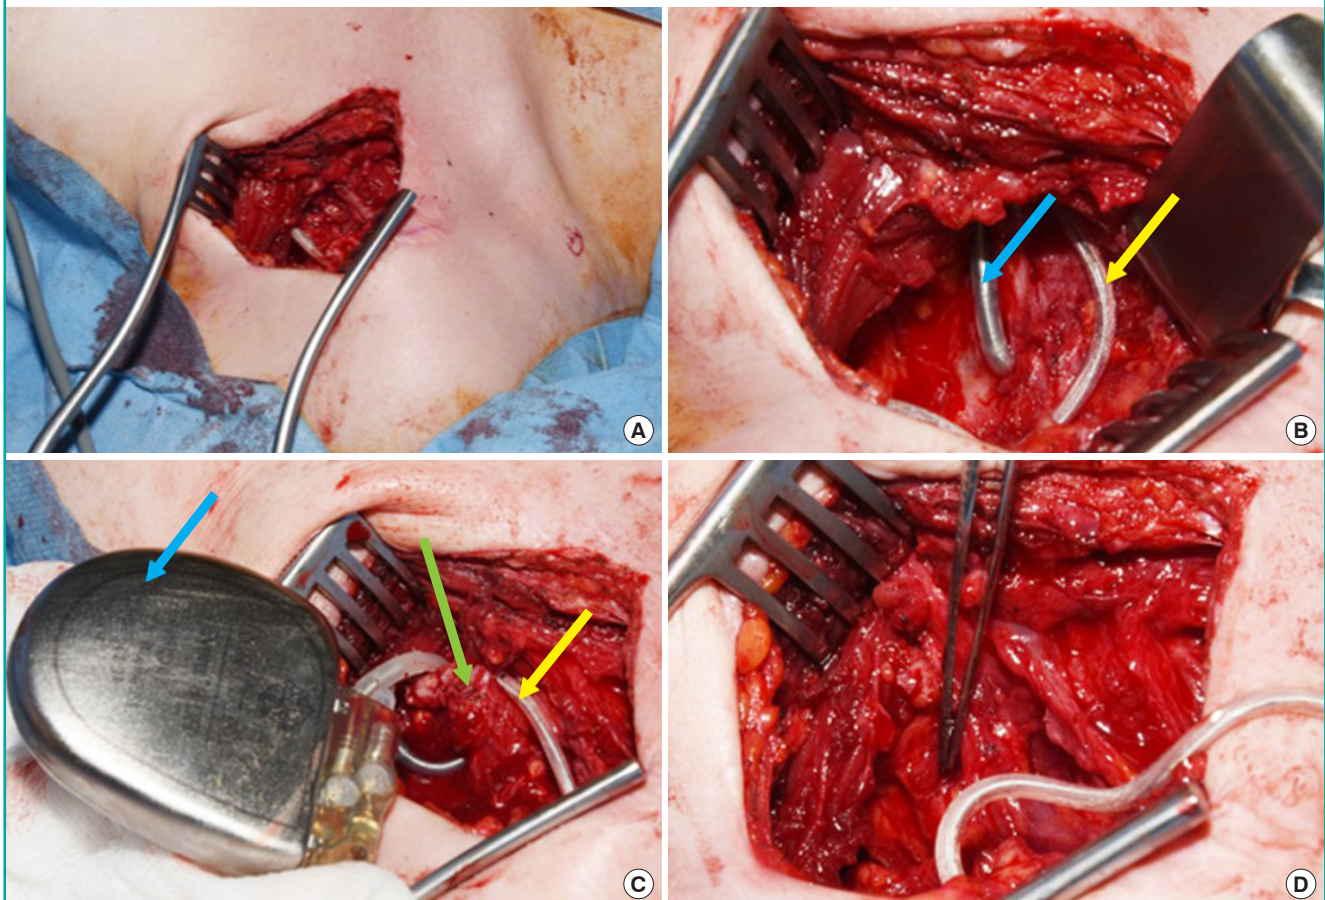
**Fig. 2. Intraoperative images of ICD repositioning**

Surgical exploration (Fig. 2) revealed that the ICD box and the loop of the ICD lead were pushing upward towards the neck, resulting in compression and chronic irritation of the brachial plexus. Limited neurolysis was performed to release the device from the lateral cord. Repositioning and securing of the ICD generator to a more medial position within the submuscular plane away from the brachial plexus was performed.

(A) Access through original left infraclavicular incision. (B) Dissection into subpectoral pocket revealed the implantable cardioverter defibrillator (ICD) lead loop (yellow arrow) from computed tomography and the laterally situated ICD generator (blue arrow). (C) Once the box (blue arrow) was dissected out the loop of ICD lead (yellow arrow) remained tethered by fibrotic scar tissue (green arrow) necessitating neurolysis. (D) Following careful dissection, the loop was freed from the brachial plexus and the box and lead re-positioned. The forceps here is indicating the lateral cord of the brachial plexus.
