Determination and classification of intraoral phosphor storage plate artifacts and errors

Purpose: The aim of this study was to determine the reasons and solutions for intraoral phosphor storage plate (PSP) image artifacts and errors, and to develop an appropriate classification of the artifacts.

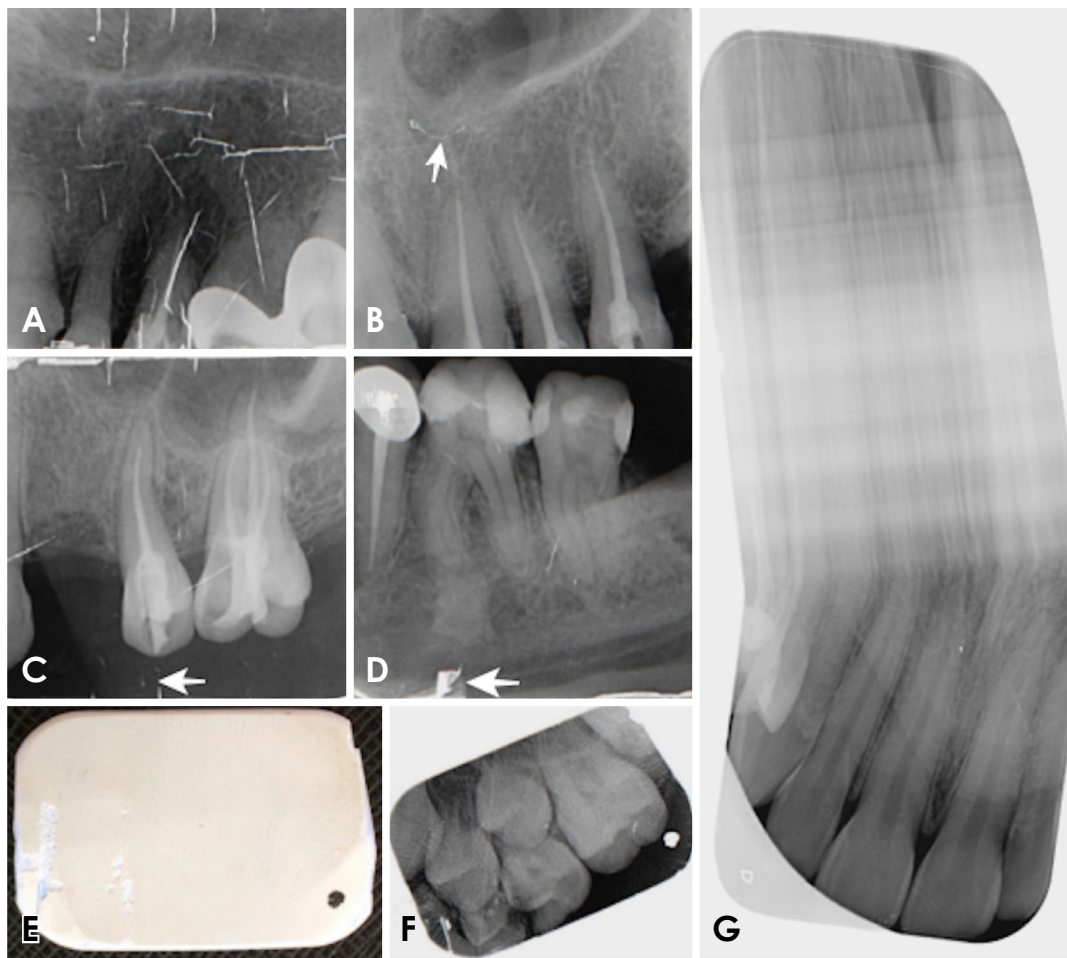
In the study, the third most common error involved short scratches (Table 1). These deformations are shown as irregular or straight radiopaque lines anywhere on the radiograph. Using a plate that is not properly matched with the scanner causes the image to elongate longitudinally and produces bright stripes (Table 2, Fig. 2).^{8,9}

Fig. 2. Phosphor storage plate (PSP) damage. A. Stretches. B. Crescent-shaped bending (arrow). C. Bite marks (arrow). D. Partial stripping (arrow). E. Peeled plate surface. F. Reticulation caused by a peeled PSP surface. G. Elongation of the image resulting from use of a mismatched plate.

Another common error came from short scratches caused by deformations in the plates. Damage to the photo-stimulating luminescence layer and cracking in the supporting polyester layer can occur for a variety of reasons, including careless manipulation when positioning the PSP in the mouth, excessive bending, unintentional biting by the patient, using force when placing the film into the scanner, and mechanical stresses of the rollers and holders during the scanning process. Manufacturers recommend using protective covers to minimize mechanical damage to the plates.^{8,9} Previous studies have suggested that plastic bar-

rier envelopes were not able to prevent bite marks.⁴ PSP damage can be handled using Roberts and Mol’s method,¹⁷ which involves placing double-sided pieces of tape around the sensor plate cover. It has also been reported that the use of both cardboard sheaths and disposable plastic envelopes prevents PSP damage; however, this also causes movement of the phosphor plates in the disposable packets.¹³ PSPs should be checked every day for scratches. If scratches are found on the surface, a test image should be taken and, if necessary, the PSP should be replaced. It was observed that the rate of physical damage to the PSPs was much higher than reported by Chiu et al.⁴ and Gülsahi et al.,⁵ but similar to that reported by Çalıřkan and Sümer.³ In this study, the high rate of the PSP damages was due to the fact that new PSPs could not be purchased when needed because of the hospital’s financial situation and the high costs of the PSPs.

Wiping the plates may also have a negative effect on plate quality. For this reason, Kalathingal et al.¹⁸ advised that plates should be given a light wipe only when needed and should be cleaned with 95% alcohol and a soft cloth to remove any surface dust particles, body oil contamination, and smudges. The current study found no wiping artifacts, because the plates were cleaned with cleaning pads only when the PSP surface was contaminated.

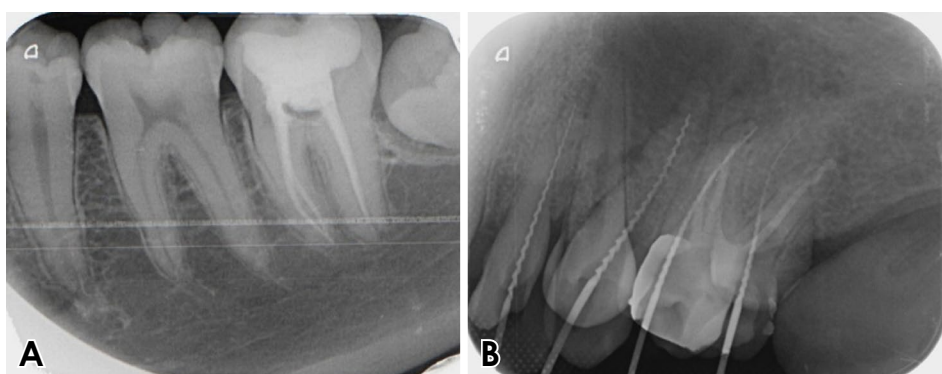
Fig. 4. Scanner artifacts. A. Laser slit dirt. B. Eraser unit artifact.

An inadequate erasing process causes a ghost image of the previous exposure to appear on the image. The solution is to check the setting. The eraser setting should be at the highest erasing power, while the scanning speed should be

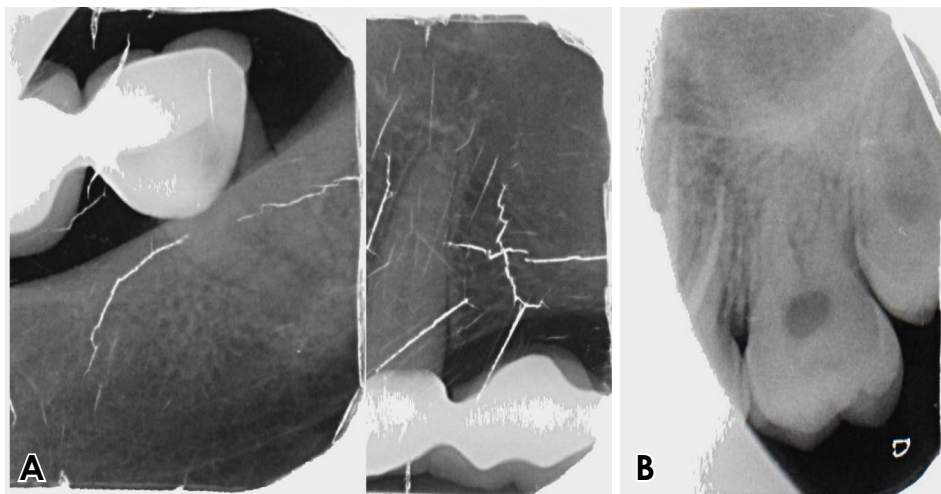
Fig. 8. Software artifacts. A. A bisection artifact (dividing the same image into two images). B. Plate size determination error. The reason for this artifact is that the scanner detected a different size from that of the scanned plate.

Plate size determination error most likely occurs when the scanner detects a different size from that of the scanned plate. The current study observed this artifact when the number 2 plate was detected as being the number 0 plate, causing half of the image to be missing. Çalışkan and
