## Impaction of a continuous glucose monitoring sensor

**Keywords** Biosensor / Home blood glucose monitoring / Foreign bodies

Received: January 20, 2021 • Revised: April 14, 2021 • Accepted: May 4, 2021  
pISSN: 2234-6163 • eISSN: 2234-6171 • <https://doi.org/10.5999/aps.2021.00178> • Arch Plast Surg 2021;48:392-394

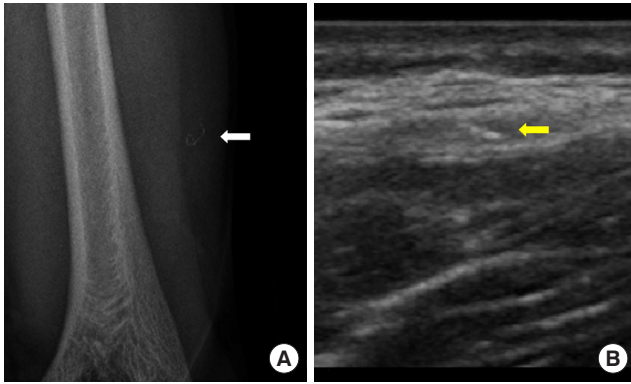
A 33-year-old man presented to the plastic surgery department for foreign body removal 1 month after the insertion of a CGM sensor (Dexcom G5, San Diego, CA, USA) in the left upper arm. The patient had used the CGM system for 5 years, and the insertion was done in the usual manner. After insertion, mild pain and redness at the insertion site continued for 3 days. At the patient's initial visit, no inflammatory signs were noted. The entire sensor wire was visible on simple radiography (Fig. 1A) and ultrasonography (Fig. 1B). In the operating room, the sensor wire was identified in the intermuscular septum and removed (Fig. 2A). No foreign body reaction or inflammatory signs were found around the foreign body. The foreign body

**Fig. 1.** Preoperative images. The sensor wire detached from the transmitter (white and yellow arrows) is shown on simple radiography (A) and above the deep fascia on ultrasonography (B).

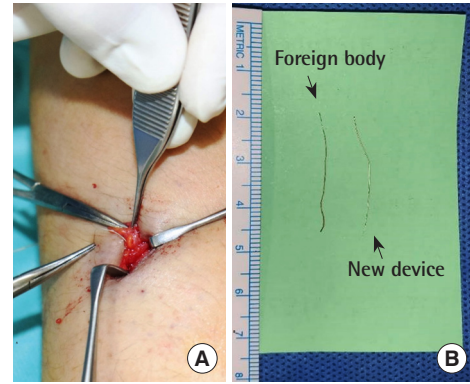
measured 2.5 cm, leading us to assume that the entire sensor wire had detached from the transmitter, not fractured. The foreign body showed a darkish change in color after 1 month, compared with a new device (Fig. 2B). No remnant foreign body was found on follow-up simple radiography.

The patient was an expert user of the CGM device, and the device had been inserted in the usual manner. Therefore, it is unlikely that the patient misused the device (e.g., by excessive pinching of the skin during insertion) as an explanation for the detached whole sensor wire. The process of using the device is simple, and the patient was skillful and used it in the routine manner; thus, we hypothesize that this case resulted from a device defect rather than misuse.

**Fig. 2.** Intraoperative images. (A) The sensor wire was identified in the intermuscular septum and removed. A foreign body reaction or inflammatory signs were not shown around the foreign body. (B) The foreign body measured 2.5 cm, leading us to assume that the whole sensor wire had detached from the transmitter, not fractured. The foreign body showed a darkish color change over the course of 1 month, compared with a new device.

not identified and the surrounding tissue was not inflammatory, making it difficult to trace the wire. In this case, the sensor wire was identified on simple radiography and ultrasonography. However, the sensor wire was so thin that it was difficult to detect the sensor wire even using intraoperative radiography or ultrasonography. We continued to search for the localized area on radiography for a long time and eventually found the sensor wire.

It would have been easier to trace the sensor wire if a safety device had been attached to the wire. To the best of our knowledge, this is the first reported case of a CGM device complication resulting from a device defect. The development of CGM is in full swing and new device models are being introduced, but the possibility of this complication should be taken into account and patient education is needed.
