Images in Cardiovascular Disease

More Is Not Always More: A Timely Reminder Why Not to Use Too Much Hardware

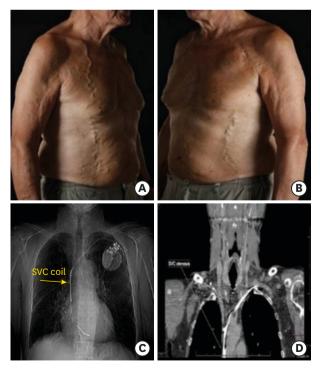
Figure 1. Striking bilateral symmetrical varicosities over the chest and abdomen (A, B), suggestive of SVC obstruction. Chest X-ray showed normally positioned dual coil ICD (C). Computed tomography venogram confirmed stenosis of the SVC (D).

Data curation: Khanra D, Panchal G, Chandan N; Supervision: Petkar S; Validation: Petkar S; Visualization: Petkar S; Writing - original draft: Khanra D; Writing - review & editing: Dowd R, Petkar S. infraclavicular approach (**Figure 1C**). Computed tomography venogram confirmed stenosis of the SVC (**Figure 1D**). SVC obstruction is a known entity (in up to 30% cases) in the context of bulky ICD leads. However, it remains asymptomatic and thus often goes unnoticed until the need for device upgrade with a new lead or extraction arises.¹⁾ Having said that, venous engorgement such as in our case is very rare. One of the common causes of stenosis at the right atrium (RA) - SVC junction is the SVC coil of a dual coil ICD. Superiority of dual, versus single coil leads, in terms of defibrillation efficacy remains to be proven.²⁾ Moreover, the SVC coil increases lead complexity, cost, risk of lead failure, and lead removal.³⁾ Also, in the absence of a bradycardia indication, the potential of an additional atrial lead to enhance arrhythmia discrimination, reduce inappropriate shocks, rate of hospitalization and mortality has not been borne out by scientific studies.⁴⁾ A SVC coil induces not only wall adhesions, but also sclerotic reorganisation of the venous wall resulting in stenosis and obstruction.¹⁾

In our patient, we are managing his heart failure with optimal medical therapy including angiotensin receptor antagonist and neprilysin inhibitor and sodium glucose transporter 2 inhibitor. We anticipate the need for a venoplasty of the SVC-RA junction if we do ever consider upgrading his ICD with a new left ventricular lead. In retrospect, the SVC obstruction may have been prevented if a single coil ICD was implanted in the first place. In contemporary practice of ICD implantation, an SVC coil can cause more trouble than be of benefit to a patient.
