내성천 유역 하천의 물리 서식지 특성 평가

Assessment of Physical Habitats Characteristics in Naeseongcheon Basin Streams, Korea

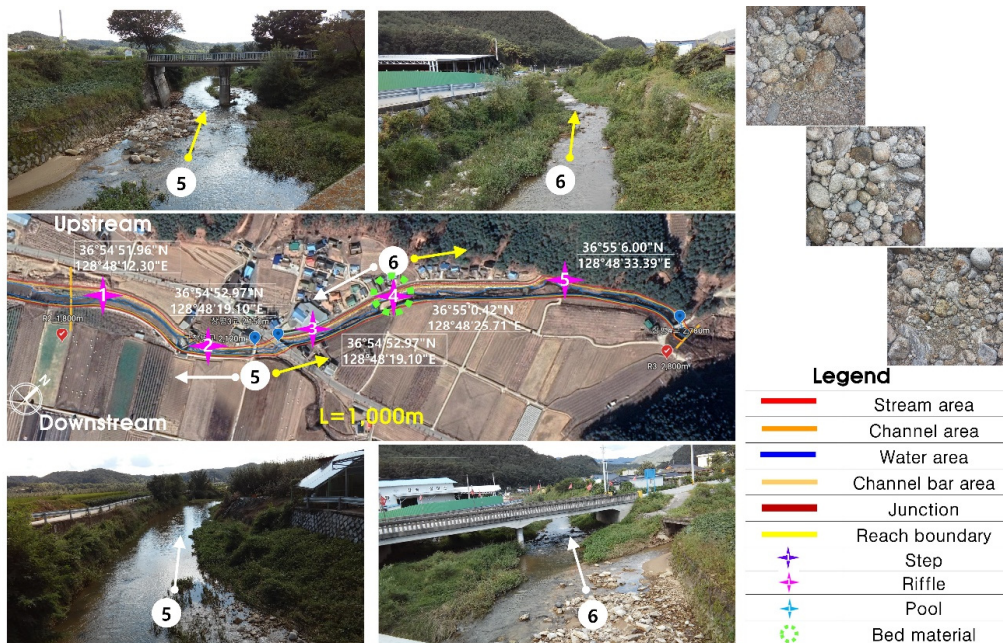
Fig. 3. Example photographs of field survey contents in Changpyeongcheon (Mid gradient Reach No.3).
