Development of a Diagnostic Technique of the Historic Structures Using a Thermal Infrared Camera

Abstract: The establishment of the investigation and the maintenance technique is required for preservation of old structures in Japan. This study attempts to diagnose the deterioration status of the historic structures using the thermal infrared camera. In some structures, the difference of the spatio-temporal change was observed in the surface temperature. For example, the cold joint of concrete was examined using this method effectively. As a result of this study, we have found useful guidelines in developing methodology to conduct diagnosis of historic buildings by using thermal infrared camera.

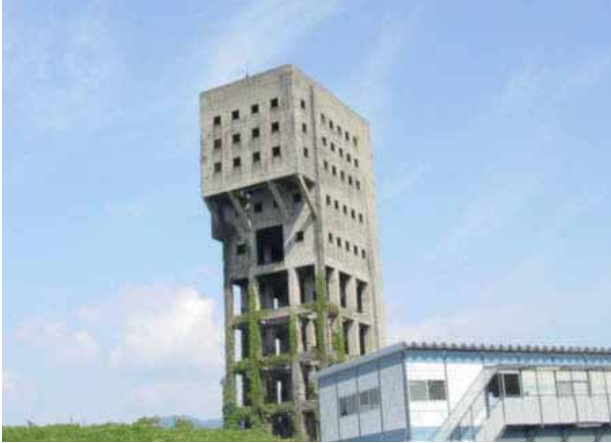
Fig 2. Vertical Shaft Oar of Shime Coal Mine

Shime Coal Mine was first started in the year 1889 under the direct management of then Japan Navy. By demolition of Japan Navy due to the consequences of World War II in 1945, the management of Shime Coal Mine was transferred to the Ministry of Transport. In 1949, it was taken over by the Japanese National Railways, and finally was closed in 1964. In Japan, it was the only national coal mine, and the total coal output from start till end was about 22 million tons. The construction of Vertical Shaft Oar of Shime Coal Mine was started in 1941 and completed in the year 1943. Having Ferro-concrete structure, it possesses the dimensions of 17.3m x 12.9m x 48.6m. Vertical Shaft Oar of Shime Coal Mine is Japan's oldest existing

winding tower type vertical shaft. Currently it is in the possession of New Energy and Industrial Technology Development Organization, Japan. The vertical shaft oar of the Shime Coal Mine image is shown in **Fig.2**.

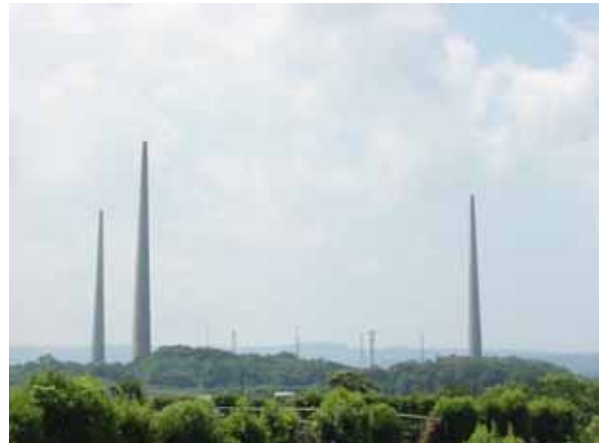
Fig 3. Hario Radio Tower

The construction works of three radio towers and a transmitting station office of Hario Radio Station were started under the control of ex-Japan Navy in November 1918 and were completed in November 1922. It was used for national defense and law and order maintenance of Japan, marine safe security etc, until it became abolished in March 1997. There are three radio towers, arranged by an equilateral triangle having 300m distances between them. The height of the 1st and 2nd towers is 135m each and 137m for the 3rd one. The base and top diameters of towers are 12.12m and 3.17m respectively. The base circumference is 33.0m and the thickness of the tower walls is 76cm. These towers are reflecting the highest technology of Ferro-concrete structure construction of those days. The Hario Radio Tower image is shown in **Fig.3**.
