# Flood Hazard Map in Kumagaya City

**Abstract :** We made a hazard map using GIS and remote sensing for the greatest inundation damage that happened for the 20th century. We calculated the land cover classification using Landsat from 1983 to 2000. We calculated it from a damage report and an aerial photo for a flood. We considered relation of both land cover classification and the damage. We expected the inundation damage in the future and made a hazard map.

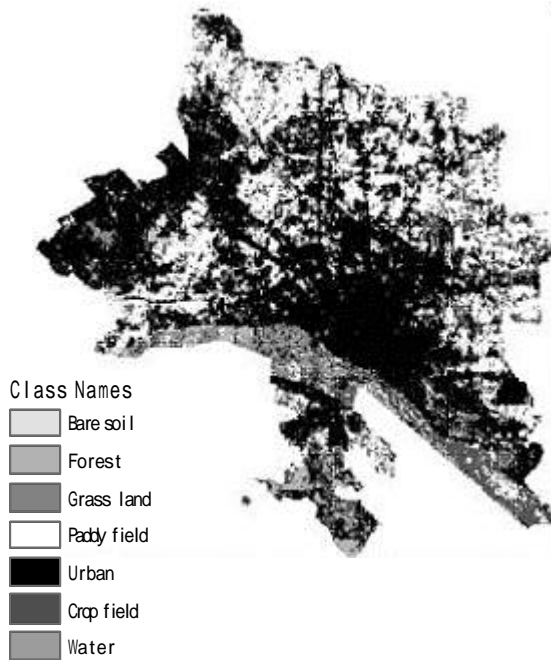
Fig.5 Land Cover Classification

The land cover classification was carried out from Landsat-TM data. When creating a land cover classification map using Landsat-TM data, it is difficult to classify a paddy field and a crop field with sufficient accuracy from one period of the data. Therefore, it classified using the two periods of data for the fallow and cultivation seasons. Classification items are paddy fields, crop fields, forest, bare soils, urban areas, and water areas. Land cover classification result in Kumagaya City was shown in Fig.5, Table.1.

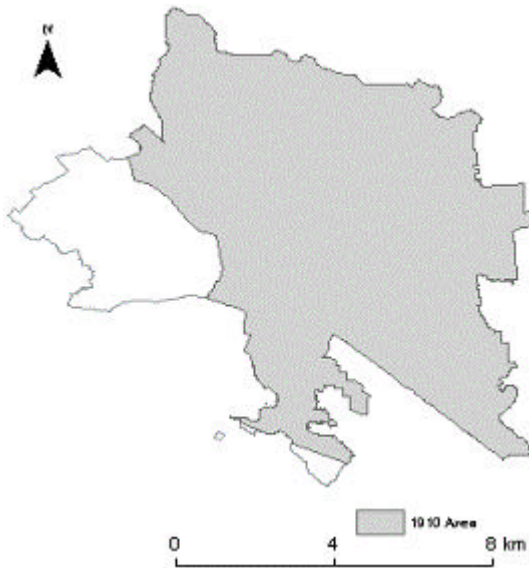
Fig.1 Inundation Actual Map in August, 1910

The inundation area, in 1910 and 1947 showed that covered the whole area in Kumagaya City. The inundation areas for both years were quite similar. In 1958, the east side of Kumagaya City was mainly the inundation area. The inundation areas were shown in Fig.1, 2, and 3 for 1910, 1947, and 1958, respectively.

In creation of a hazard map, the past actual inundation area maps were used, and read with the scanner and geometrically corrected using the digital map 25000. Next, these maps were digitized using ArcGIS. The target inundation was August 1910, typhoon (Fig.1), September 1947, Kathleen typhoon (Fig.2) and September 1958, Kanogawa Typhoon (Fig.3). The reason why we collected was that the damage was the most serious and it was generally officially announced as inundation an actual map.

The inundation area was trimmed with the contour line for 1910, and with the watershed for 1947 and 1958 using 50-mDEM. The paddy field was extracted from the land use of digital map 25000 (map image), a topographic map 50000, and the land cover classification from Landsat TM.

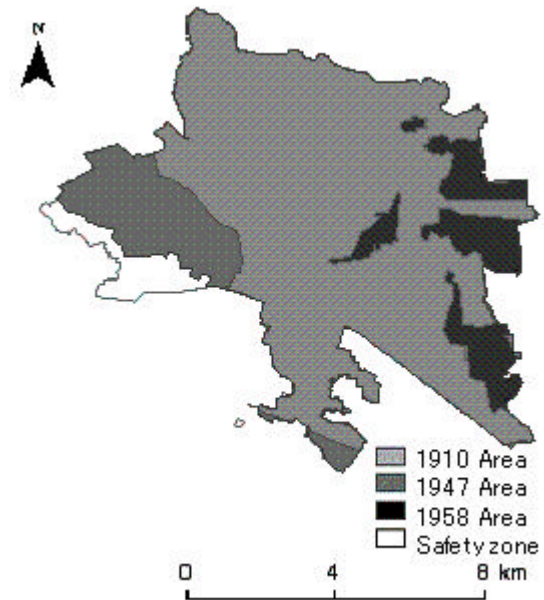
Fig.4 The proposed hazard map

The inundation areas in 1910, 1947, and 1958 were combined, as a hazard map, shown in Fig.4.

Finally added the paddy field to the flood region polygon, the hazard map was made of the three maps (Fig.4).
