USING REMOTE SENSING TO DETECT THE COASTLINE CHANGE FOR MANGROVE REPLANTATION AT BAN LAEM SING, CHAO PHRAYA RIVERMOUTH, IN THE GULF OF THAILAND

Absornsuda Siripong
Marine Science Department, Faculty of Science
Chulalongkorn University
Phya Thai Road, Khet Pathumwan, Bangkok 10330, Thailand
sabsorns@chula.ac.th
ISRS-2006-PORSEC Meeting
Busan, South Korea,
1-4 November 2006.

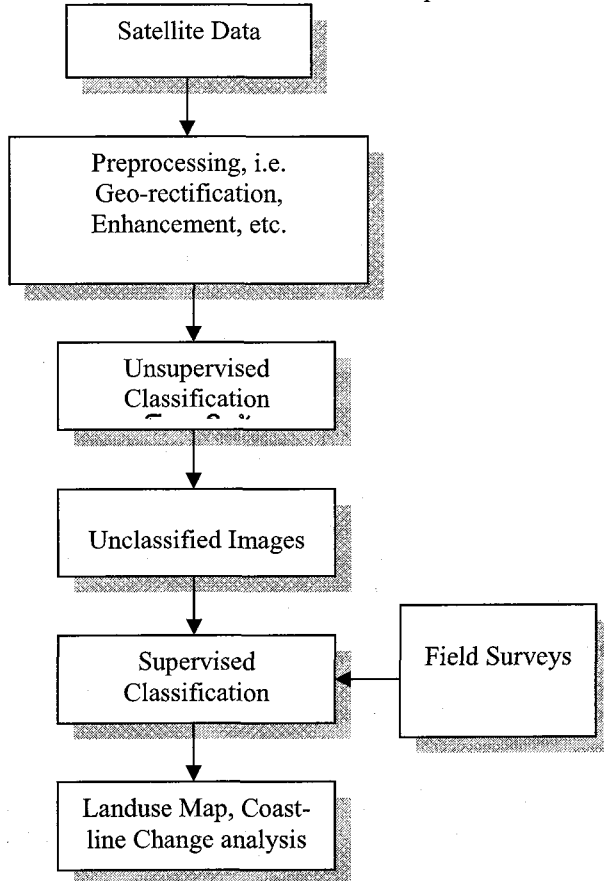
Figure 1. Remote sensing method for coastline change detection.

The sixteen Landsat TM from 1987 to 2002 were used in this study, using ERDAS image Version 8.7. The diagram of remote sensing technique is shown in Figure 1.

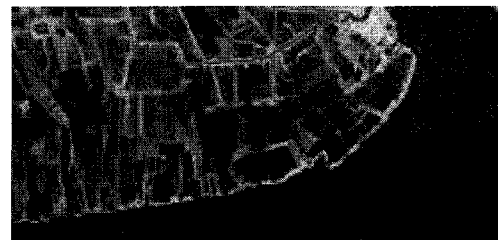
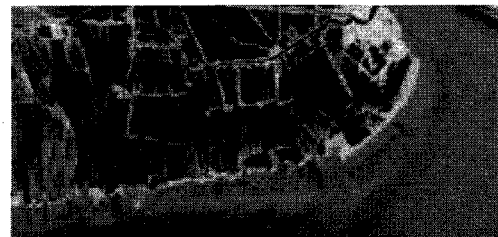
25 December 1987, as reference for comparison.

2 September 2002.

Figure 3. The comparison of the two coastline on 1987 to 2002 by Landsat TM resolution 30 m.

The coastline was divided into 31 sections (Figure 4). Each section at 15 dates were compared with the data on 25 December 1987 (Figure 3) as base map. The example of the study area was shown in Figure 5.

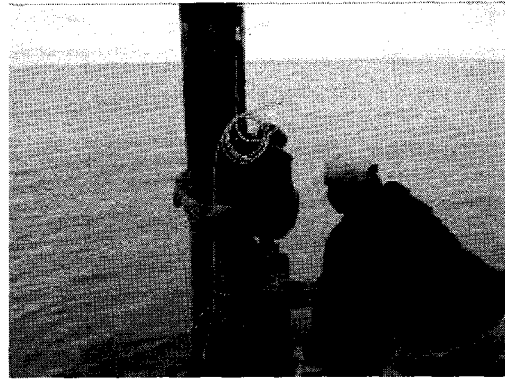
Figure 7. The wave gage was deployed on 12 September 2006.

The field surveys on sea current, wave and sediment concentration were conducted before and after the construction. During 14 to 16 September, an experiment was done to measure the efficiency of the fence to reduce the wave and current (Figure 7). The analysis is not complete yet.
