Analysis of Costa Concordia Incident - Focussed on Safety Side

요 약 : 본 논문은 2012년 1월에 발생된 이탈리아 국적 크루즈 선박 Costa Concordia 사고를 분석한 논문으로써, 사고의 발생경위와 원인 및 배경등을 선박운항에 있어서 안전적인 측면에서 분석하고, 이를 토대로 해결방안 및 향후에 일어날 크루즈선박 사고에 대한 대비책을 제시하였다.

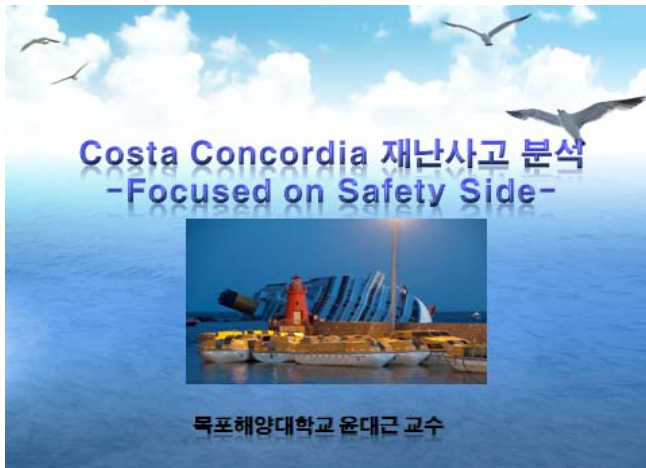
1. Port of Registry: Genoa, Italy
2. Launched: Sep. 2, 2005
3. In Service: July 2006
4. Out of Service: Jan. 13 2012
5. Tonnage: 114, 137 GT

Height above waterline: 60m (approximately 85 percent of ship's overall height). Total of 13 passenger decks

6. Length: LOA 290.20m
7. Beam: 35.50m
8. Draught: 8.20m
9. Decks: 13
10. Speed: 19.6 Knots (In Service) 23.0 Knots (Maximum)
11. Capacity: 3,780 Passengers
12. Crew: 1,100 (see next slide)
13. Ship Value: 570 M \$
