Development of Protection Techniques for Explosive Demolition of RC Pillar

철근콘크리트 기둥 발파해체를 위한 방호기술 연구

ABSTRACT. Safety concern is one of the most important parameters in the design of building demolition by explosive blasting. Accidents were sometimes reported due to the flying chips of fragmented materials in building demolition work in urban area. Laboratory experiments were performed to investigate the failure behavior of reinforced concrete pillars under blast loading and to develop an effective protection technique. Sixteen reinforced concrete pillars were constructed. The failure behavior and the flying chip velocities were observed by means of a high-speed camera. Protection scheme was designed and the effects of several protection materials were investigated. Two kinds of non-woven fabrics and wire net were tested as protection materials. The results showed that reinforcing bar was one of the important factors to determine specific charges, and that mesh size of wire net and tied-up method affected the protection of flying chips. Control of gas effects is also a key to the control of flying chips. It was recommended to use both wire net and non-woven fabrics as primary an

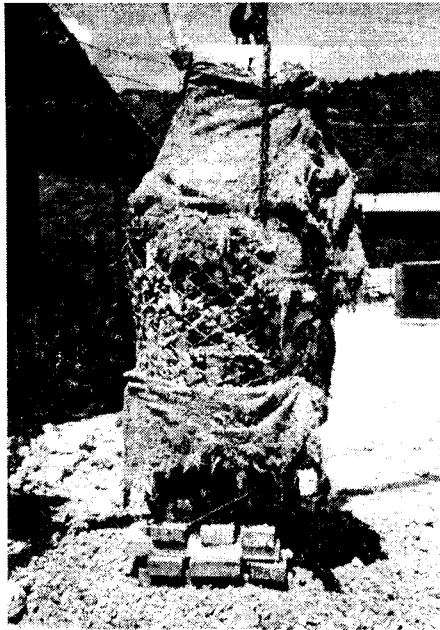
The results of the 7th to 10th test showed that combination of wire net and non-woven fabric might be a good protection method. The gray non-woven

fabric could not control the fragments passing through the net (see Fig. 7) while the white gray non-woven fabric control them very effectively (see Fig. 8) It is recommended to use wire net as primary protection material and white non-woven fabrics as secondary one.

Fig. 7. View after Blasting,
Column I (C+A)
