Study on Leak Rate of SCC Degraded Alloy 600 Tubings of PWRs

Seong Sik Hwang, Joung Soo Kim, Ken E. Kasza*, and Jangyul Park*

Korea Atomic Energy Research Institute

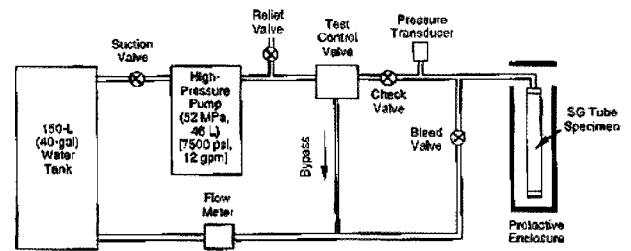
Fig. 1. Schematic of the pressure test facility.

During the first stage of the room temperature pressure test, it was attempted to obtain first leak pressure, leak rate at certain pressure and burst pressure. Two tubes of SGH002, SGH006 were prepared for this work. In the second stage of the test, a 100 psi pressure increment and holding for 4 to 10 minutes were adapted to see first leak pressure and leak rate changes with time. The pressurization stopped at a certain value at which a measurable leak rate could be obtained, and this process allowed the tubes to avoid an unstable burst, which makes the metallography harder. Tubes SGH001, SGH005, SGH009, SGH010 were used for this analysis. Fig. 1 shows the schematic of the room temperature pressure test facility.

The high temperature pressure test aimed at knowing the leak behavior at the PWR operating temperature of 282 °C. The facility consists of a high temperature water reservoir and test section where the temperature of the specimen and pressurized water were controlled. The maximum water pressure of this test is around 2800 psi. Details of the facility are also described in the report NUREG CR-6511. For the high temperature pressure test, tube SGH005 was used. The pressure was raised to 1200 psi and held for 45 minutes and then increased to 2760 psi slowly while checking if a leak symptom was detected at the muffler from which steam came when it leaked.

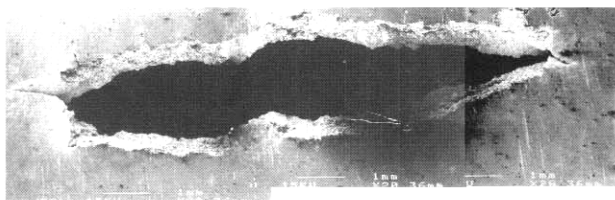
Fig. 2. Crack morphology of SGH002 after the pressure/leak test at room temperature.

The first leak was detected at 2500 and 3400 psi on tubes SGH002 and SGH006, respectively, which was similar to the crack developing pressure, 3000 psi at which the tube was confirmed as 100 % through wall by nitrogen gas. A droplet on the tube SGH002 was formed at 2500 psi, but it did not grow further for 5 minutes. At 3200 psi, one drop every 3 seconds was formed from the crack on the tube SGH002. It showed a leak rate of 0.24 liter/min at 4300 psi and 4.28 liter/min at 5000 psi, and ruptured at 5200 psi. Fig. 2 shows the crack of SGH002 after the pressure and leak test done at room temperature. The crack was torn like a fish mouth, which was formed during

rupture at 5200 psi, at a length of about 11 mm.

Both tubes have tear ligaments on the fracture surface. This means the leak rate came from two or more adjacent cracks. The length of the stress corrosion cracked area was measured at about 10.3 mm and 10.95 mm in SGH002 and SGH006, respectively.

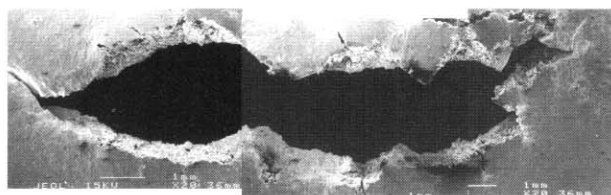
Fig. 3. Crack morphology of SGH006 after the pressure/leak test at room temperature

Tube SGH006 revealed a water spray at 3400 psi, which turned into a droplet, and one was made every 4 seconds. It showed a leak rate of 0.27 liter/min at 4000 psi and 3.87 liter/min at 5000 psi and ruptured at 5700 psi. This tube did not show leakage at 1560 psi and 2500 psi. Fig. 3 shows the tube SGH006 after the pressure test. Besides the main crack of 11 mm long, a few hairline cracks were opened after rupture at 5700 psi.

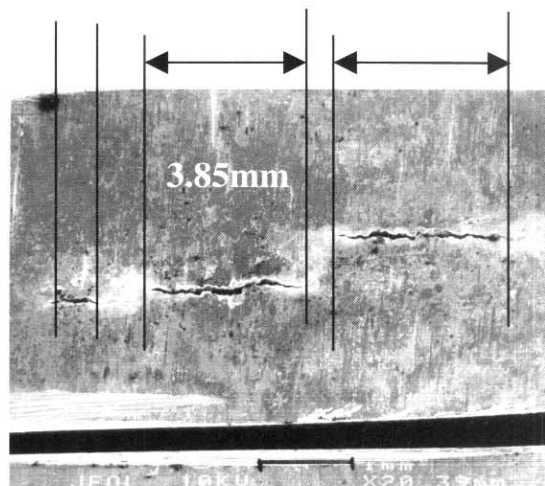
Fig. 4. Flaws on the SGH001 after the pressure/leak test at room temperature.

Fig. 4 shows flaws of the tube SGH001 after the pressure test at room temperature. Two or more cracks are linked with each other in an axial direction, and they showed a different opening. The crack length of the inside tube is shorter than that of the outside surface on each tube. It is considered to come from two things: the inside pressurization procedure and the out diameter crack development. An effective crack length, which is related with the leak rate, is considered to be the inside length of the crack. The relationship between the leak rate and crack length will be discussed later in this article.

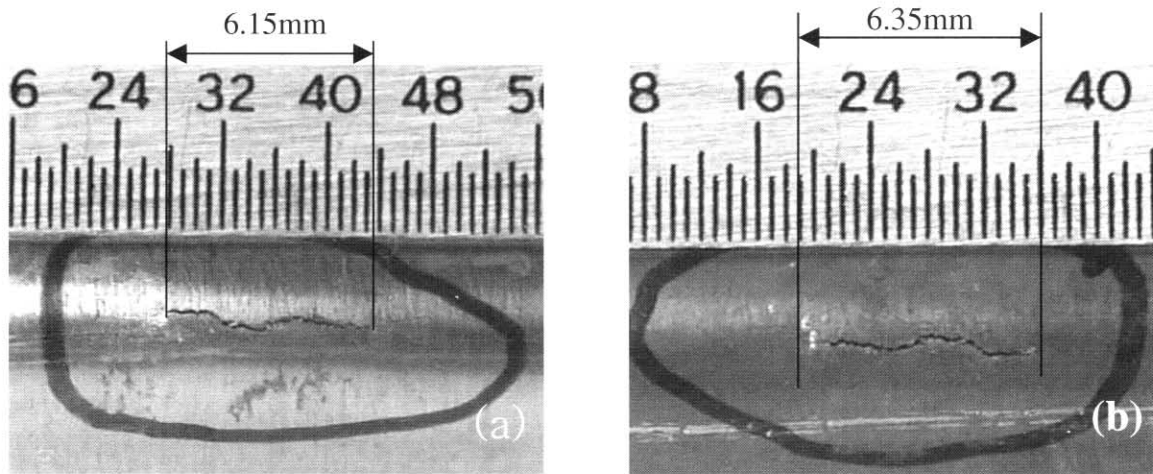
Fig. 5. Flaws on the SGH005 after (a) High temperature pressure test, (b) Room temperature pressure test.

A room temperature pressure test on the tube SGH005 was carried out after the high temperature pressure test, which is described later in this section. The tube demonstrating a non-measurable leak in the previous test, showed a jet spray at 60 psi, leak rate of 0.23 l/min at 1560 psi and 0.43 l/min at 3000 psi. After the high temperature pressure test, where a non-measurable leak was detected, the specimen was heat tinted to perform the metallography easily. The crack seems to open during the heat tinting, to show a jet spray at low pressure and to show a large leak rate at 1560 psi. Fig. 5-(b) shows a feature after the

room temperature pressure test; the length of the flaw increased slightly, but apparent features such a crack opening did not change from the Fig. 5-(a), which was obtained after the high temperature pressure test.

This behavior may be interpreted as a crack closure inside the tube while opening up the outer crack by the internal pressure. The ECT(Eddy current test) indicated that the effective length of the crack after the pressure test decreased to 12.7 mm from 15.2 mm, whereas the EC voltage increased to 99 volts after the pressure from 30 volts before the pressure test. These ECT results allow us an assumption of crack closure during the pressurizing. However, the ECT results and the assumption could be fortuitous. The situation may be different in the case of primary side cracking, that is, as the internal pressure increases, the leak rate might also increase if the tube had an inside cracking. The pressure test results are summarized in Table 2.

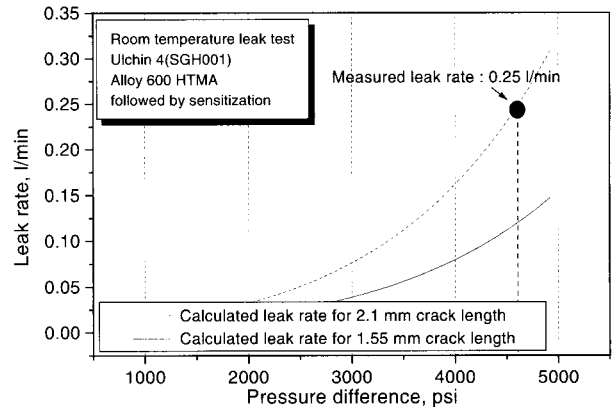
Fig. 6. Calculated and measured leak rate on the tube SGH001.

Four different pressures were applied to obtain the leak rate for the tube SGH001. The first leak from the tube was recorded at 3620 psi in the form of a single water droplet. The leak rate of that kind of drop is considered to be less than 0.01 l/min, and the crack length calculated from the leak rate model is about 0.6 mm. A measurable leak rate was obtained at 4600 psi; it changed slightly with time at the same pressure. According to the leak rate model, the calculated crack length is 2.10 mm for the final leak rate of 0.25 l/min. Crack lengths of the main crack of this tube were 3.85 mm and 1.55 mm outside and inside, respectively, as shown Fig. 4. The calculated crack length of 2.1 mm is between the measured crack length of the inside diameter and outside diameter. From the difference between the measured and calculated crack lengths, it is considered that some of the final leak rate came from the minor cracks. Fig. 6 shows the calculated leak rates for 1.55 mm and 2.10 mm crack and measured leak rate 4600 psi as a function of applied pressure. When the pressure reached at 4600 psi, the calculated leak rate for a 1.55 mm crack is 0.12 l/min. The measured value of 0.25 l/min is close to the calculated value for a 2.10 mm crack.

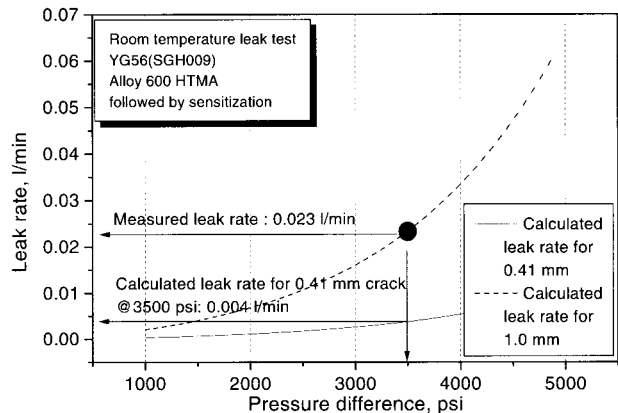
Fig. 7. Calculated and measured leak rate on the tube SGH009.

In the case of SGH009, the final leak rate of 0.023 l/min was obtained at 3500 psi. The calculated crack length is 1.0 mm, which is longer than the inside crack length and much shorter than the OD crack length. From the point of the pressure variation as shown in Fig. 7, the calculated

leak rate for the measured crack length of 0.41 mm at 3500 psi is 0.004 l/min. The measured leak rate of 0.023 l/min is on the leak rate line for 1.0 mm crack length. This means that the crack length related leak of SGH009 is in between the measured inside crack length and the outside diameter crack length also.

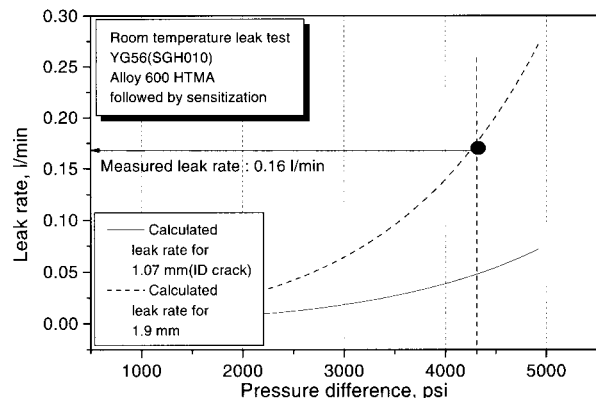
Fig. 8. Calculated and measured leak rate on the tube SGH010.

As seen in Fig. 8, the calculated leak rate for a 1.9 mm crack length fits the measured leak rate well. That is, a twice or four times larger leak rate than the calculated one in the tubes SGH009 and SGH010, seems to be related to a different crack opening of the two tubes. Unlike the tube SGH001, the two tubes had a crack opening area twice as large as the calculated one as indicated. From this fact, we know that heat YG5,6 opened easily rather than increasing in crack length, consequently showed a larger leak than expected from the leak model.

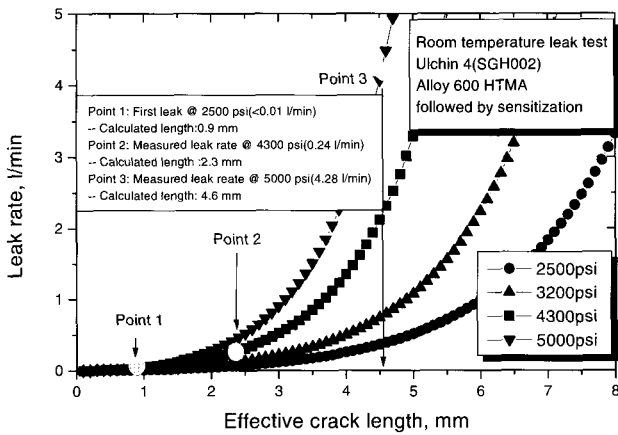
Fig. 9. Effective throughwall crack length on the tube Ulchin 4 calculated from the leak rate model (SGH002)

The leak rate behaviors of the tubes SGH002, SGH005, and SGH006 are shown in Fig. 9 to Fig. 11. Because the main purpose of the pressure test for those three tubes was to obtain the leak rate at a certain pressure and burst pressure, the final leak rate of each tube was obtained just before the burst. The final features of the flaws in those tubes were obtained after the burst, so it is hard to relate the leak rate to the crack length of those tubes.

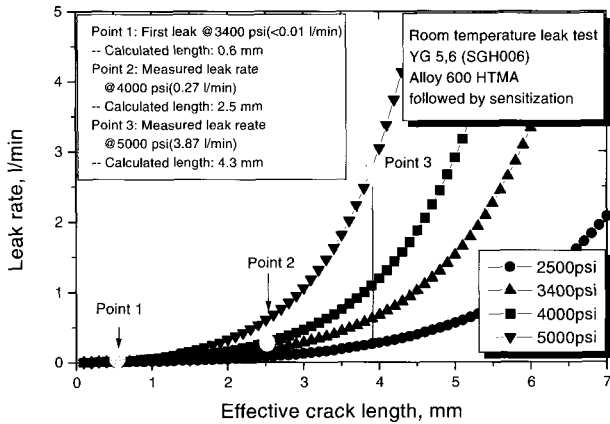
Fig. 10. Effective throughwall crack length on the tube YG5,6 calculated from the leak rate model (SGH005)

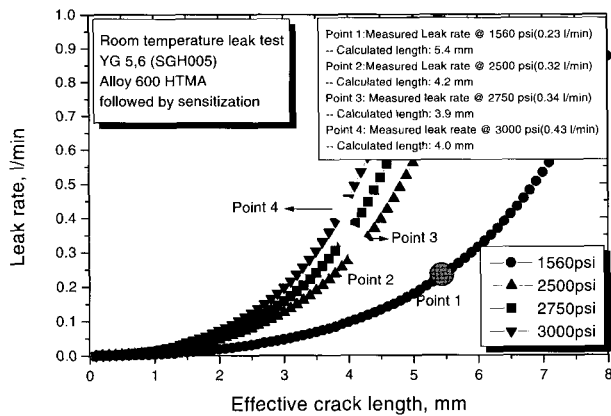
Fig. 11. Effective throughwall crack length on the tube YG5,6 calculated from the leak rate model (SGH006)
