## **River Water Environmental Management System by Construction of Early Warning System - A Comparative Study on Korea and Japan.**

Typhoons Rusa (2002) and Maemi (2003) struck Kangwon and Gyeongnam provinces of Korea and caused the most extensive flood damages ever known since the foundation of Meteorological Agency in 1927. Many cities are inundated, crippling the critical facilities and resulting in high irreversible losses of human lives, and damages to infrastructures. These kinds of flood damages were among the worst natural disaster that Korean people experienced. In order to reduce flood damage, it is necessary to investigate how to use the information of water environment during the rainfall disaster. Therefore as per the result of this study, we have suggested few but effective countermeasures for controlling the flooding damages and also the advancements in the areas of disaster information dissemination and early warning system for water environmental management by using optical fiber system in Japan are discussed.

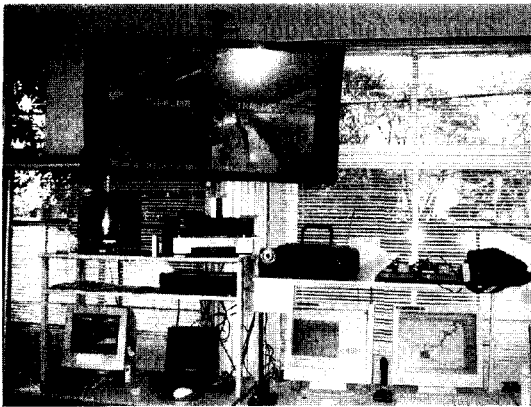
Figure. 4 Monitoring system for observing the water environmental condition

To meet the local resident's growing need for information on river system, an optical fiber information system is in progress. Foundation of River and Basin Integrated Communications of Japan is conducting researches on the essential factors to be taken in consideration to reduce flood damage. It has proposed few of the items such as data of transmission of water movement with real time using graphic information, and water quality monitoring etc. As shown in Figure. 4 and 5, items like centralized supervision and operation of river facilities by remote observation, the provision of river basin information network, and improvement of internal network of Construction Ministry were discussed. In addition, it also pointed out the challenges of the monitoring system such as effective observation of the river condition, secure time

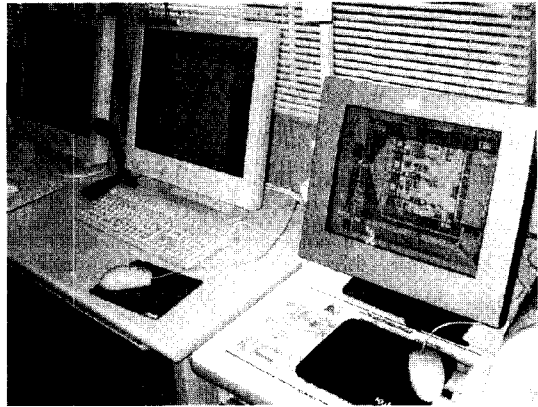
Figure. 5 Main flood control and water management system for early warning
