Non-Destructive Evaluation of Semiconductor Package by Electronic Speckle Pattern Interferometry

This paper proposes non-destructive ESPI technique to evaluate inside defects of semiconductor package quantitatively. Inspection system consists of ESPI system, thermal loading system and adiabatic chamber. The technique has high feasibility in non-destructive testing of semiconductor and gives solutions to the drawbacks in previous technique, time-consuming and the difficulty of quantitative evaluation. In result, most of defects are classified in delamination, from which it is inferred to the insufficiency of adhesive strength between layers and nonhomogeneous heat spread. The 90% of tested samples have a delamination defect started at the around of the chip which may be related to heat spread design.

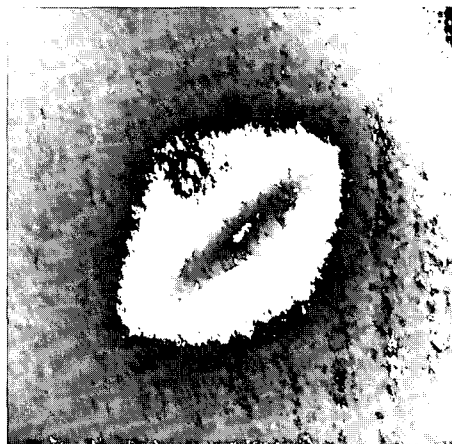
(a) C-scan result

(b) ESPI Phase map

(c) Contour line of surface displacement from ESPI

(d) Quantitative evaluation from line profile of (c)

Fig. 4 Comparison of ESPI and scanning ultrasonic microscope

Although ESPI is successful technique in non-destructive testing field, it is needed to confirm the reliability for application to inspection of semiconductor due to the first try. Artificial defect is introduced inside of semiconductor by impact testing machine and the defect is detected by the proposed inspection system which is compared with ultrasonic testing method. Inside temperature of chamber is supported at 50°C and falls down slowly by temperature control system. Fig. 4 shows the results of scanning ultrasonic microscope and ESPI. The defect is a crack with a diagonal line and delamination is observed around crack in Fig. 4(a). The delamination defect colored with () and crack size can be estimated from Fig. 4(b), (c) and (d). The quantitative result (24.5 mm) of scanning ultrasonic microscope which is estimated by interpolation is compared with that (23.6 mm) of ESPI which is directly obtained by speckle fringe pattern analysis. However, it is that the important difference between two methods is time-consuming. In ESPI, it takes about 2 minutes to get high-resolution image, on the contrary, in scanning ultrasonic microscope, it takes more than 10 times.

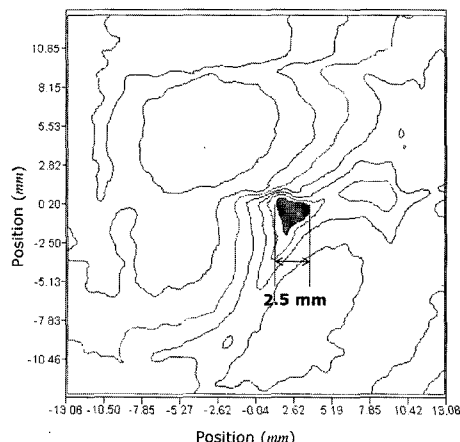
(a) ESPI Phase map of inside impact-damaged defect

(b) Quantitative evaluation of inside defect from contour line

Fig. 5 Inspection of impact-damaged defect ()

between component materials in heating and cooling processing causes thermal stress that gives defects. Fig. 5 and 6 show inspection results of damage that occurs as a result of operator's failure which is within 10% of total life time. Fig. 5 shows inspection results of impact-damaged specimen, ESPI phase map (a), and contour line (b) of out-of-plane displacement. Small void defect, estimated as 2.5 mm, is in the center of sample. Fig. 6 shows void defect inside of package, which is inferred to thermal shock of silicon chip by overvoltage. In this case, it is supposed that the inside of semiconductor is burn in local and adhesive is melted between layers contact to silicon chip. Fig. 7 shows inspection results of damage that occurs between 10 and 60% of life time as a result of misuse, abuse or the other external causes. The 90% of tested samples in the period have delamination defects between layers on silicon chip which is estimated to cause for the insufficiency of adhesive strength by cyclic thermal loading above the growth of defect in manufacturing process.

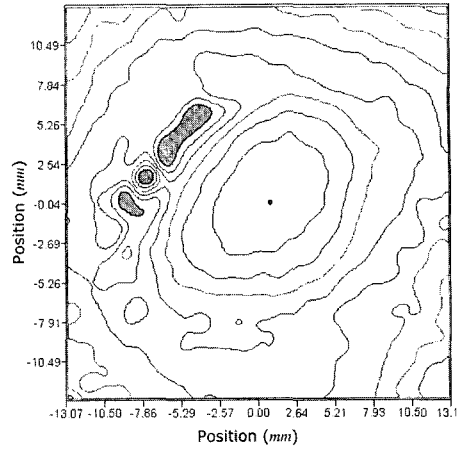
(a) ESPI phase map

(b) Contour line of surface displacement

Fig. 6 Inspection of void defect ()

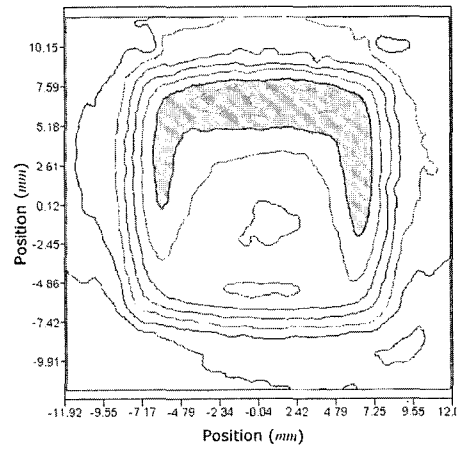
(a) Starting from the edge of package

(b) Starting from the center of package

Fig. 7 Inspection of delamination defect ()
