**Traumatic Rupture of the Subcutaneous Bypass Vascular Graft  
- A case report -**

Jung Eun Lee, M.D.\*, In-Seok Jang, M.D., Jun Ho Yang, M.D., Sung-Hwan Kim, M.D.,  
Jong Woo Kim, M.D., Jun Young Choi, M.D., Sang Ho Rhie, M.D., Ph.D.

Department of Thoracic and Cardiovascular Surgery, Medical College, Gyeongsang National University.  
Institute of Health Science, Gyeongsang National University.  
Department of Thoracic and Cardiovascular Surgery, Asan Medical Center\*.

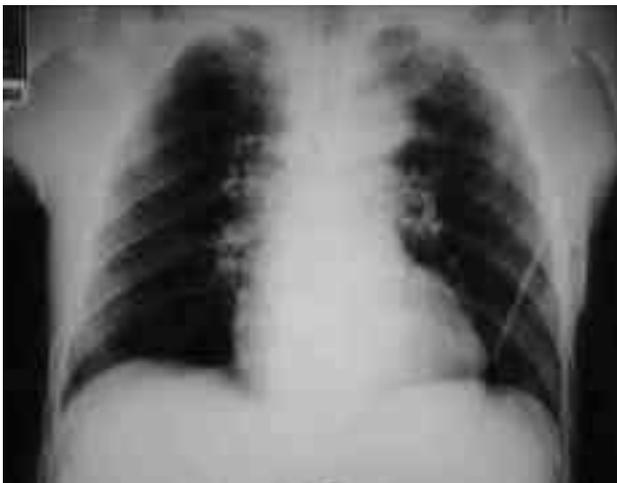
**Fig. 1.** Initial chest PA shows that there is not rib fracture, chest wall contusion, and lung haziness. Clear lung parenchyma was indicated that lung contusion is not existed. The blunt traumatic force was not strong to injury chest wall structures. Left lung field broad stick was a remained thermometer beneath his back skin.

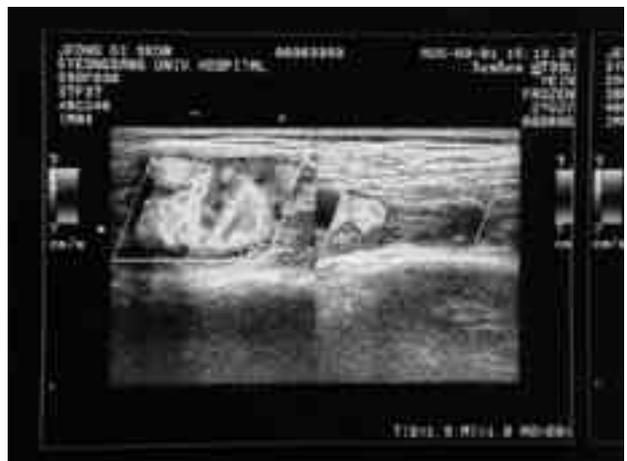
**Fig. 2.** Chest wall sonography shows turbulent flow in the cavity of the mass lesion (left side), and well maintained distal intra-graft blood flow (right side).

A 68-year-old man was referred to Department of Emergency of the Gyeongsang National University Hospital. After he had had a blunt trauma, he found a newly appearing pulsating mass of 10 cm diameter on his right chest wall. The lesion had a turbulent blood flow in the cavity of the mass by ultrasonographic finding. The lesion was a rupture of superficial prosthetic vascular graft under the skin.
