# Contribution of Water Chemistry in Initiation of Some Accelerated Corrosion Processes in CANDU-PHWR Primary System

Ioana Pirvan<sup>†</sup>, Maria Radulescu, and Manuela Fulger

*Institute for Nuclear Research, Pitesti-P.O. Box 78, ROMANIA*

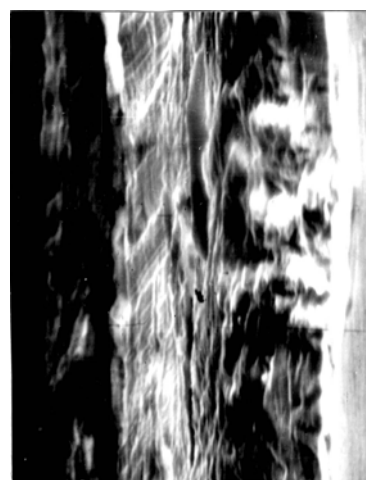
**Fig. 2.** Morphology of oxide film formed on Zr-2.5%Nb tested 30 days in LiOH- pH=12.5 (x1000)

Morphologically, these oxides differed from the black and uniform oxides, obtained in LiOH with pH=10.5, having a layered oxide structure with different pore sizes (Fig. 2) "From the report 2)".

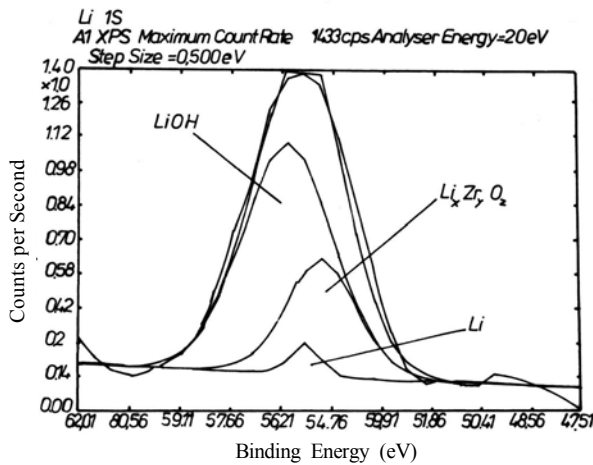
Fig. 3. XPS spectrum on Zr-2.5%Nb tested 30 days in LiOH-pH=12.5

XPS examination of a thick, no-uniform, white and pulvulent oxides emphasized the presence of  $\text{Li}^+$ , LiOH and lithium zirconate in oxide lattice (Fig. 3). The incorporation of  $\text{Li}^+$  in zirconium oxide lattice conducted to a

bigger concentration of anionic defects produced by  $\text{Zr}^{4+}$  ions substitution with  $\text{Li}^+$  ions in oxide, increasing oxygen diffusion through oxide.

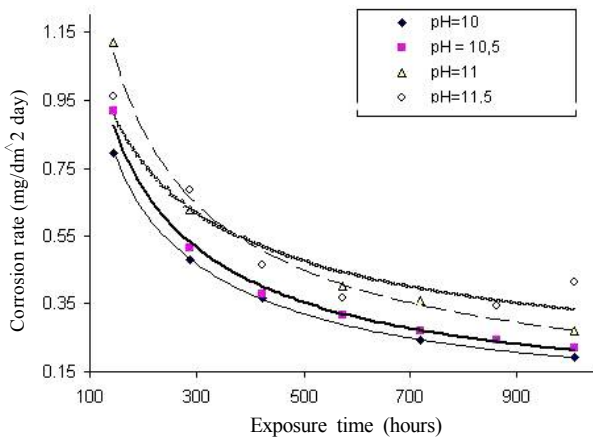
Fig. 4. Corrosion kinetics of carbon steel coupons tested at 310°C (9.8 MPa) in LiOH

The corrosion rate of carbon steel SA 106 gr. B and martensitic steel 403m coupons, tested at high temperature and pressure, increased with LiOH solution pH (Fig. 4).

At pH=11.5 the oxide films were no uniform, porous and no adherent. Their thickness increased with pH of LiOH solutions, from 1-1.5 µm for pH=10.5 to about 6÷8 µm for carbon steel SA 106 gr. B and 3-4 µm for martensitic steel 403 m, after 30 testing days at 310°C.

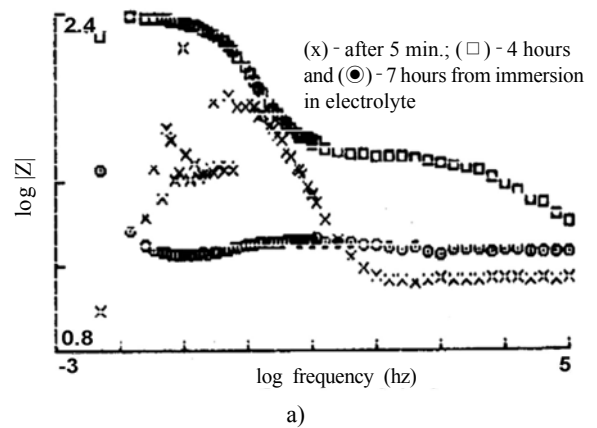
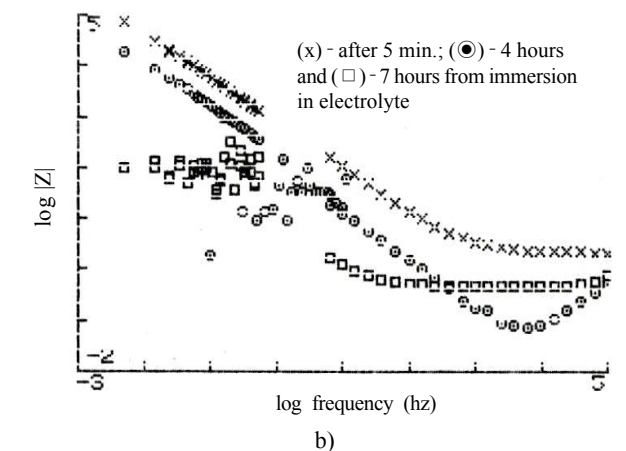
Fig. 5. Bode curves corresponding to the oxide films formed at 310°C (9.8 MPa on carbon steel SA 106 gr.B in LiOH-pH=11.5 (a) and martensitic steel 403 m in LiOH-pH=11 (b) coupons after 60 testing days)

The electrochemical impedance spectroscopy determinations showed that the oxide films formed on coupons tested in LiOH solution with pH=11 and 11.5 had a low capacitive behavior and were less protective than those formed in LiOH solution with pH=10.5, because the penetration of electrolyte in the oxide layer conducted to important modifications in the shape of Bode curves, after different periods from immersion moment in solution (Fig. 5).

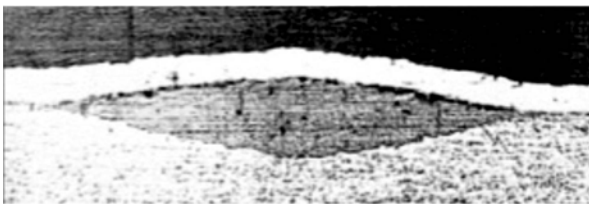
Fig. 14. Zirconium oxide nodule in section (x 40)

At oxygen concentration above 70 ppb (100 ppb) in presence of a neutron flux, an accelerated corrosion of Zircaloy-4 cladding has been observed, and is characterized by the formation of nodular type oxides “From the report 4)”. White ZrO<sub>2</sub> nodules, with a diameter up to 4 mm and thickness up to 300 μm, having lenticular form were formed after 90 testing days at 310°C (10.6 MPa) in INR TRIGA Reactor (Fig. 13 and 14).

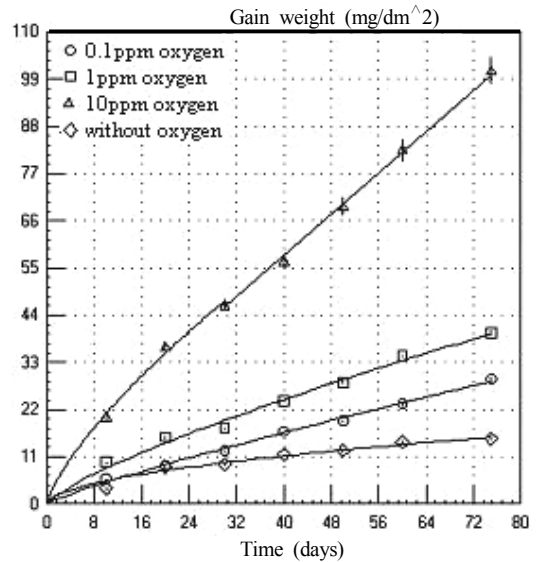
Fig. 15. Corrosion kinetics of Zr-2.5%Nb coupons tested at 310°C in LiOH solution (pH=10.5) with oxygen

An acceleration of Zr-2.5%Nb alloy corrosion at oxygen concentration above 0.1 ppm O<sub>2</sub> was observed (Fig. 15).
