# Thermally induced bone necrosis during implant surgery: 3 case reports

**Abstract** (J Korean Assoc Oral Maxillofac Surg 2011;37:406-14)

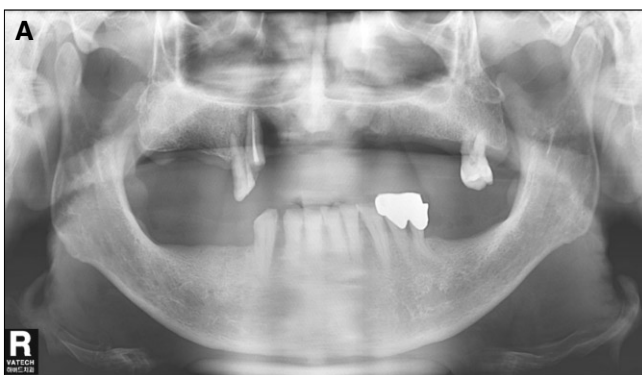
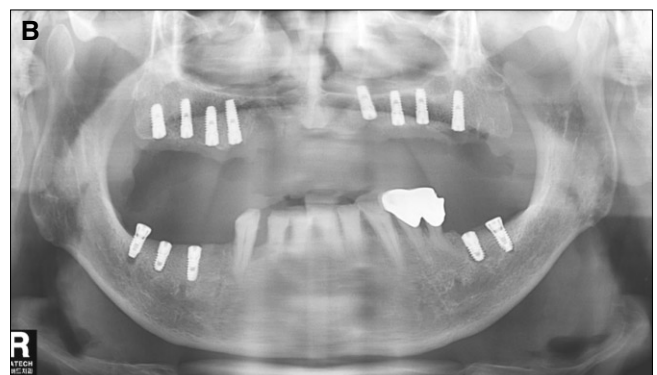
**Fig. 1.** A: Preoperative radiography. B: Postoperative radiography. Implants were placed on areas #36, 37, 45, 46, and 47 in the mandible.

A 63-year-old man with no medical history presented with a partially edentulous lower jaw. No previous periapical pathology was noted in the mandible in the preoperative radiographs. (Fig. 1. A) Osstem implants were placed in the positions #36, 37, 45, 46, and 47. (Fig. 1. B) The patient complained of pain within 7 days of surgery despite the administration of antibiotics and analgesics. Swelling and suppuration were not observed; however, periapical radiographs showed increased radiolucency in the middle and apical portions of the implants after 4 weeks. In particular, peri-implant radiolucencies on sites #37 and 45 were noticeable. (Fig. 1. C) Reoperation was performed immediately after noting the radiolucencies. During the surgery, a large bone defect was noted around the implants, and a high grade of implant mobility was detected at site #37. (Fig. 1. D) No implant mobility was noted for the positions #44, 45, and 46; however, the implants could be removed easily without any resistance by reverse torque. (Figs. 1. E, F)
