Evaluation of the Effect of Asphalt and Geotextile Interlayer on Unbonded Concrete Overlay

비접착식 콘크리트 덧씌우기 포장에서의 아스팔트와 Geotextile 중간층에 대한 영향 평가

International Journal of Highway Engineering

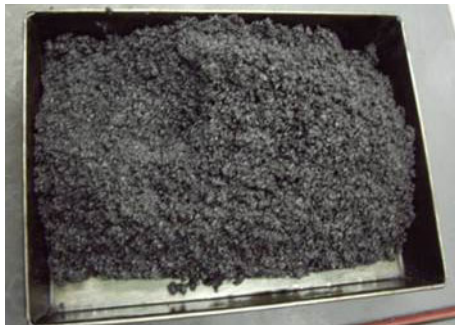
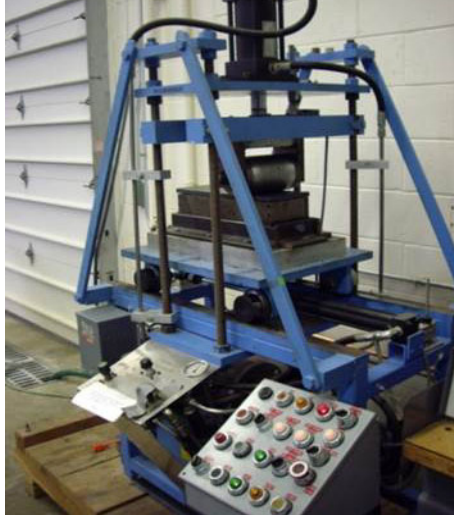
(a) Loosed Sample

(b) Compactor

Fig. 2 Preparation of Asphalt Interlayer

The bottom double-sized concrete beams (2.5 × 6 × 21 in.) were cast using steel molds and then cut to the dimensions of 2.5 × 3 × 15 in. The bottom concrete beams were saw-cut with 0.6-inch notch depth to simulate the joint or crack at existing PCC pavement. The asphalt interlayer was compacted using roller compactor with 4% air void and then cut into the beam dimensions of 0.5 × 3 × 15 in. (see Fig. 2).

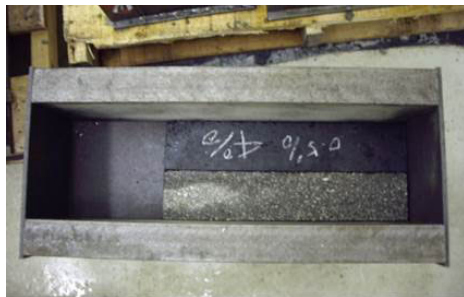
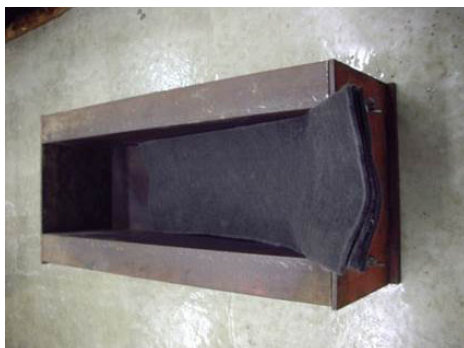
(a) Asphalt

(b) Geotextile

Fig. 3 Interlayer for Top Beam Cast

The top double-sized concrete beams (2.5 × 6 × 21 in.) were directly cast onto the geotextile or asphalt interlayer using the steel molds and then cut to the dimensions of 2.5 × 3 × 15 in. (see Fig. 3). The top concrete beam and interlayer were then placed on the pre-cast bottom concrete beam to form the whole composite beam used in the test. For the control case without interlayer, the top concrete beam was cast separately and then placed on the pre-cast bottom concrete beam.

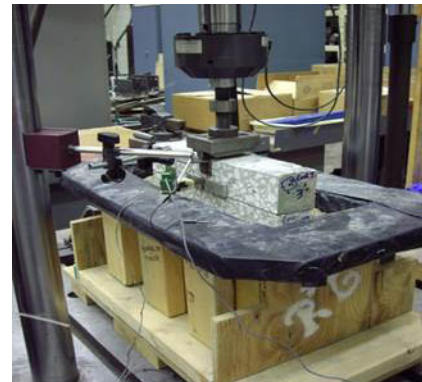
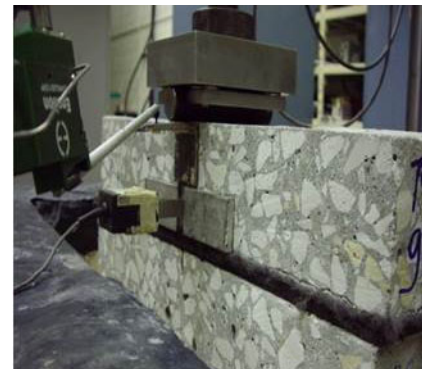
(a) Test Setup

(b) Instrumentation

Fig. 4 Composite Beam Test

The whole specimen was loaded with an 11-kips MTS servo-hydraulic actuator with the stroke position gauge being set at 0.02 in./min (0.5mm/min). An INSTRON 0.16 in. (4mm) range clip gauge was placed across the location over the notch to measure the crack opening that would initiate in the top concrete beam. The vertical displacement of the whole composite beam and soil was measured using a Linear Variable Differential Transducer (LVDT) with 1 in. (25mm) range. The test setup is illustrated in Fig. 4. Totally eight composite beams with two replicates for each interlay type

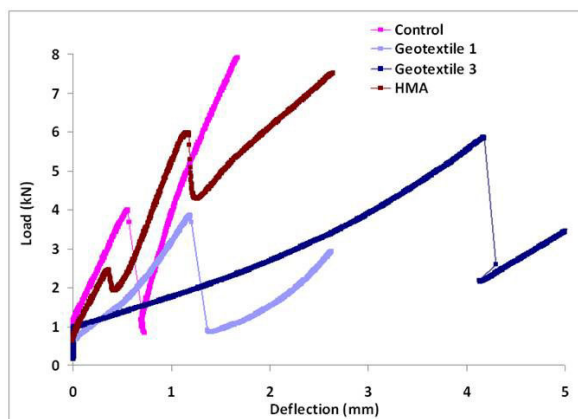
Fig. 5 Load versus Deflection Curves for Different Interlayer Types

The load and the vertical deflection of the whole structure (beam and soil foundation) were plotted in Fig. 5. The load is the output from the load cell of MTS and the vertical deflection is measured from the LVDT. As the load increases before peak load, the deflection increases with the increase of load. After the load achieves the first peak load, the load drops due to the occurrence of macrocrack in the top beam. However, the load increases again because the beam can be supported by the soil foundation. It is noted that for the composite beam with HMA interlayer, there is no visible crack observed at the first peak load and the first macrocrack in the top beam occurs at the second peak load. The peak loads at which the first macrocrack in the top beam was observed were used in the analysis because the objective of this study is to compare the effect of interlayer types on the failure behavior of concrete overlay. It is noted that the second peak load was observed in the test when the macrocrack occurs in the bottom beam for the control case and the composite beam with geotextile interlayer.

Fig. 5 shows that the existence of interlayer increases the total beam deflection at peak load, especially for the case of three-layer geotextile. For the composite beam with geotextile interlayer, the increase of deflection does not indicate the increase of deform capacity of the concrete beam because the bulk material of geotextile was compressed first

in the test which may cause the increase of total deflection.

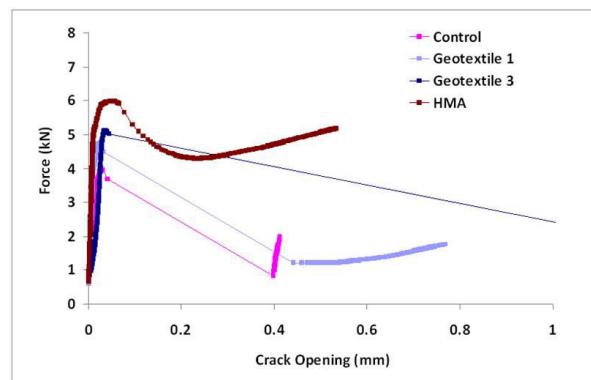
Fig. 6 Load versus Crack Opening Curves for Different Interlayer Types

The load and the crack opening of top concrete beam above notch were plotted in Fig. 6. As the load increases before peak load, the microcrack first develops in the top beam and the crack opening increases with the increase of load. As expected, the peak load from the crack opening curve was found the same as the peak load from the deflection curve. After the load achieves the peak load and a macrocrack occurs in the top beam, the load drops and the crack opening increases significantly even with the load drop. This indicates that the top concrete beam starts to lose its structure capacity.

Fig. 6 shows that the composite beams with HMA and three-layer geotextile interlayer have greater crack openings at peak load than the control case. In addition, the increase of crack opening during the load drop after peak load is less for the beam with HMA interlayer, compared to the control condition and the beam with geotextile interlayer. This is probably because the HMA interlayer is stiffer than the geotextile and it can contribute to the structure capacity.

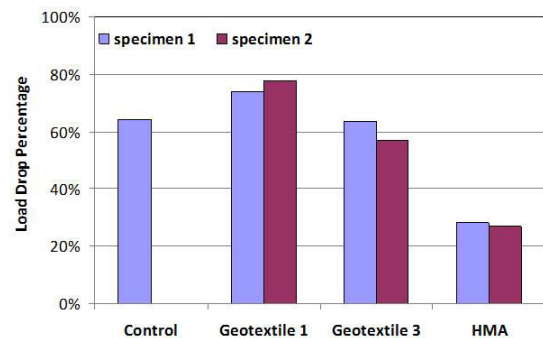
Fig. 9 Comparisons of Load Drop Percentage for Different Interlayer Types

Fig. 8 and 9 compares the peak load and load drop percentage of the composite beam for different interlayer types. The peak load indicates the load capacity before a macrocrack occurs in the top beam above the notch and it can be associated with the performance of concrete overlay in field before crack happens. The load drop percentage was calculated as the difference between the peak load and minimum load (after drop) divided by the peak load. The load drop was thought as a factor to estimate the residual structure integrity of composite beam after a macrocrack has been formed. Previous researches have shown that the load carrying capacity of slabs was based on the residual strength of concrete beams (Roesler et al. 2004). Thus, the magnitude of the load drop percentage can be associated with the performance of concrete overlay in the field after initial cracking has occurred.

the specimen will affect the fracture behavior of the composite beam and this could be the main reason causing the high variation between two specimens for the same interlayer type. Generally, it was found that the three-layer geotextile interlayer and HMA layer increased the peak load when the first macrocrack occurred in the top concrete beam, while the HMA interlayer caused the smallest load drop percentage after the first macrocrack. This is probably because the HMA interlayer can still carry the load after the macrocrack occurs in the top concrete beam. The three-layer geotextile did show better performance than the single-layer geotextile through the greater peak load and smaller load drop percentage. It indicates that the thickness of geotextile interlayer will affect the fracture behavior of unbonded concrete overlay and the thicker geotextile interlayer is recommended.
