New Retear Pattern after Rotator Cuff Repair at Previous Intact Portion of Rotator Cuff

(Clin Shoulder Elbow 2016;19(4):237-240)

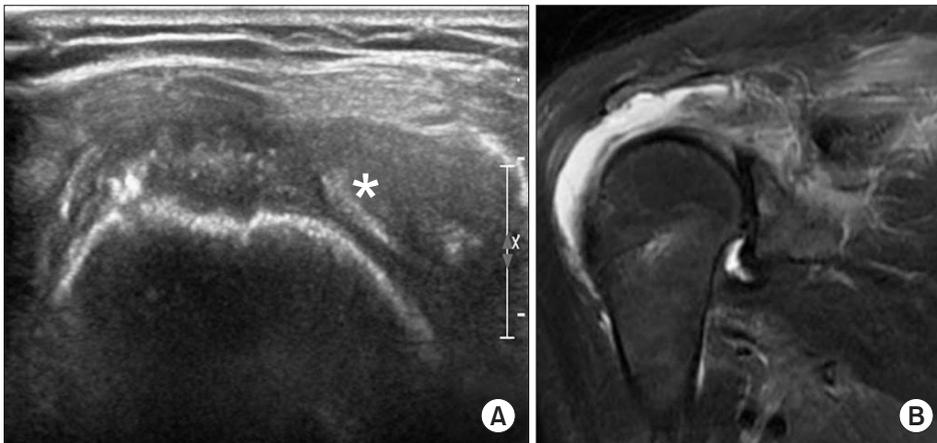
Fig. 3. Image evaluations of the ultrasound and magnetic resonance imaging (MRI). (A) The retracted cuff (asterisk) was shown on the ultrasound. (B) The type 1 retear (rupture in the tendon-bone) was noted on the fat-suppressed T-2 coronal MRI.

L1 of internal rotation of the right shoulder. The empty can test was positive. VAS was 6. The retracted rotator cuff was demonstrated by ultrasonography (Fig. 3A). With symptoms failing to be alleviated after conservative management and standardized rehabilitation, the right shoulder was investigated by MRI, which showed that the type 1 retear of the full-thickness rotator cuff tear was posterior to the area that had previously undergone rotator cuff repair (Fig. 3B). She underwent arthroscopic surgery on the right shoulder due to ongoing symptoms at another clinic. Arthroscopy showed no definite tear at the previous repair site (Fig. 4A), except for a 1×1 cm crescent-type rotator cuff tear on the 0.5 cm posterior side of the healed cuff, which is the same region in the MRI (Fig. 4B). After removal of the loose suture strands at the healed repair site, rotator cuff repair was carried out with the single row technique for the new tear, which was at the posterior side of the healed cuff (Fig. 4C). She underwent a standardized rehabilitation program postoperatively. VAS was 1. With respect to the functional scores, she showed improvement of KSS, ULCA, and Constant scores from 41, 15, and 47 to 89, 32, and 88 at the last follow-up of 18 months, respectively.

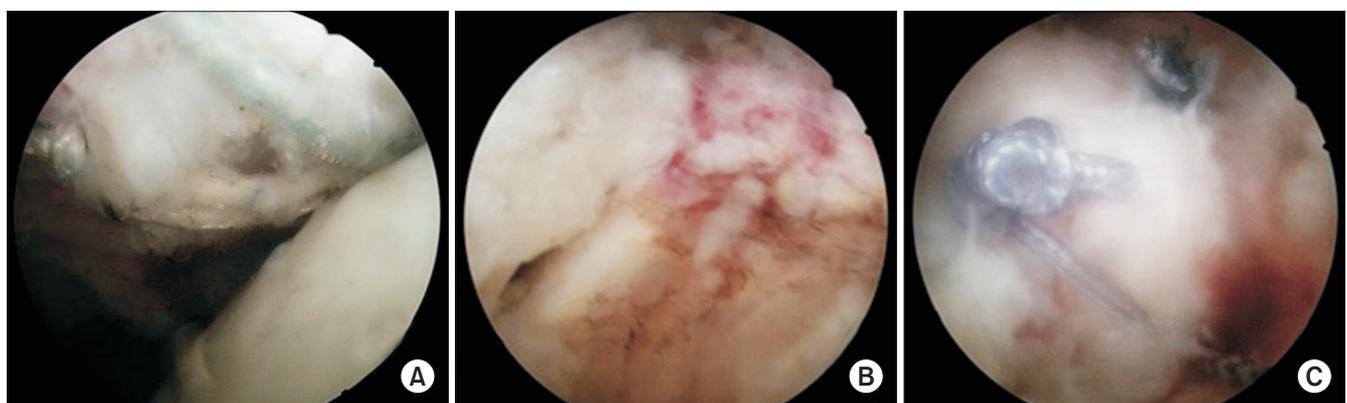
Fig. 4. Arthroscopic images for the right shoulder. (A) The intraarticular side of the previous torn rotator cuff was healed up on the intraarticular view of the arthroscope through the posterior portal. (B) Retear was noted at the posterior side to the previous repaired rotator cuff on the subacromial view of the arthroscope through the posterolateral portal. (C) The single-row repair was done for the reteared cuff with a suture anchor.
