# 전기 헤어드라이기에 대한 화재 시험법에 관한 연구

## Fire Testing Methods For The Electric Hair Dryer

**Purpose:** The purpose of this study is to development the fire evaluating test methods for the Electric hair dryers.

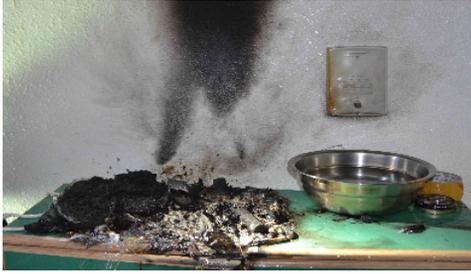
(a) Fire due to dust

전기 헤어드라이기의 발화에 대한 필드고장을 <Fig. 1>과 같이 분석한 결과 내부 축적된 먼지에 의한 발화, 화장실 등의 습도가 높은 환경조건 내 사용으로 인한 열화진행에 의한 발화, 이물질 등으로 인한 팬 구속으로 인해 순간적으로 과부하가 걸려 발생하는 발화사고, 수건 등으로 환풍구가 막혀 축열로 인한 발화 현상 등을 확인할 수 있었다.

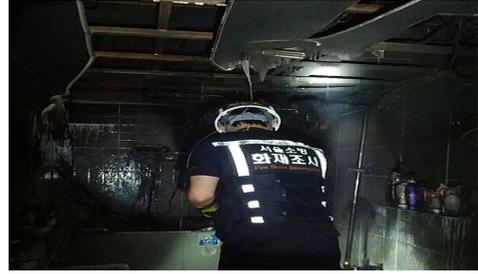
(b) Fire caused by high humidity deterioration

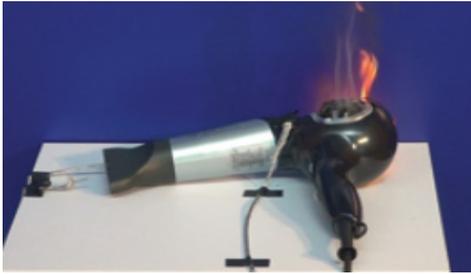
(c) Fire due to redemption fans

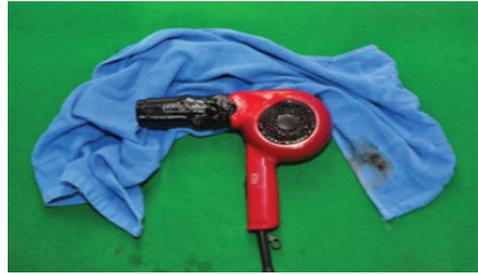
(d) Fire due to heat accumulation

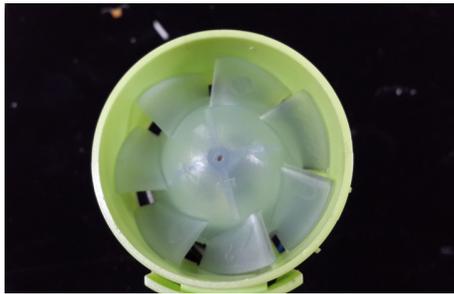
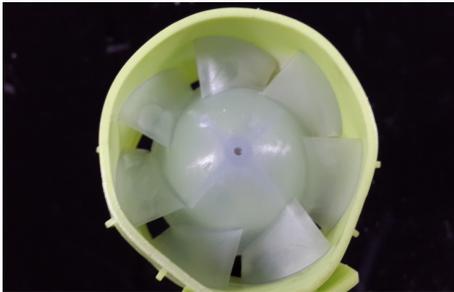
Fig. 2 High temperature test result

(a) The cooling fan (before test)

(b) The cooling fan (after test)

시험결과 A제품의 경우 24시간 만에 고온 및 고온고습시험에서 <Fig. 2>와 같이 외관케이스가 변형되어 팬을 구속하였고, 모델 B의 경우 고온시험 672시간, 고온고습시험 1,000시간 만에 외관케이스가 변형되었다. 외관케이스 변형상태에서 동작 시 이상현상을 확인하기 위하여 전원을 인가하였을 때 팬의 구속

으로 인해 순간적으로 과부하가 걸렸고, 히터부의 과열로 인해 회로 내 보호소자가 작동하여 전원을 차단하였다.

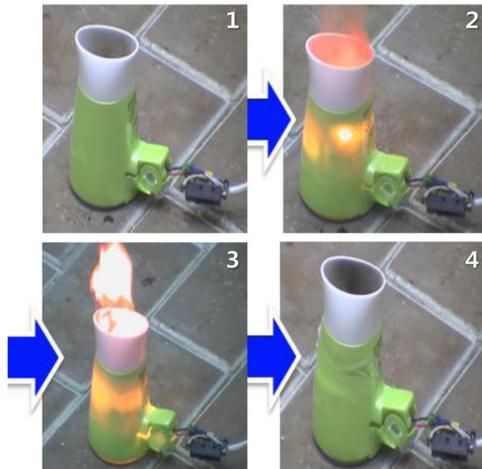
Fig. 3 Power operation test on the product attached dust

추가적인 재현시험을 위해 구속된 상태의 헤어드라이기에 먼지를 삽입한 후 전원을 인가하였다. 그 결과 <Fig. 3>과 같이 불꽃이 외부로 솟아올랐고, 순식간에 화재가 발생하였다.

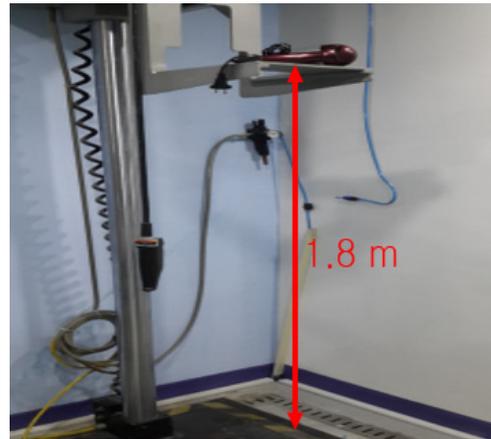
Fig. 4 Drop test

기계적 내구성 시험을 위해 헤어드라이기를 <Table 5>와 같이 일반적인 성인 남성의 평균 키보다 높은 1.8m 높이에서 <Fig. 4>와 같이 낙하시험을 수행하였다.

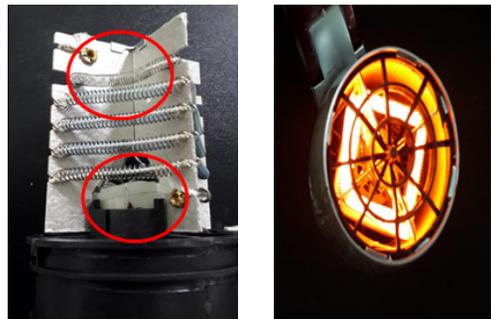
(a) Internal changes (after test) (b) Checking the operation (after test)

Fig. 5 Drop test results (30 times)

시험결과 30회 낙하 후 내부 모터부의 손상이 발생하였고, <Fig. 5 (a)>와 같이 열선의 휘이 육안으로 관측되었다. 동작상태 확인을 위하여 전원을 인가하였을 때 모터손상으로 인해 <Fig. 5 (b)> 히터부가 붉게 달아오르는 것을 확인하였다.

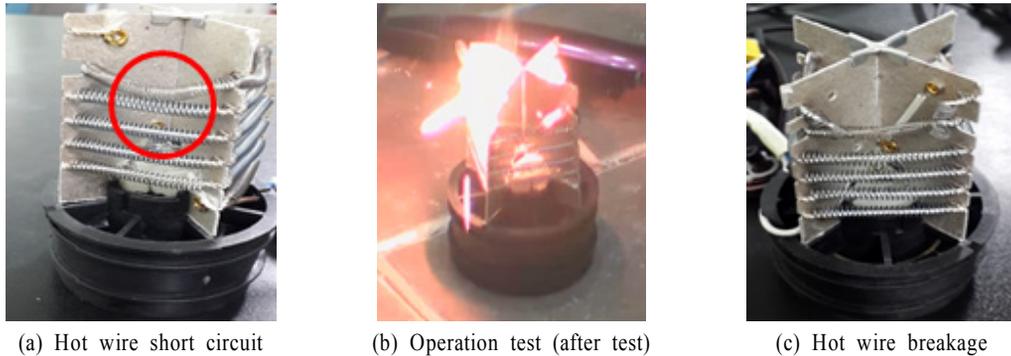
Fig. 6 Drop test results (40 times)

낙하 시험 40회 후 내부 변화 및 동작 상태를 확인해 본 결과 <Fig. 6 (a)>와 같이 내부열선은 더 휘어져 다른 열선과 단락이 되었고, 전원을 인가하자 <Fig. 6 (b)>와 같이 불꽃과 함께 히터부가 발화하였고, 그로 인해 열선이 <Fig. 6 (c)>와 같이 단선되었다.
