Experimental Study on the Structural Safety of the Tractor Front-End Loader Against Impact Load

Purpose: This study was conducted to experimentally investigate the structural safety of and identify critical locations in a front-end loader under impact loads. **Methods:** Impact and static tests were conducted on a commonly used front-end loader mounted on a tractor. In the impact test, the bucket of the front-end loader with maximum live load was raised to its maximum lift height and was allowed to free fall to a height of 500 mm above the ground where it was stopped abruptly. For the static test, the bucket with maximum live load was raised and held at the maximum lift height, median height, and a height of 500 mm from the ground. Strain gages were attached at twenty-three main locations on the front-end loader, and the maximum stresses and strains were measured during respective impact and static tests. **Results:** Stresses and strains at the same location on the loader were higher in the impact test than in the static test, for most of measurement locations. This indicated that the front-end loader was put under a severe environment during impact loading. The safety factors fo

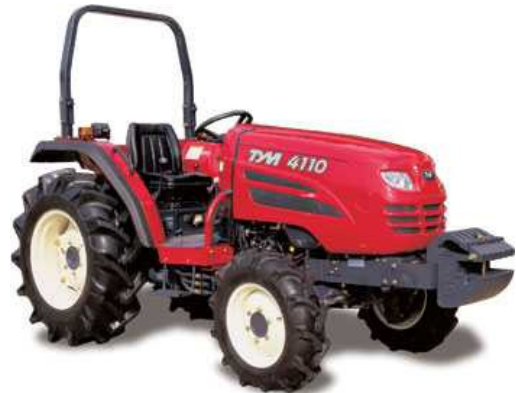
Figure 1. View of the tractor used in this study.

In this study, a front-end loader was mounted on a tractor to perform the impact load test. The tractor used was the 4110 model of Tongyang Moolsan with rated power of 29.1 kW, weight of 17.6 kN, and wheelbase and ground clearance values of 1813.6 mm and 330 mm, respectively. Moreover, the front-end loader used was the KTS-763 model of Taesung, a parallel type loader with two boom and bucket cylinders (Han, 2012). It had a weight of 5.8 kN, maximum allowable load of 4.9 kN and bucket capacity of 0.45 m³.

Tables 1 and 2 list the specifications of the tractor and front-end loader, respectively. Figure 1 shows the illustration of the tractor. The specifications of the tractor

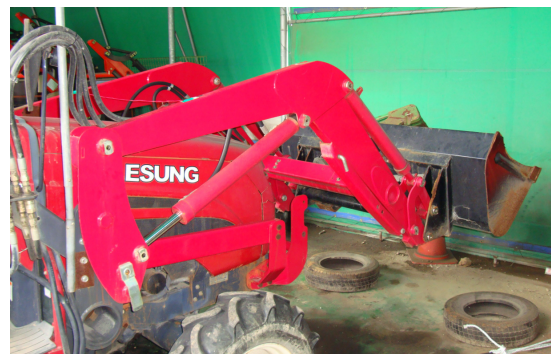
Figure 2. View of the front-end loader attached to the tractor.

are important because they determine the dimensions of the front-end loader attached system. Frames for attachment of the front-end loader were fixed on each front side of the tractor, and the front-end loader was mounted on these frames through bolted connections (Figure 2).

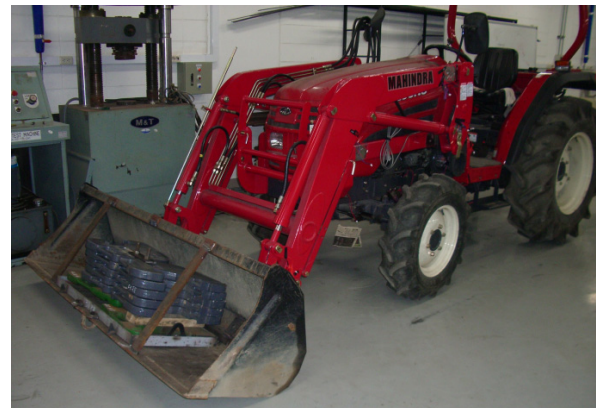
Figure 4. Weight added on the bucket.

The front-end loader bucket was loaded to the maximum allowable limit of 4.9 kN using weights (Figure 4). For the

impact test, the bucket loaded to the maximum allowable limit was raised to the maximum lift height. It was then allowed to free fall until a height of 500 mm off the ground, where it was stopped abruptly. This operation was repeated 20 times. During the test, the stresses and strains were measured at 23 locations on the front-end loader. Further, the static test was performed with the same bucket loaded with weights. In the static test, the bucket was raised to the maximum lift height (2670 mm), median height (1335 mm) and a height of 500 mm from the ground, and the stresses and strains were measured at the same locations as in the impact test.

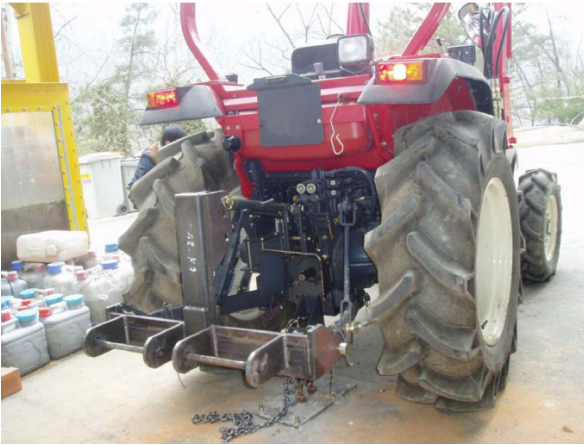
Figure 5. Anchor to connect the tractor to the ground.

part of the tractor where the front-end loader is mounted. An anchor was thus used to maintain contact between the rear part of the tractor and the ground to prevent the tractor from overturning owing to moment imbalance between the front and the rear portions about its center of gravity (Figure 5).

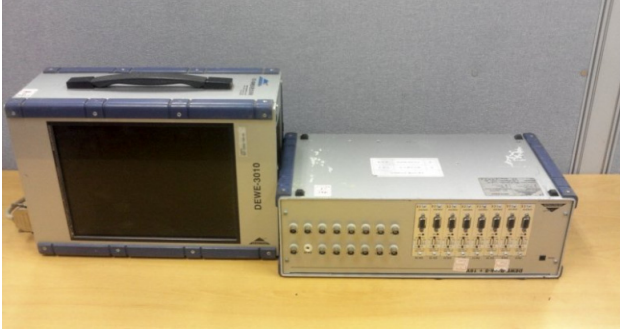
Figure 7. Data acquisition system (DEWE-3010).

The set up and specifications of the data collecting equipment are as shown in Figure 7 and Table 5. A low pass filter of 10 Hz was used to eliminate noise during measurements. For the impact test, the sampling rate was set to 2000 Hz, since a high peak strain occurs in a short

Strain gage module of a data acquisition system (DEWE-3010) was used to measure and collect the strain gage signals. When the nominal resistance of a strain gage is given as input to the data acquisition system, the module automatically sets up the Wheatstone bridge circuit including the strain gage, and the output to input voltage ratio of the Wheatstone bridge circuit is then generated corresponding to the strain gage signal. The strains and stresses at the measurement locations can be calculated by plugging in the values of the generated output to input voltage ratios in Eqs. (1) and (2) (Hannah and Reed, 1992) below.
