# Critical Influence of Rivet Head Height on Corrosion Performance of CFRP/Aluminum Self-Piercing Riveted Joints

This study investigates how rivet head height affects the corrosion performance of carbon fiber reinforced plastic (CFRP) to aluminum alloy self-piercing riveted joints. Specimens with two different head heights were prepared. A rivet head protruding out of the top CFRP laminate forms the proud head height while a rivet head penetrating into the top CFRP generates the flush head height. The salt spray test evaluated corrosion performance. The flush head joints suffered from severe corrosion on the rivet head. Thus, the tensile shear load of flush head joints was substantially reduced. Electrochemical corrosion tests investigated the corrosion mechanisms. The deeper indentation of the flush head height damaged the CFRP around the rivet head. The exposure of damaged fibers from the matrix increased the cathodic potential of local CFRP. The increased potential of damaged CFRP accelerated the galvanic corrosion of the rivet head. After the rivet head coating material corroded, a strong galvanic couple was formed between the rivet head base metal (boron steel) and the damage

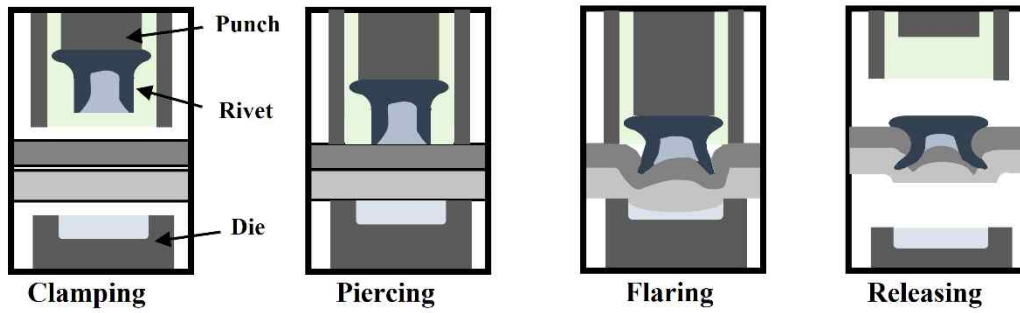
Fig. 1 Schematic diagram of four stages of SPR process.

divided into four stages as shown in Fig. 1. A mechanical interlock between the two sheets can be obtained by this process. In recent years, many advantages over traditional joining methods made SPR one of the important joining process for several renowned automotive companies. However, the galvanic corrosion susceptibility of SPR joints is an economic and safety concern for automotive manufacturers. It is well known that a strong galvanic couple can be formed between CFRP and steel rivets if the joint is exposed to a corrosion environment [5-7]. In general, CFRP is cathodic and performs as a noble material. The steel rivet is anodic and acts as an active material for corrosion. As a consequence of galvanic corrosion, the joint strength can be reduced and joint life-span can be shortened. Joint integrity such as head height, interlock distance, and remaining bottom material thickness are the well-known determining factors of the SPR joint strength [8]. The head height has been proven to play a crucial role in the quality of CFRP to aluminum alloy SPR joints. Head height can be defined as either proud head height or flush head height. If a rivet head protrudes out of the top CFRP laminate, proud head height is formed. In contrast, when the rivet head has deeper indentation as the

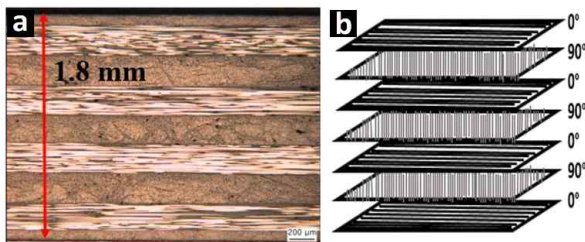
Fig. 2 CFRP laminate (a) cross-section, and (b) schematic of uni-directional prepreg orientation.

The joint consisted of a thermosetting carbon fiber laminate, an aluminum alloy sheet, and a boron steel self-piercing rivet. Almac<sup>®</sup> (50 – 65% Sn, 20 – 30% Zn, 6 – 11% Al) coating of 18 μm average thickness was applied on the rivet as the corrosion protective sacrificial layer. The mechanical properties of CFRP, aluminum alloys and rivet material used in this study are given in Table 1. The self-piercing rivets of 5.3 mm shank diameter, 7.8 mm head diameter and 6.0 mm length were used for preparing the specimen. The CFRP laminate was fabricated by 7 unidirectional carbon fiber prepreg in the form of 0° and 90° orientation. Fig. 2 shows the cross-section of CFRP laminate and the schematic of prepreg orientation.

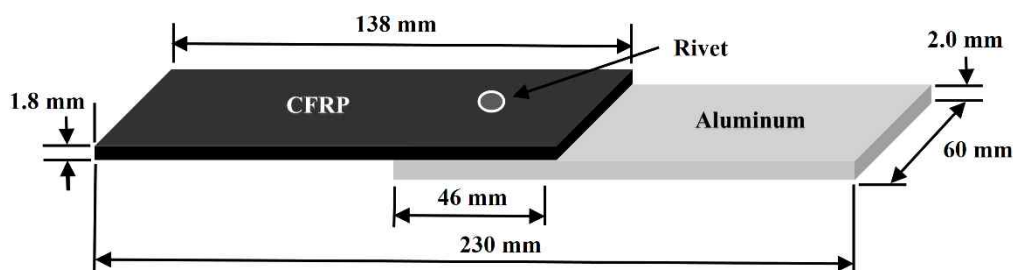
Fig. 3 Schematic of lap shear SPR joint geometry.

ISO 14273 standard, and had a total length of 230 mm and an overlap of 46 mm. The width of the specimen was 60 mm. A rivet was inserted at the center of the overlap area. The schematic of single lap shear specimen geometry is shown in Fig. 3. The joining process was performed by 4 kN of pre-clamping force and 49 kN of setting force.

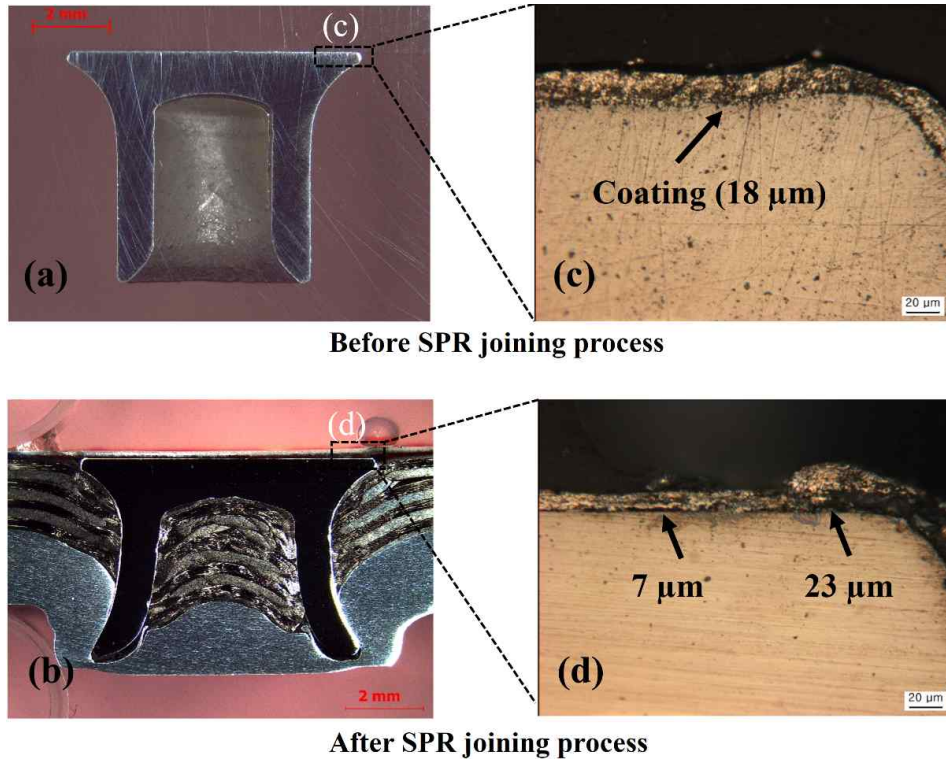
Fig. 4 Cross-sections of rivet (a) as received condition, and (b) after joining process of CFRP to Al joint, (c) and (d) magnified view of rivet head coating as received condition and after joining process, respectively.

7  $\mu\text{m}$  after the joining process. The coating thickness was reduced by about 61% of its initial thickness. In addition, the coating accumulation was observed at the edge of the rivet head. This phenomenon may happen as a result of coating squeezing out from the contact area between rivet head and rivet punch. At the edge of the rivet head, the coating thickness was increased up to 28%, and it was measured 23  $\mu\text{m}$ . This result is compatible with an earlier research that investigated the effect of joining process on rivet coating morphology. The research reported coating accumulation around the top sheet from rivet shank [10]. Therefore, the change of rivet head coating morphologies in different degree by the application of various setting

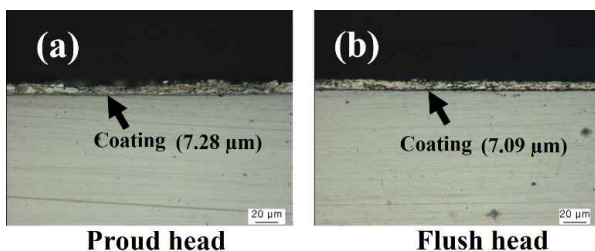
Fig. 5 Coating thickness on rivet head after SPR joining process of (a) proud head height (b) flush head height.

forces should be avoided for this study. Fig. 5 presents the coating thickness on the proud head (CFRP/Al 5083-O joints) and the flush head (CFRP/Al5052-H32 joints) after the SPR joining process by the application of same setting force. The average coating thicknesses on the rivet heads were measured 7.28  $\mu\text{m}$  and 7.09  $\mu\text{m}$  for proud head and flush head, respectively. This 2.6% difference in coating thickness may not have a significant effect on corrosion behaviour. Hence, Al5052-H32 (H32: strain-hardened and stabilized) and Al5083-O (O: annealed) were set as bottom sheet. In spite of, the application of same rivet, die geometry and setting force; different joint integrity were achieved due to the difference in strength and hardness of Al5052-H32 and Al5083-O. The joint integrity in terms of head height, interlock distance, and remaining bottom material thickness are given in Table 2. In CFRP/Al5083-O, as the rivet head was protruded out of the top surface of the top CFRP sheet, a proud head height was created. In CFRP/Al5052-H32, rivet head penetrated into CFRP laminate because of deeper indentation, and a flush head height was produced. The lower strength and hardness of Al5052-H32 facilitated the higher indentation of the rivet, and produced larger interlock distance of 0.55 mm. But, the deeper indentation of rivet head led to higher head

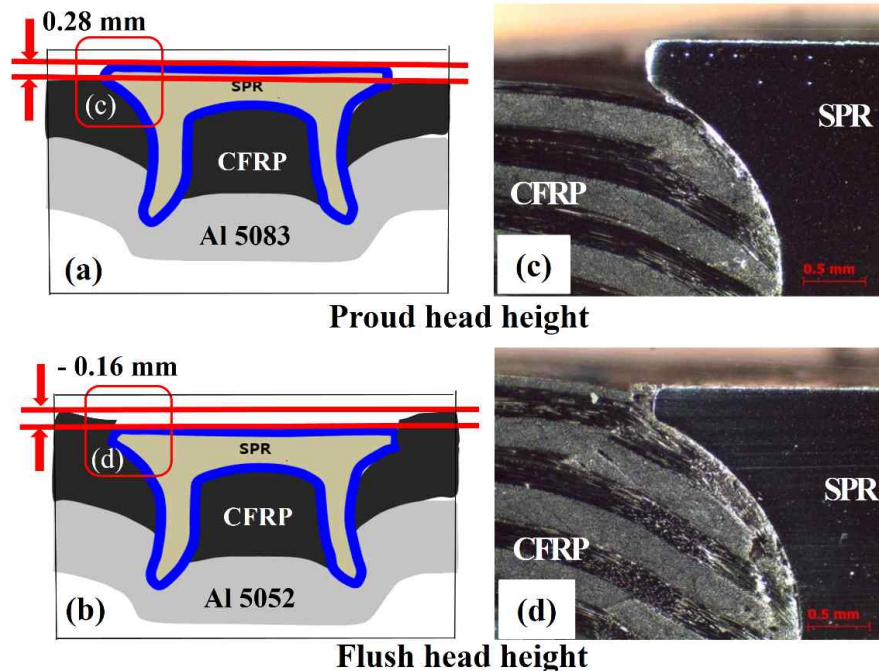
**Fig. 6** Cross-sections schematic of CFRP to Al alloy SPR joints with (a) proud head, and (b) flush head, (c) and (d) magnified view of proud head and flush head joints, respectively.

flushness of  $-0.10$  mm and lower remaining bottom material thickness of  $0.17$  mm. On the other hand, the higher strength and hardness of Al5083-O led to the proud head height of  $0.28$  mm, lower interlock distance of  $0.36$  mm and higher remaining bottom material thickness of  $0.44$  mm. Fig. 6 presents the head heights formed by CFRP/Al5083-O and CFRP/Al5052-H32 SPR joints. In addition, these two aluminum alloys were selected because of their similar corrosion properties. The electrochemical corrosion test results of Al5083-O and Al5052-H32 are presented in section 3.4.

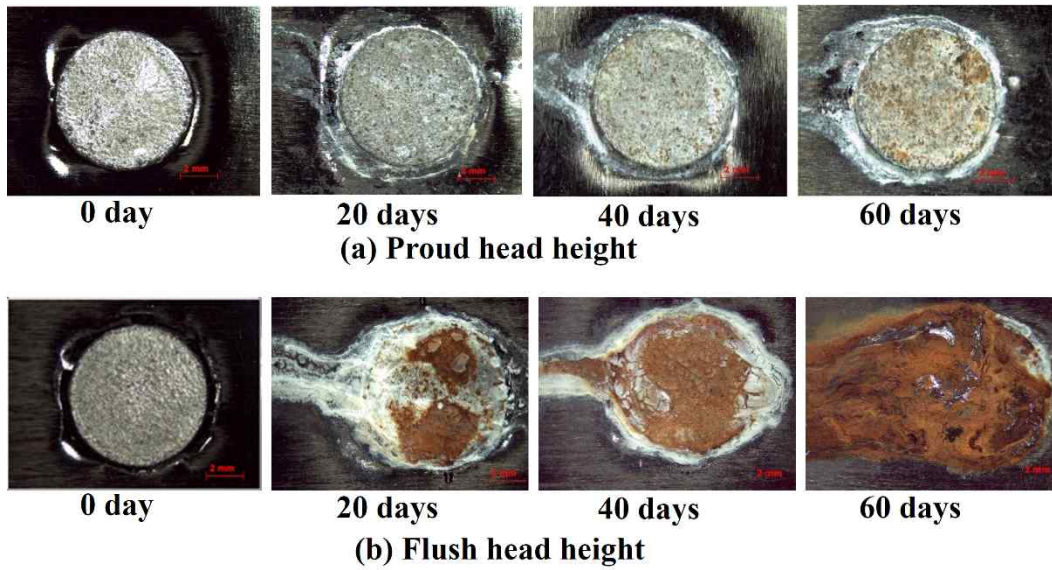
Fig. 7 Corrosion morphologies of rivet head for different salt spray test time of (a) proud head height, and (b) flush head height.

The single lap shear samples were placed in a salt spray corrosion test. Samples were taken after 10, 20, 40 and 60 days of corrosion test. The rivet head corrosion in different aging time by salt spray test are presented in Fig. 7. The proud head resisted the formation of red corrosion product for more than 40 days. In contrast, the flush head formed red corrosion product by less than 20 days and

experienced severe corrosion on the following aging days. The energy-dispersive X-ray spectroscopy analysis was done to characterize the white and the red corrosion products (Fig. 8). Zinc oxide was identified as white corrosion product as a result of rivet coating corrosion, and iron oxide was identified as red corrosion product because of rivet base metal corrosion.

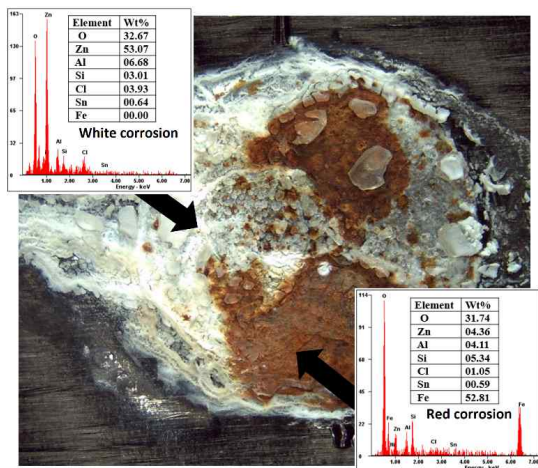
Fig. 8 Energy-dispersive X-ray analysis (EDXA) analysis for white and red corrosion product characterization on rivet head.

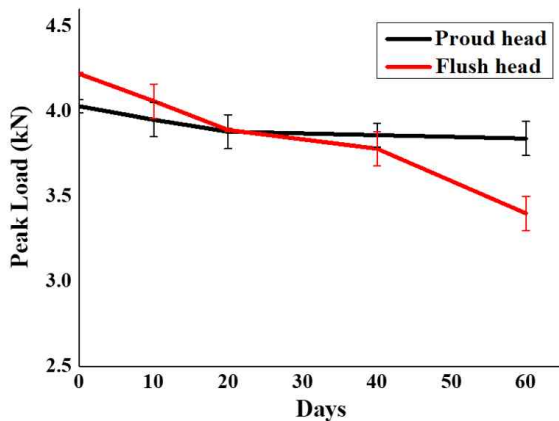
Fig. 9 Shear load for proud head and flush head SPR joints in different aged salt spray test time.

The single lap shear test of corroded samples at the different aging time was conducted. Fig. 9 indicates the change in peak load at the different aging time of salt spray test. The results showed that the severe rivet head corrosion of flush head led to a reduction of peak load up to 19.5% by 60 days. Moreover, the initial failure mode of rivet pullout from the top and the bottom sheet was changed to rivet pullout from only the top sheet by 40 days of corrosion. In comparison, proud head experienced a reduction of peak load by only 4.7% without any significant change in failure mode. Fig. 10 shows the initial

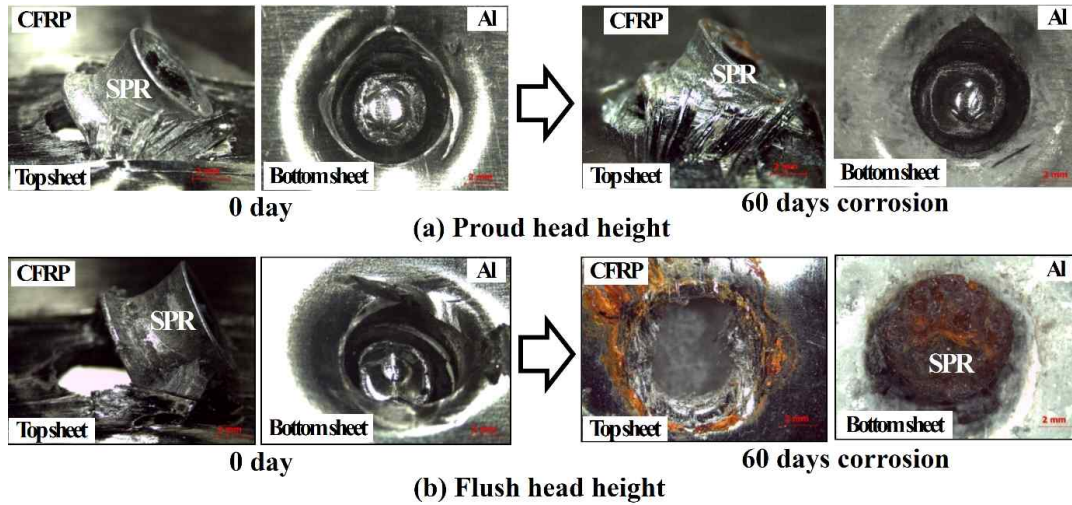
Fig. 10 Failure mode at initial condition and 60 days aged corrosion of (a) proud head height, and (b) flush head height.

failure mode and 60 days aged failure mode for proud head and flush head SPR joints.

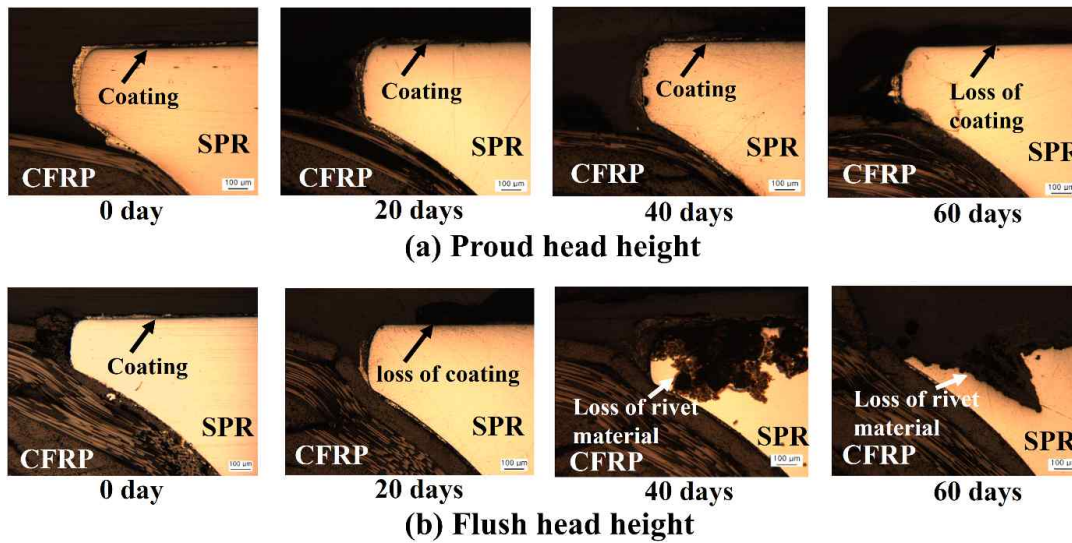
Fig. 11 Cross-section of rivet head at initial condition, and corrosion in 20, 40 and 60 days of salt spray test of (a) proud head height, and (b) flush head height.

The cross-sections of rivet head at the different aging time of corrosion test were also analyzed (Fig. 11). In case of proud head, the coating of the rivet head was gradually corroded with aging time, and no coating was observed at 60 days. The result is consistent with the observation of red corrosion product on the rivet head at 60 days (Fig. 7). In comparison, the faster corrosion of rivet head coating was evident for the flush head. The coating was corroded by less than 20 days and exposed the rivet base metal. The red corrosion product was formed due to the rivet material (boron steel) corrosion by 20 days, and eventually, led to severe corrosion of rivet head material by 60 days.

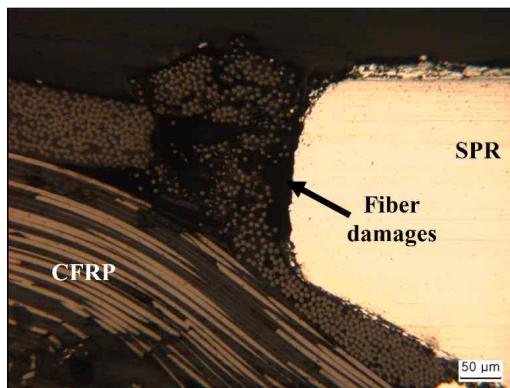
Fig. 12 CFRP breakage and delamination around the rivet head by flush head SPR joint.

The higher indentation of the flush head can locally damage the top CFRP laminate around the rivet head. Unlikely, the proud head did not experience any significant fiber damages. Fig. 12 shows the fiber damages phenomena of CFRP around the rivet head due to deeper penetration of the flush head. The carbon fiber breakage, delamination, and de-bonding from matrix around the rivet head have been evident in the case of the flush head which is consistent with the findings of a prior study [9].

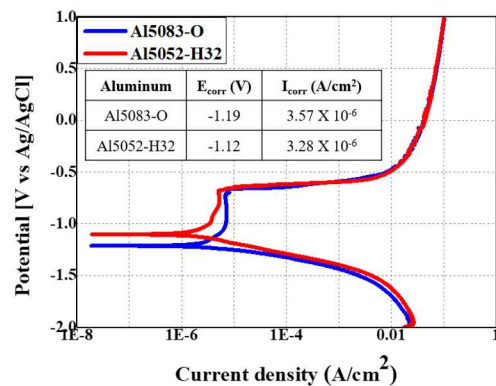
Fig. 13 Potentiodynamic polarization curve of Al5083-O and Al5052-H32 aluminum alloys.

Two different aluminum alloys were applied as bottom sheet to prepare the different head height by the application of same rivet setting force. The potentiodynamic polarization test results of A15083-O and A15052-H32 are shown in Fig. 13. The corrosion potential of A15083-O

bottom sheet, the difference in the potential value of 0.07 V may not have a significant influence on the rivet head corrosion mechanism which is the point of interest in this study.

and Al5052-H32 were measured as - 1.19 V and - 1.12 V, respectively. As the aluminum alloys were used for

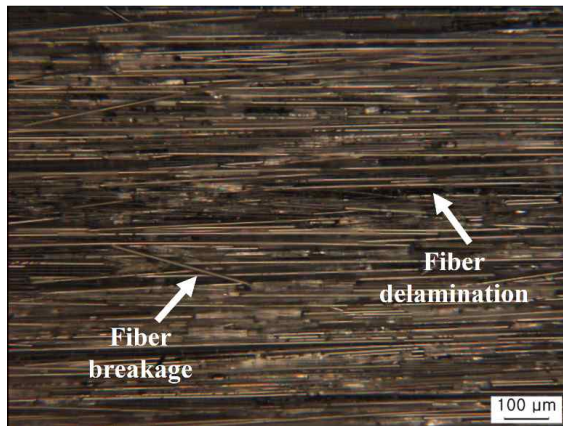
Fig. 14 Fiber breakage and delamination by removal of CFRP top ply.

In proud head height, a galvanic coupling was in between rivet head and CFRP top surface. But, in flush head height, a galvanic coupling was formed between rivet head and damaged CFRP. In this situation, the corrosion potential measurement of damaged CFRP is essential. But, it is very challenging to measure the corrosion potential of damaged CFRP around the rivet head. In order to generate a similar condition of fiber breakage and delamination, the top ply of the CFRP laminate was peeled off. The fiber breakage and delamination from the matrix happened during the removal of top ply. Fig. 14 shows the morphology of damaged fiber after peeling off the top ply of the CFRP sheet. The potentiodynamic polarization tests were conducted for the top surface of CFRP laminate as received condition and the surface with damaged fibers after removal of the top ply. Fig. 15 presents the potentiodynamic polarization test results of CFRP. The corrosion potential of CFRP laminate was measured as - 0.13 V. In contrast, 0.08 V was measured for damaged fibers. The results are compatible with previous research which reported that the different surface condition of CFRP laminate produced by polished and unpolished specimen performed different corrosion behavior [11]. The potentiodynamic polarization tests were conducted for rivet head with coating and after removal of coating (Fig. 16). The corrosion potential and corrosion current density of CFRP and rivet are presented in Table 3. Here, the galvanic coupling of CFRP to rivet head is 0.21 V higher for the flush head than that of the proud head at the initial time of corrosion test. As a result, the corrosion of the rivet coating was faster for the flush head. After rivet head coating corrosion, the base metal of rivet was exposed to the corrosive environment, and the red corrosion product was formed by only 20 days for the flush head. At this mo-

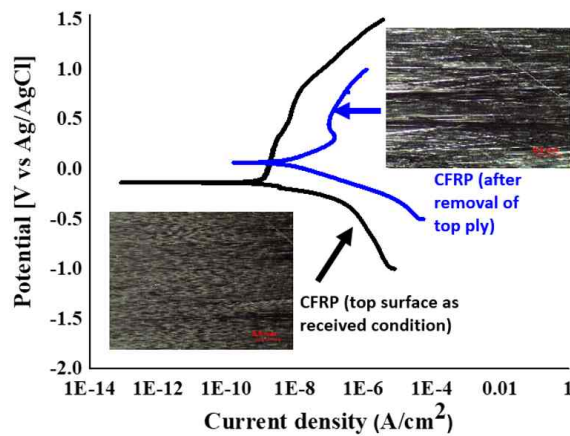
Fig. 15 Potentiodynamic polarization curve of CFRP (top surface of received condition and after removal of top ply).

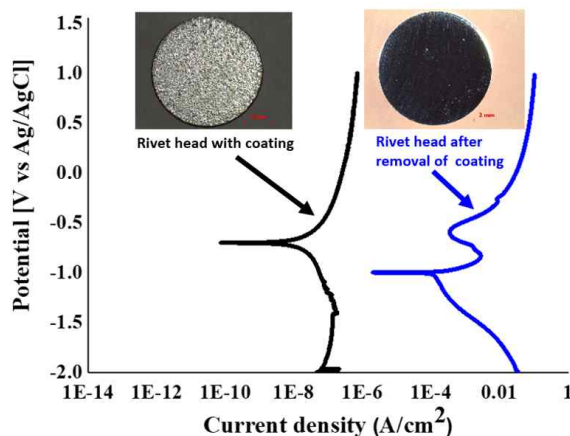
Fig. 16 Potentiodynamic polarization curve of rivet head (with Almac<sup>®</sup> coating and after removal of coating).

ment, the galvanic coupling was formed in between CFRP damaged fiber and rivet base metal boron steel. The corrosion mechanism of proud head and flush head are presented as a schematic in Fig. 17. The corrosion potential of rivet without coating was measured as  $-1.0$  V, which was  $0.3$  V more anodic than that of the rivet with coating. The higher amount of Sn in Almac<sup>®</sup> coating may lead to lower anodic potential of coated rivet than that of an uncoated rivet. At this situation, strong galvanic coupling of  $1.08$  V was formed in between damaged CFRP and rivet head (boron steel). The increase in the potential of galvanic coupling became a further acceleration factor to corrosion after the loss of rivet head coating by 20 days. Henceforth, the rivet head of flush head was severely corroded by 60 days. Comparatively, the corrosion of a proud head was not as bad as a flush head. At the starting of the corrosion test,  $0.57$  V potential difference of CFRP laminate and rivet head led to the slower corrosion of rivet head coating. At 60 days of aging time, the loss of coating led to the formation of red corrosion product on rivet head. In addition, the loss of rivet head coating can increase the galvanic coupling up to  $0.87$  V which is not as severe as  $1.08$  V of a flush head case.

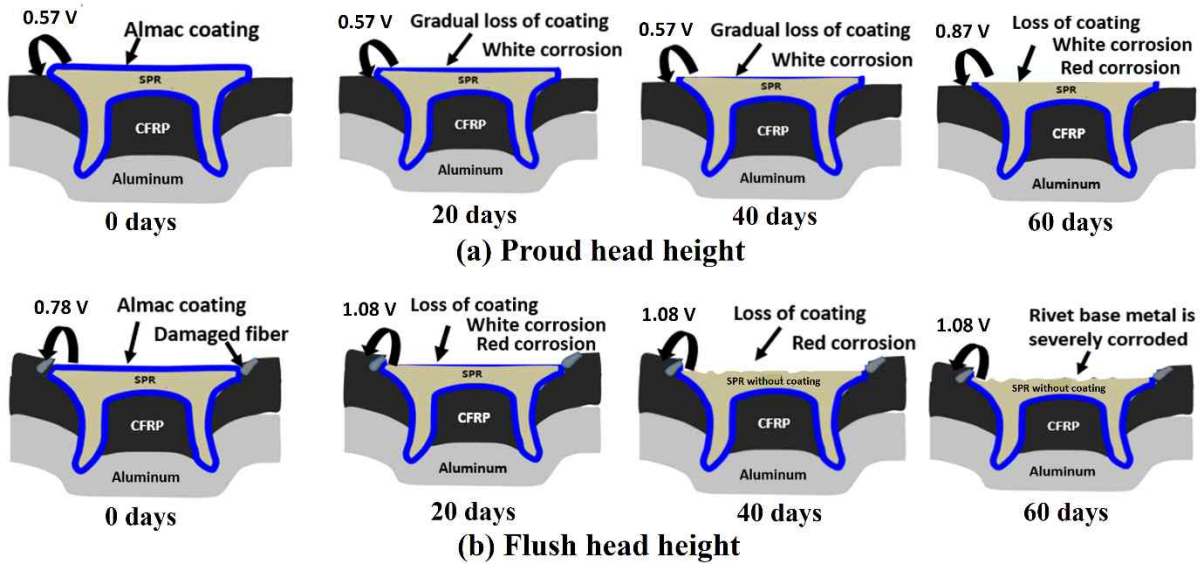
Fig. 17 Schematic diagram of corrosion mechanism of rivet head at different aging time for (a) proud head height, and (b) flush head height.
