# Characteristics of Friction Behavior of Ceramic Friction Materials according to Surface Materials

Ji-Hun Park<sup>1</sup> · Jung-Woo Lee<sup>2\*</sup> · Jong-Won Kwark<sup>3</sup> · Woo-Jin Han<sup>4</sup> · Oneil Han<sup>5</sup>

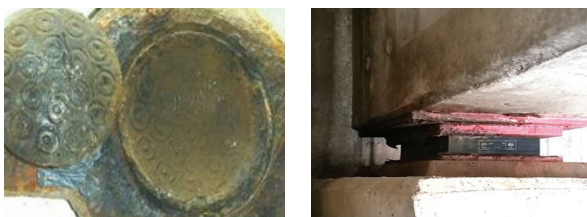
**(a) high-strength brass friction material rust**      **(b) corrosion of bearing supports due to rust**

**Fig. 2. Corrosion of bearing supports**

led to a decline in the performance of the friction material. Particularly, integration due to gradual rust generation is problematic because this support type involves contact between two metal surfaces(Fig. 2).

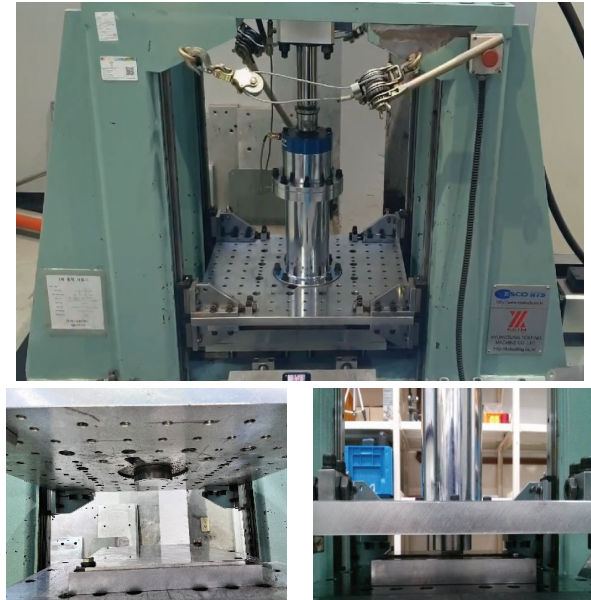
Fig. 3. Friction test setup

This test was based on the friction test method outlined by Han et al.(2023). The friction tests adhered to the AASHTO standard, which describes a method for evaluating the effect of frictional behavior on the bearing support. The friction test machine, capable of measuring displacement and load acting upon the specimens, is shown in Fig. 3. Detailed specifications of the test machines are listed in Table 1. The friction material specimen was configured with a thickness and diameter of 5
