## Ultrasonography in the management of lip complications caused by hyaluronic acid

Ultrasonography is highly accurate for evaluating soft tissues. Given that minimally invasive aesthetic procedures are on the rise, complications have become more prevalent. Thus, ultrasonography holds promise for assisting in the diagnosis and management of complications arising from these interventions. This report highlights the importance of ultrasonography in the treatment of complications caused by hyaluronic acid injection. A patient visited a dental office 24 hours after hyaluronic acid application, presenting pain and bruising in the middle and inferior thirds of the face on the right side. To evaluate blood vessels, the surgeon used Doppler-mode ultrasonography, which enabled the precise application of hyaluronidase to reestablish blood perfusion and preserve adjacent structures. Therefore, to avoid severe outcomes, such as necrosis or even amaurosis, the use of ultrasonography is suggested, improving the precision and safety of these procedures. (*Imaging Sci Dent* 2024; 54: 296-302)

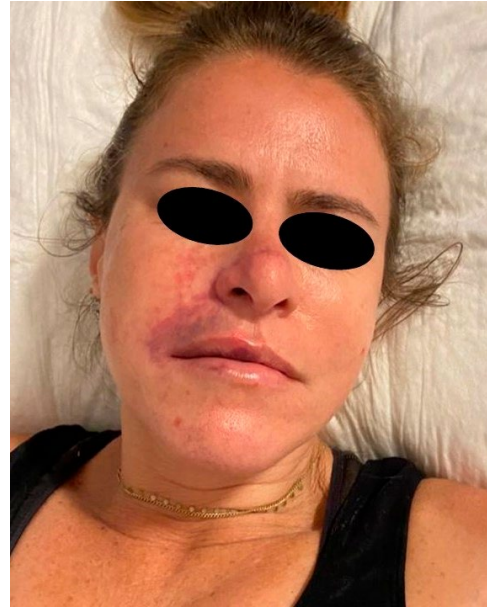
**Fig. 1.** Photograph of the patient's face obtained before ultrasound-guided hyaluronidase application.

A 53-year-old female patient visited the dental office 24 hours after receiving a 1 mL injection of HA with lidocaine into her upper and lower lips. She exhibited painful symptoms and ecchymosis in the area of the right upper lip, nose, and oral vestibule (Fig. 1). During the anamnesis, she reported no comorbidities and denied taking any medications. She also mentioned that approximately 2 years prior, she had undergone several cosmetic procedures, including the insertion of polydioxanone threads, a mini temporal lift, botulinum toxin injections, and zygomatic filler.

Using USG, it was clearly observed that the area affected by arterial compression was located in the region of the right upper lip. The filler material impacted the space between the subcutaneous layer and the orbicularis oris muscle. Laterally, the convergence of fibers from the zygomaticus minor, levator labii superioris and ala nasis, and levator labii superioris and levator anguli oris muscles was evident in the region of the modiolus (Fig. 2A). Compression of the branches stemming from the facial artery led to tissue hypoxia, resulting in changes in skin color and the lip mucosa, as depicted in Figure 1.

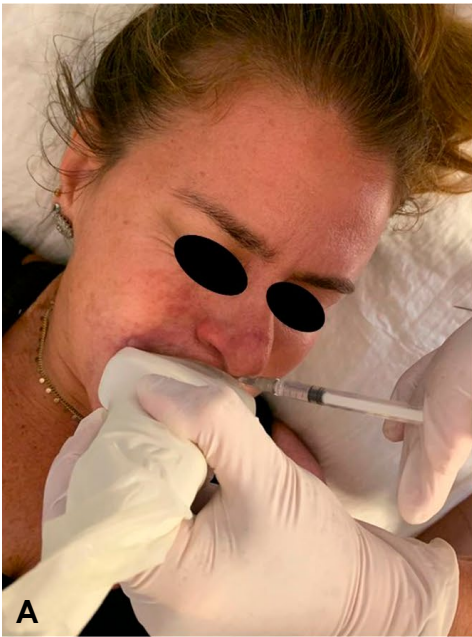
**Fig. 3.** Ultrasonography images of the patient’s face during hyaluronidase application. A. The transducer positioned transversely during application of the enzyme. B. Ultrasonographic image of the right upper lip region to visualize the needle (arrows), hyaluronidase (▲: hyperechoic aspect). C. Ultrasonographic image of the right lip commissure region after the application of hyaluronidase. D. Doppler ultrasonographic image of the right upper lip region with the transducer in a transverse position showing the reestablishment of blood flow in the region of the subnasal artery, a branch originating from the superior labial artery, after application of hyaluronidase. E. Doppler ultrasonographic image of the right upper lip region, with the transducer in an oblique position to visualize the reestablishment of blood flow in the area surrounding the superior labial artery after new application of hyaluronidase. E: epidermis; D: dermis; ST: subcutaneous layer; OM: orbicularis oris muscle; SM: submucosa; V: vestibule; T: teeth; ▲▲: labial vessels; MX: maxilla.

After identifying the affected regions through USG, the next step involved the guided administration of the hyaluronidase enzyme to alleviate the vascular blockage. It is important to note that the date and time of each hyaluronidase application are indicated in the upper right corner of the USG images presented in Figure 3. The treatment spanned 3 hours and consisted of five applications of the hyaluronidase enzyme, totaling 5 mL, administered to the patient's upper lip under USG guidance (Fig. 3A) to degrade HA. The clinician administered the enzyme precisely, using the USG images to avoid excess and prevent damage to surrounding tissues. This approach allowed for real-time visualization of the boundaries of the affected area (Fig. 3B), leading to the successful restoration of normal arterial flow in the region.

USG with Doppler mode was crucial for determining the precise location, depth, and characteristics of the filling material, as well as for mapping and analyzing the arterial flow in branches of the facial and ophthalmic arteries. The patient was discharged only after complete remission of symptoms and the restoration of arterial flow were confirmed by USG Doppler mode analysis (Figs.

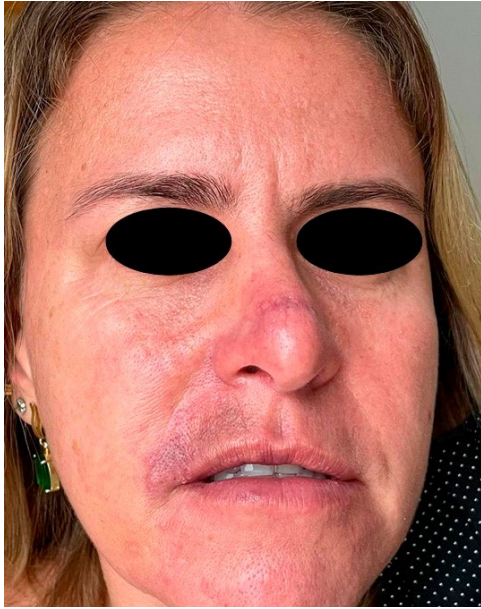
**Fig. 4.** Photograph of the patient's face 1 day after ultrasound-guided hyaluronidase injection.

3C-E). Additionally, the next day, an improvement in skin color was clinically observed following ultrasound-guided treatment (Fig. 4).
