**Behavior of Dams during the 1995
Hyogoken-Nambu Earthquake and
Earthquake Resistance of Dams**

Behavior of Dams during the 1995 Hyogoken-Nambu Earthquake and Earthquake Resistance of Dams

Yoshikazu YAMAGUCHI, Dr. Eng.

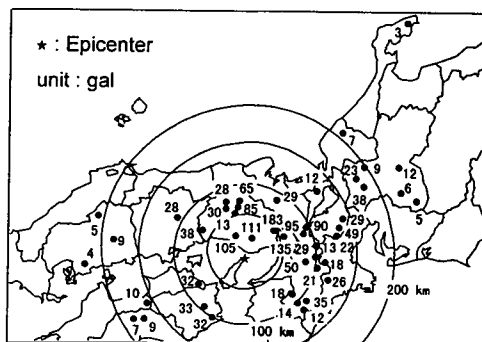
Figure 2. Map of horizontal peak acceleration at dam foundation.

About 50 dams are located within 50 km of the epicenter of the earthquake. Figure 2 shows the distribution of the horizontal peak accelerations recorded at the dam foundations during the earthquake. The dam closest to the earthquake fault, called the Nojima Fault, was the Tokiwa Dam (about 800 m from the Nojima Fault). There are also many old dams in Kobe City, where the earthquake damage was most severe. The Gohonmatsu Dam,

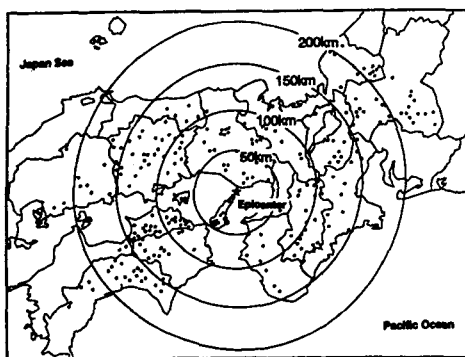
Figure 3. Locations of dams inspected by site offices.

dams. The locations of the inspected dams are shown in Figure 3.

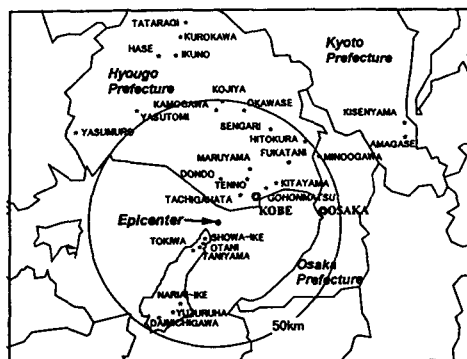
Figure 4. Location of dams inspected by Ministry of Construction.

The Ministry of Construction carried out detailed on-site inspections of dams, including the dams where minor damage was reported, through the special safety inspections by site offices, and analyzed the details of damage and gathered the acceleration records. Figure 4 shows the locations of the 28 dams inspected and Table 2 summarizes the survey results. The survey results are outlined below.

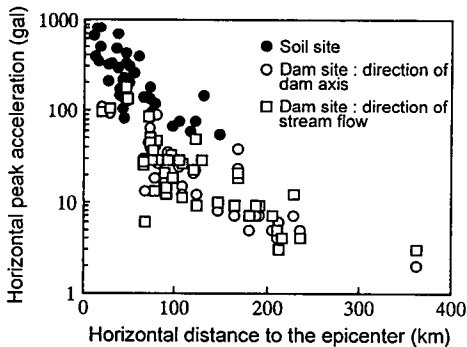
Figure 9. Attenuation of horizontal peak accelerations with distance to the epicenter.

The horizontal peak accelerations observed during the earthquake are shown in **Figure 9**, and the vertical peak accelerations are shown in **Figure 10**.

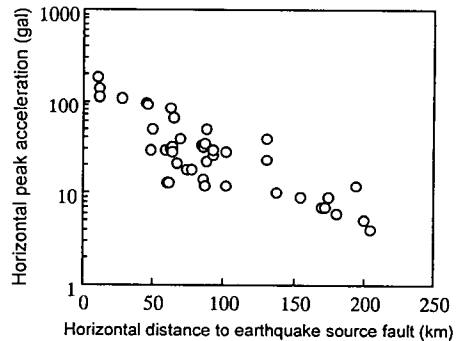
Figure 11. Attenuation of horizontal peak accelerations with distance to earthquake source fault.

Figure 11 shows the horizontal peak accelerations at dam sites with distance from the earthquake source fault [1]. The location of the earthquake source fault was estimated from the distribution of epicenters of aftershocks on the day of the main earthquake (Jan. 17) in the Hanshin area, and coincides with the Nojima Fault in the Awaji area.

The acceleration records at 8 dams were obtained within a distance of 50 km from the earthquake fault, and the maximum horizontal acceleration at dam sites was 183 gal (10 km from the earthquake source fault). After the overall assessment of the acceleration records shown in Figure 11 and other records at rock sites similar to dam sites, the Committee estimated that the maximum horizontal

acceleration induced by the earthquake was about 220 gal at rock sites where dams might be built [1].

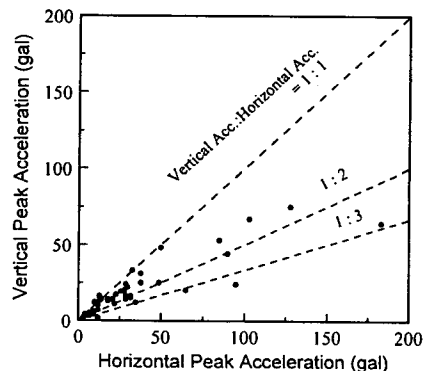
Figure 12. Horizontal peak acceleration versus vertical peak acceleration.

Figure 12 shows the relationship of the horizontal peak acceleration with the vertical peak acceleration observed at dam sites during the Hyogoken-Nambu Earthquake [1]. The ratio of the vertical peak acceleration to the horizontal peak acceleration ranges from 1/3 to 1/1. This ratio tends to decrease as the horizontal peak acceleration increases.

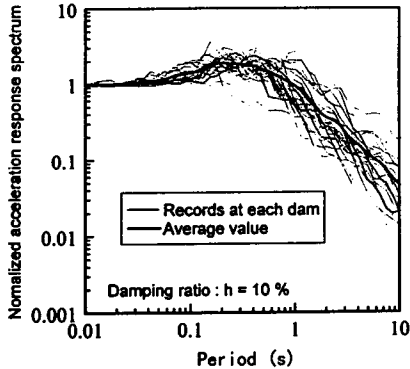
Figure 13. Response spectrum of the acceleration observed at dam foundations.

Figure 13 shows the response spectrum of the acceleration at a damping ratio of 10% in the stream direction observed at 25 dam foundations during the Hyogoken-Nambu Earthquake [1]. Each spectrum is normalized so that the maximum observed acceleration is equal to 1. The average value of the response spectra for the natural period ranging from 0.1 to 0.6 seconds is about 2. The response spectra decreases rapidly when the natural period exceeds about 0.6 seconds.

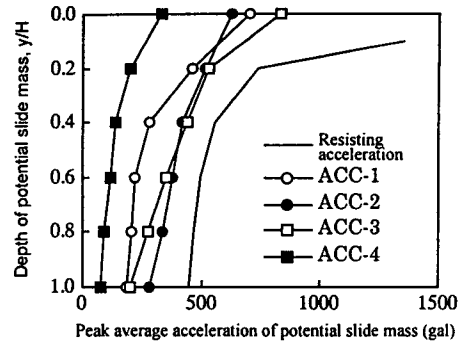
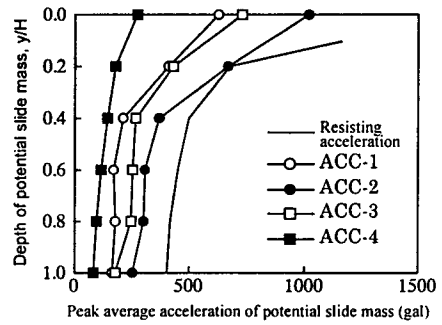
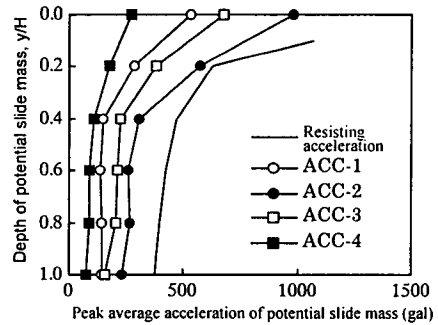
Figure 21. Peak average acceleration of potential slide mass.

Figure 21 shows the relationship of the peak average acceleration of the sliding mass for a given y/H with the critical acceleration. Here, the critical acceleration is defined as the acceleration which causes the potential sliding mass to begin to slide. The critical acceleration was calculated using the shear strength of the materials shown in **Table 5**. The figure shows that the peak average acceleration is larger in the upper part of the dam, but that the value is still within the critical acceleration in all cases. This reveals that the rockfill dam is safe against sliding.
