Some Case Studies of Hydrodynamic Bearings in Power Plants in Japan

Some case studies of hydrodynamic bearings in power plants in Japan

Tanaka M.^a

Keywords : Journal bearing, thrust bearing, oil seal, damage, tribology, steam power plant

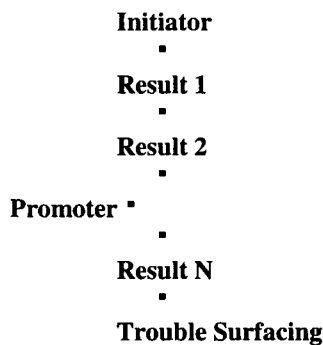
Figure 1 shows why so many troubles take place in actual machines even though design engineers make the most of the state-of-the-art knowledge of tribology. There may be an initiator that triggers off the chain of events finally making the trouble rise to the surface. A promoter may expedite the chain reaction at one stage or another. Among this chain of causes and results, the events closest to the troubles are easy to recognise as the primary or direct causes listed in the previous section.

Fig.1 Chain of cause and result
