Detection of the Ultrasonic Signals due to Partial Discharges in a 154kV Transformer

Dong-Jin Kweon*, Sang-Bum Chin* and Hee-Ro Kwak**

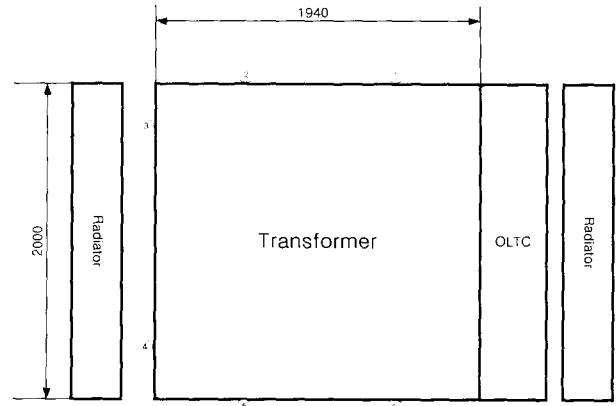
Fig. 5 Positions of the ultrasonic sensors in the first test

In the first test, the ultrasonic sensors were mounted at equality intervals on the transformer steel wall to detect the ultrasonic signals due to the partial discharge as shown in Fig. 5. The ultrasonic sensors were mounted on the middle point of the transformer.

In the first test, the 18 ultrasonic signals occurred for 14 hours of measuring time. 11 of them had the maximum value in magnitude at sensor ⑥, 3 of them had at sensor ①, 2 of them had at sensor ③, and the rest were at sensors ② and ④. The delayed time from the ultrasonic source to the sensor was the shortest where the magnitude of the ultrasonic signal was the maximum.

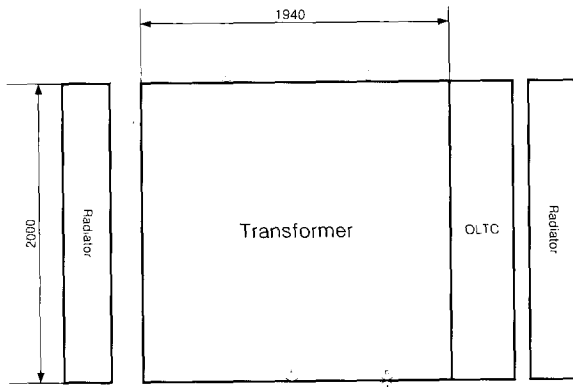
Fig. 7 Positions of the ultrasonic sensors in the second test

As the result of the first test, the ultrasonic signals due to partial discharge were located around sensor ⑥. Therefore, sensors ④ and ⑤ in Fig. 5 were moved around sensor ⑥ to detect ultrasonic signals more precisely, as shown in Fig. 7. Sensor ④ was mounted at the lower position of the transformer, and sensors ⑤ and ⑥ were mounted at the upper position.

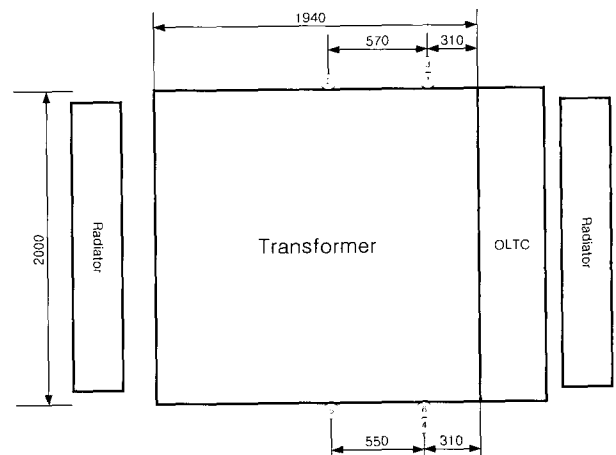
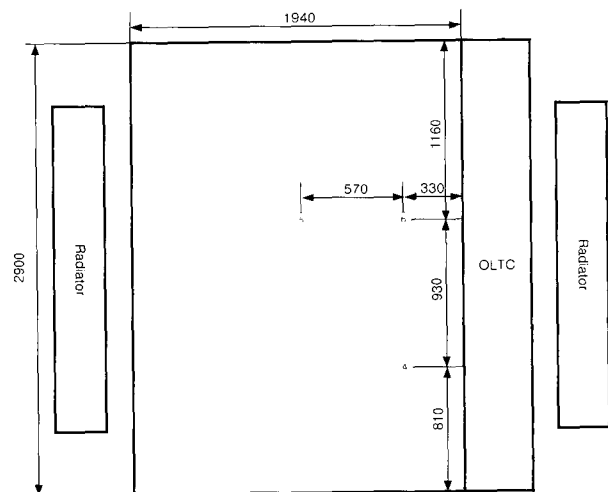
Fig. 9 Positions of the ultrasonic sensors in the third test

After the second test, the gas in oil was analyzed again. The C2H2 gas was still produced at the warning level. After 1 month, the ultrasonic test was carried out again to estimate the position of partial discharge. The 6 ultrasonic sensors were mounted on the right side around the OLTC at which the partial discharge is likely to occur, as shown in Fig. 9.
