Application of hydrogeological and geophysical methods to delineate leakage pathways in an earth fill dam

Sung-Ho Song¹ Yoonho Song² Byung-Doo Kwon³

ABSTRACT

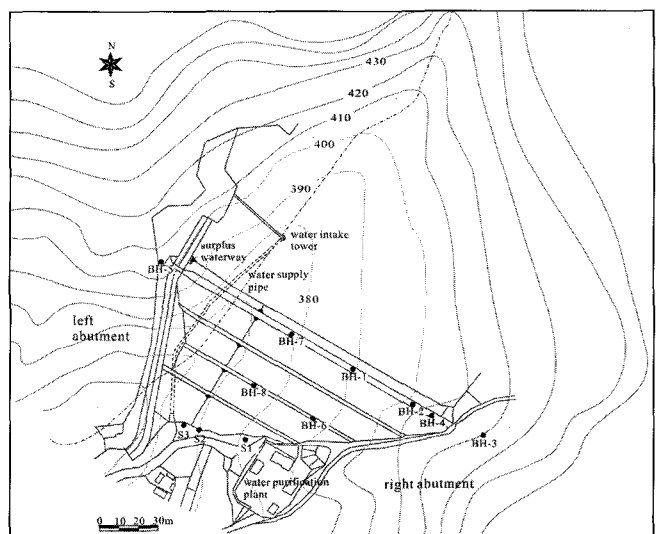
Leakage was detected at three locations near the toe drain (S1, S2, and S3 of Figure 1) of the dam. Eight boreholes were drilled along the crest and the downstream steps of the dam for various hydrogeological tests and temperature logging (Figure 1).

Fig. 1. Plan view of the general setting of the Sandong earth fill dam, with locations of water purification plant, water intake tower, overflow spillway, water supply pipe, three leakage points (S1, S2, and S3), and eight boreholes (BH-1 to BH-8).

This study area is a reservoir site which has anomalous leakage through one abutment. Two tracer tests indicate that the leakage pattern is through the right abutment, and the leakage rate is calculated to be 12.1 m/day from BH-8 to the discharge point S1 (Figure 1). The results of monitoring of drawdown and leakage variations with discharge of reservoir water indicated that the leakage possibly occurred at the bedrock boundary near BH-2 and BH-4. The trend of leakage at S1 was related to the reservoir level, so we have concluded that the leakage pathway in this reservoir dam is through the right abutment.

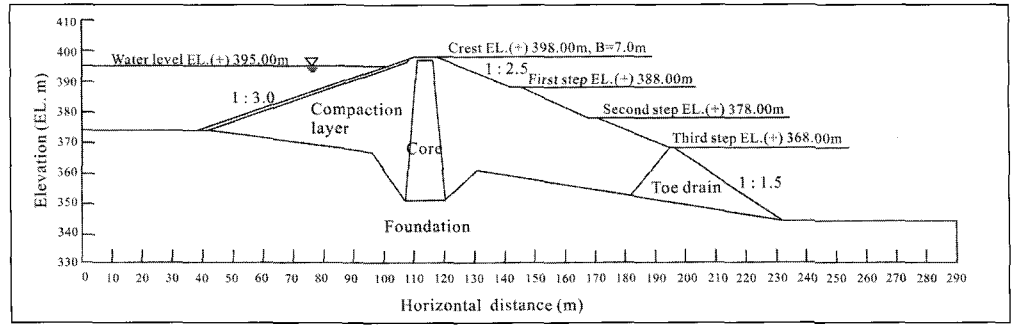
Fig. 2. Vertical cross section of the dam.

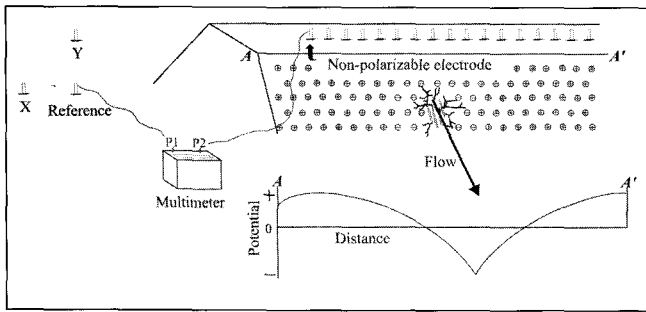
Fig. 8. Schematic diagram for geometry of data acquisition using the SP method at the dam wall (modified from Butler and Llopis, 1990).
