## Compaction Grouting for remedial works of Settlement of CWIS(Cooling Water Intake Structure) of a Power Plant

Su-Jung Gwak<sup>1)</sup>, Man-Soo Lee<sup>2)</sup>

The unexpected settlement of the CW Intake Structure (CWIS) of Combined Cycle Power Plant 450MW CCPP in Bangladesh has been continuously observed after this structure was completed.

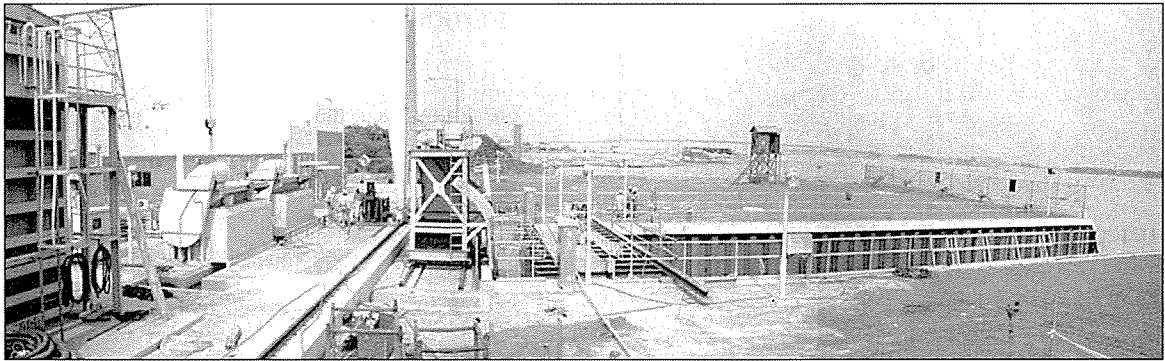
Fig. 1 Scenery of Intake Area

Several investigations based mainly on the CPT<sup>1)</sup> result indicated that the very loose silty sand layer with high permeability below the CWIS existed due to losses of fine particles through the interface zone between the CWIS and sheet piles during rainy season but it didn't have reduced significantly a bearing capacity yet. Additionally, it was known that the settlement of CWIS was resulted from the area of very loose soils which had been enlarging as the severe difference of the elevation between ground water and river water would have been suddenly developing.

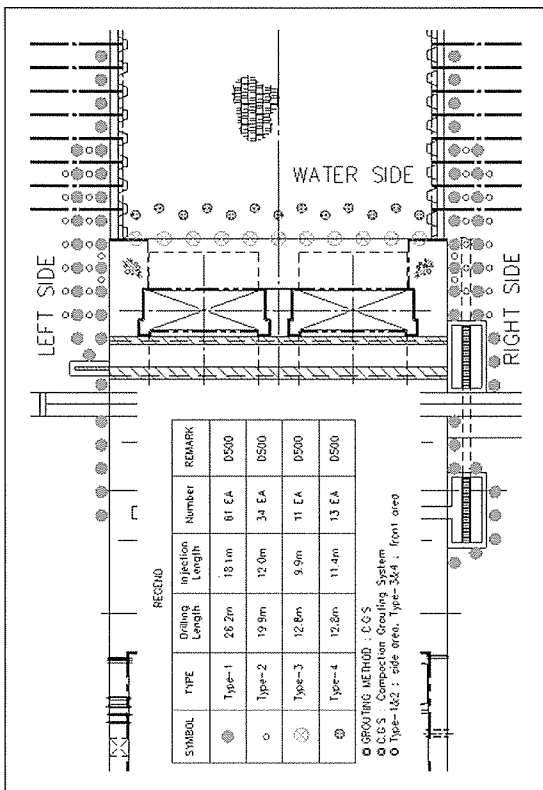
Fig. 2 Layout of CGS Work

Remedial works had been designed to cease additional settlement of the CWIS and to decrease the permeability

of soils of the interface zone between the CWIS and the sheet piles based on the analysis results.

Herewith Compaction Grouting System(CGS) method was adopted in order to decrease voids among soil particles and to increase both the shear strength and the bearing capacity of this soils by forming rigid mortar piles support.

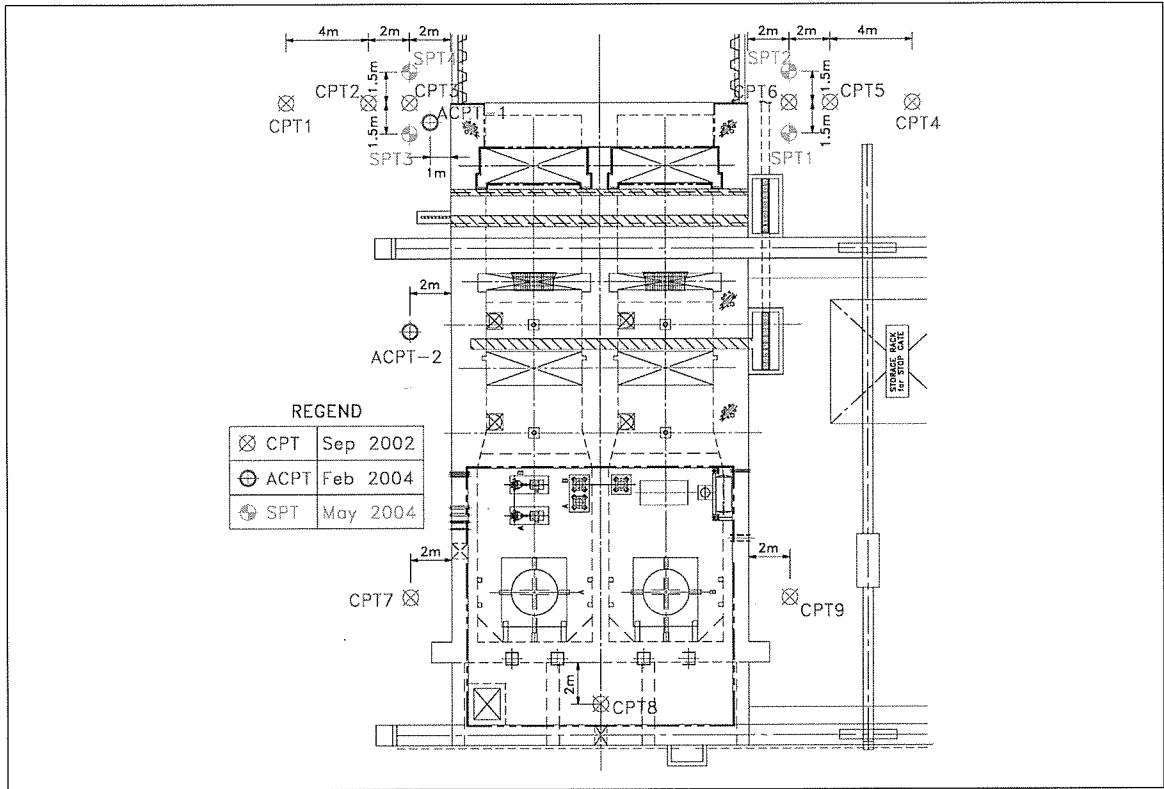
Fig. 6 CPT Test Location

loose to loose zone of sands and silty sands below 3m(G.L-18.5m) the base of CWIS(on southern side area), where it abuts the sheet piles(test location CPT 2, CPT 3, CPT 5 and CPT 6). But the subsurface profile at test locations CPT 1, CPT 4, CPT 7, CPT 8 and CPT 9 indicated the presence of a medium to very density zone of sand and sand silty.
