# Cause Analysis of Flow Accelerated Corrosion and Erosion-Corrosion Cases in Korea Nuclear Power Plants

Y. S. Lee<sup>1†</sup>, S. H. Lee<sup>1</sup>, and K. M. Hwang<sup>2</sup>

<sup>1</sup>Korea Hydro & Nuclear Power Co., LTD, Central Research Institute

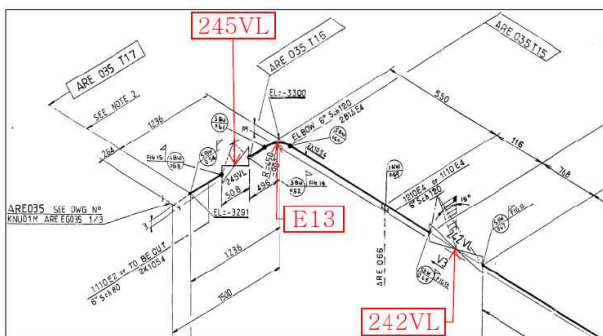
Fig. 6. SG1 elbow line isometric drawing.

Wall thinning was founded in a bending elbow (A106

Gr. B) of SG1 line in feedwater system during the RFO-18. The elbow was replaced and similar elbows of other lines inspected. The elbow of SG (Steam Generator)3 line was also thinned but the elbow of SG2 line was not thinned.
