Case Study of Slope Investigation on the Cretaceous Sedimentary Rocks Using the Geological Cross-Sections

Myeong-Hyeok Ihm¹ · Woo-Seok Kim^{2*} · Oil Kwon³

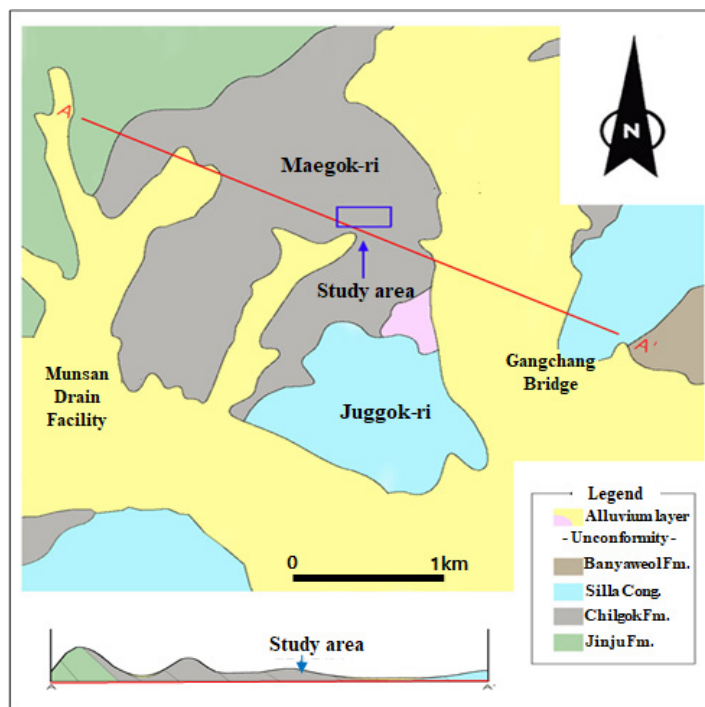
The rock in the study area was non-marine sediment rock that belonged to the Gyeongsang Supergroup, the Hayang Formation, and the Chilgok Formation deposited in the Cretaceous period of the Mesozoic age (GSK, 1928a, 1928b), and was red in color, which indicated it was formed under an oxidizing environment (Fig. 4). Two intermediate dacites, which were penetrated along the discontinuity surface at a later stage by making the sediment rock as parent rock, were penetrated and distributed several meters wide (Fig. 3).

Fig. 4. Geological map and cross-section map (A-A') of the study area.

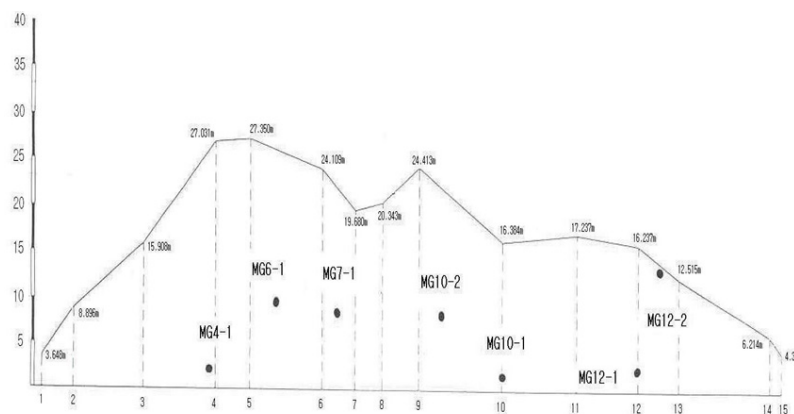
The physical properties and mechanical tests of eight rocks collected in the representative locations (Fig. 6) inside the slope that reflected the rock type and discontinuity characteristics were conducted. The test items were specific gravity, water content ratio, absorption rate, wet unit volume weight in the physical test, and uniaxial compression and point load strength tests. The results are summarized in Table 3.

Fig. 6. The location map of rock samples on the slope (MG: sample No.).
