A Visual Inspection System for Monitoring Weld Quality in LNGC Ship Construction

Abstract: In this paper, a visual welding inspection system for LNGC ship construction process is developed, which is mounted on a wall-climbing robot. For this purpose, we designed the inspection hardware system composed of two cameras and specially designed flexible illumination system. Two cameras with different fields of view are adopted for observing various kinds of defects. Using this inspection system, we can detect and classify four important welding defects ; 1) bead shape abnormality, 2) bead pitch abnormality, 3) arc strike, and 4) scratch, which crucially affect the LNGC tank capacity. Since each of them has its own characteristics on its shape and its image intensity, we can use visual sensors to inspect welded regions effectively. The effectiveness of the proposed system and the inspection algorithm is verified through a series of experiments. As experimental results, the accuracy to detect defects successfully is over 90% and the task time for inspection is within 8 seconds.

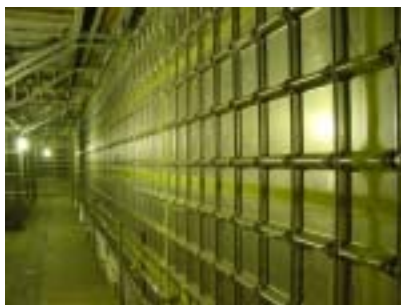
The LNGC(Liquid Natural Gas Container) ship is designed to convey the Liquid Natural Gas between countries with three or four tanks for storing the LNG. The inside walls of each tank consist of a large number of thin stainless plate as shown in Fig. 1, and each thin plate is attached on another using TIG welding technique for making a big tank with cubic shape. The total length of welding line on one LNGC tank is about several kilometers. It indicates that the possibility of welding mistakes is strong. Therefore, for welding parts inspection process has become more and more important thing for the LNGC ship building process. However until now the inspection process only depends on very well trained inspector, and few automated systems are applied to it. Due to these reasons the low efficiency on manual inspection process deteriorates the productivity.

Fig. 1 The LNGC tank which consists of many plates

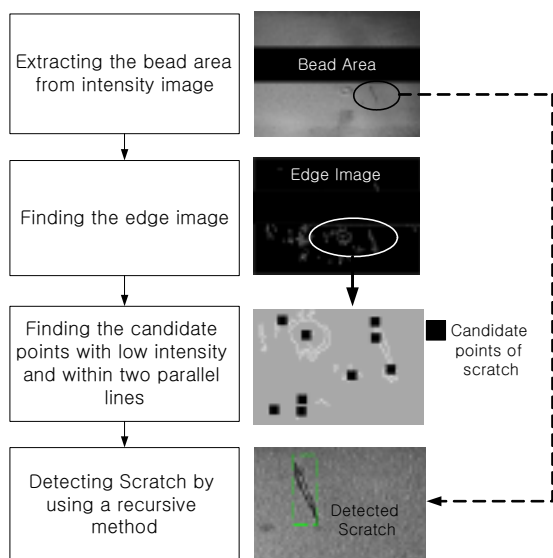
Fig 14. Intensity and edge image of arc strike

The scratch is detected with wide field view camera and side illumination source. The algorithm to detect the scratch is verified by using these raw images and we can check a result as follows:

Fig. 14. shows that the result of the scratch detection algorithm. After adapting the detection algorithm we can successively find the scratch. The task time is 0.581. The average task time with Gaussian filtering is 0.649 second for 20 test images. By these experiments we can verify the effectiveness of algorithm.
