도장 오염이 Electric Cable 의 성능에 미치는 영향 연구

대우조선해양 산업기술연구소^{*}
도장 기술 연구 그룹^{**}

A Study on Effect of Coating Stain on the Performance of Electric Cable

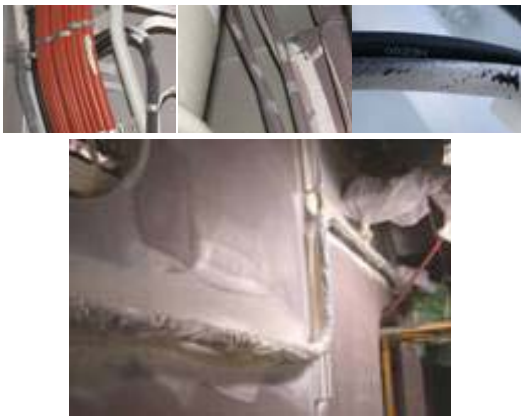
Fig. 1 Coating stains on electric cable sheath(above) and protection by vinyl material(below)

In the shipbuilding industry, the installation of electric cables in the engine room block frequently was performed before the final painting work. Despite of many protection efforts to prevent coating stains on electric cable sheaths these were unavoidably occurred by the

additional painting work, as shown in Fig. 1.

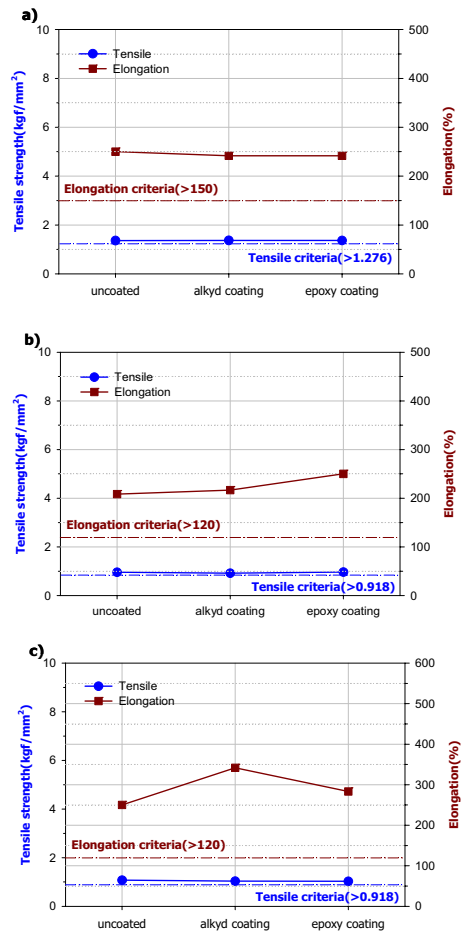
Fig. 4 Tensile test result of a)ST2 b)SHF1 c)SHF2 sheath

Fig. 4 shows tensile test results of a)ST2 b)SHF1 c)SHF2 sheath. Blue line indicates the tensile strength, red line indicates elongation and dash-dot line indicates the requirement of this standard.

There was not the decrease of the tensile property of coated sheaths, in comparison with that of uncoated sheaths and the requirement of IEC 60811-1 standard was met.

This test was performed according to IEC 60811-1 standard. For the requirement of this standard on the tensile property of a sheath material, ST2 sheath shall have the tensile strength above 1.276kgf/mm², elongation above 150%. SHF1 and SHF2 sheath shall have the tensile strength above 0.918kgf/mm², elongation above 120%.

These results show that coatings does not adversely affect on the mechanical property of sheath materials.

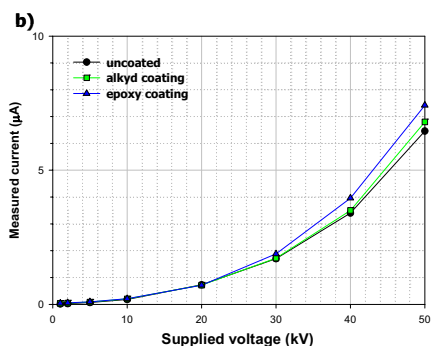
Fig. 5 shows high potential voltage test results of a)ST2 b)SHF1c)SHF2 sheath.

Fig. 5 High potential voltage test result of a)ST2 b)SHF1 c)SHF2 sheath

The measured current gradually increased as increase of the supplied voltage both of uncoated and coated sheaths.

However, although the supplied voltage was very high, the measured current was very low as the current unit of μA .

In addition, there was little difference on the measured current between uncoated and coated condition.
