## Investigation of the granite related to faulting and engineering geology

Lee, Byung-Joo, Kim, Soo-Jeong\*, Chae, Byung-Gon

KIGAM, 92 Gwahang-no, Yuseong-gu, Daejeon, 3050350, KOREA

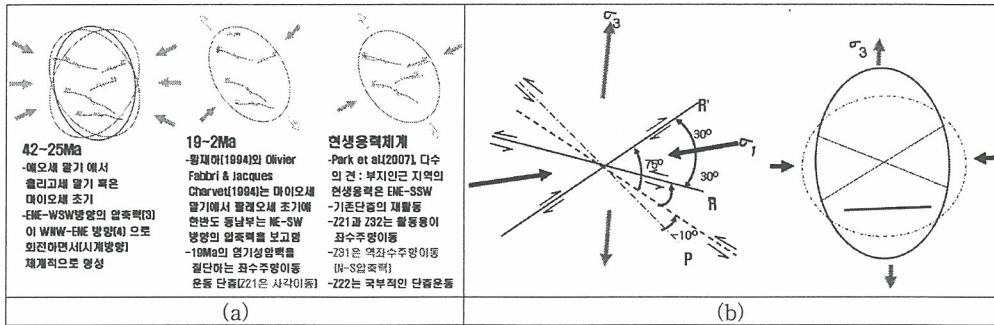
Fig 2. (a): sequence of faulting at the site (after KHNP & HEC, 2008)  
 (b): sinistral strike-slip zone, Riedel shear arrays for both sinistral and dextral faulting, R and R' form first, P shear 'come in' a little later [After Woodcock and Schbert(1994)]

Five faults are developed at the area, which are two ENE direction faults (Z22 & Z31), two WNW trend direction faults (Z21 & Z32) and E-W fault (Z23) (Fig. 1). These faults were reactivated at least 6 times from late Eocene to present (Fig 2, a. KHNP & HEC, 2008). By the trends of these faults without consideration of the movement sense they were able to make R, R' the nearly E-W compression(O1) with P (Fig. 2 b). Also E-W direction of normal fault could make the compression regime.

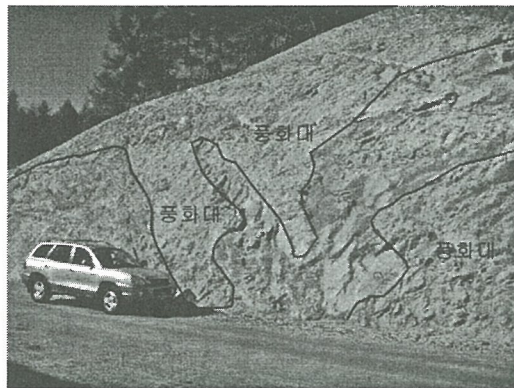
Fig. 3. Very irregular weathering contact at granite outcrop

The granite is formed by slowly cooling magma at the deep underground. So in general it is equigranular texture and relatively isotropic under the fresh and undeformed condition with over 1,500kg/cm<sup>2</sup> uniaxial compressive strength and 2,000m/sec by seismic velocity. However, when it is weathered, the feldspar is easily weathered and makes the residual soil like sand. During the weathering rock surface easily makes an exfoliation and the surface which is boundary between weather and fresh one, is very irregular (Fig. 3).
