생분해성 마그네슘 합금의 부식 특성과 표면 처리 연구

Study on Corrosion mechanism of Biodegradable Magnesium alloy and Surface treatment

한국생산기술연구원 표면처리실용화연구그룹 인천지역본부 (E-mail: june@kitech.re.kr)

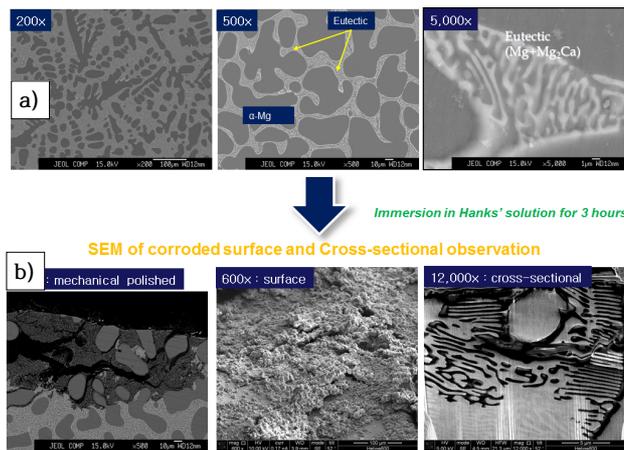
Figure 1. SEM observation of Mg alloy cross-section; (a) As cast, and (b) corroded surface and cross-section.

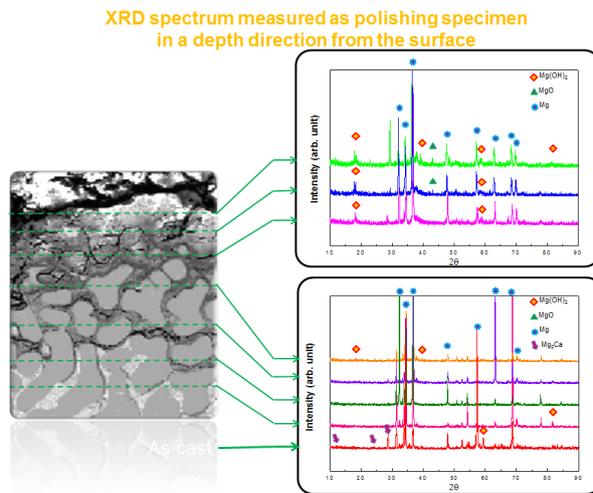
Figure 2. XRD analysis of corroded Mg alloy in deep profile(~100um)

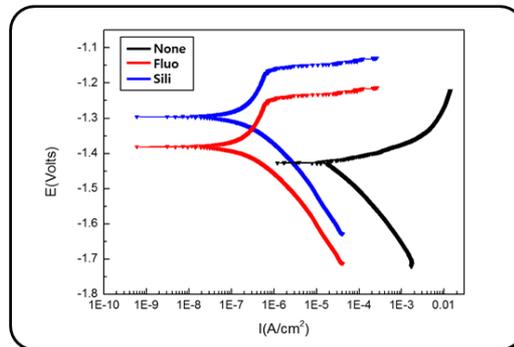
Potentiodynamic polarization curves of the samples

Sample	Open circuit potential (V)	Corrosion current density (A/Cm ²)
None	-1.4275	1.78×10^{-4}
Fluo	-1.3815	1.66×10^{-7}
Sili	-1.2965	1.96×10^{-7}

Figure 3. Potentiodynamic polarization curve of anodized Mg alloy

마그네슘-칼슘 2원계 합금을 이용하여 생체 모사용액(SBF)에서 부식을 진행하고, 부식 거동과 부식 산화물을 분석하여 부식 거동 및 부식 특성을 확인하였다. 또한, 생체적합력을 높인 아노다이징(anodizing; PEO)방법을 통해 표면처리 후 아노다이징 산화막의 특징을 관찰하고, Hank's solution(생체모사용액) 을 사용하여 부식 특성을 분석 하였고 (Potentiodynamic polarization curve), L929 세포를 이용하여 세포독성 평가(Cytotoxicity test)를 진행하였다.
